# **Evaluation Report**

137

Kirchner Model 70 Automatic Bale Wagon

# KIRCHNER MODEL 70 AUTOMATIC BALE WAGON

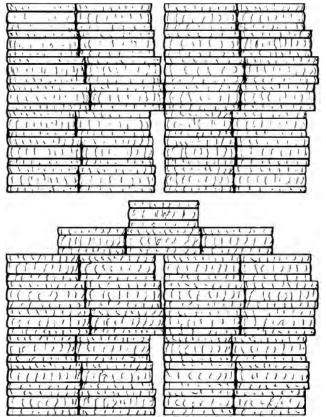
The most durable stacks were formed by stacking two or more loads wide. Multiple row stacking reduced weathering by decreasing the exposed surface area and also aided in stack stability. Uniform bale lengths were very important for multiple row stacking. Large bale length variations caused gaps between rows leading to internal weathering and spoilage. When gaps were a problem, the stack could be hand capped, by moving the top bales as shown in FIGURE 6.

FIGURE 6. Hand Capping to Reduce Weathering Between Bale Rows

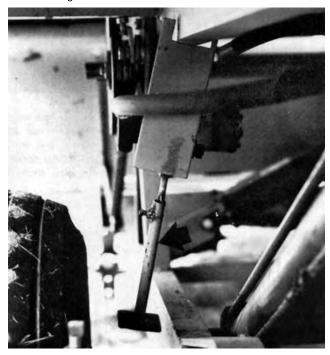
When the load deck is lowered, the load deck fingers are winched forward by a hydraulic motor. The motor was started when an activator rod contacts the main frame. The rod sometimes slipped off the main frame (FIGURE 14) as the mechanism was supported only by the hydraulic plumbing. Stable support for the activator mechanism is recommended.

FIGURE 14. Load Deck Finger Activator Rod Misaligned with Main Frame.
