EVALUATION REPORT

353

CO-OP IMPLEMENTS 742 SELF-PROPELLED WINDROWER

A Co-operative Program Between

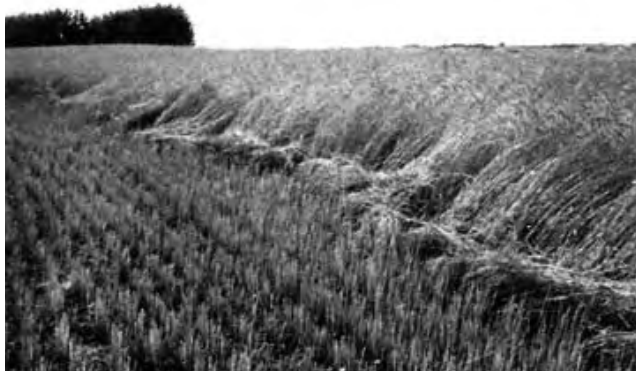
Dividers: In average straight standing crops, divider performance was satisfactory. However, the wide divider and knife drive box normally flattened a strip of crop, causing a slight crop loss (FIGURE 1). Cutting in the opposite direction on the next pass recovered most of the flattened crop. The centre divider plugged in wet and tangled rapeseed and had to be cleared with the reel. It is recommended that the manufacturer consider modifications to improve the performance of the dividers.

FIGURE 1. Crop Flattened by the Divider.

1. Modifications to improve the performance of the dividers.
2. Modifications to the reel lift system to make it more convenient to operate.
3. Relocating the instrument console for more convenient viewing or providing audible alarms for all instruments.

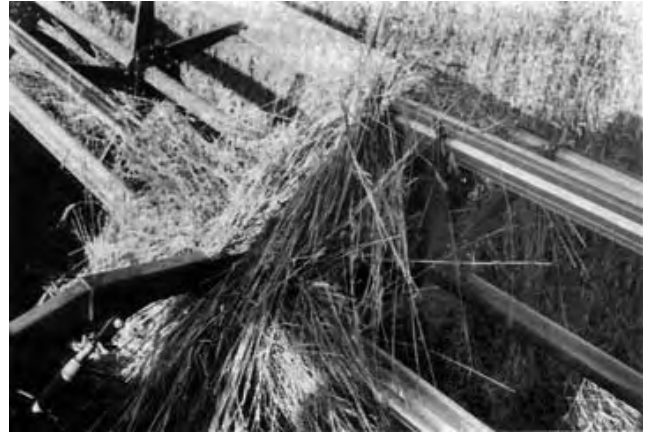
losses, in heavy and tangled crops, material occasionally caught on the two centre reel arms, and stopped the reel (FIGURE 2).

FIGURE 2. Material Caught on the Reel Arm.

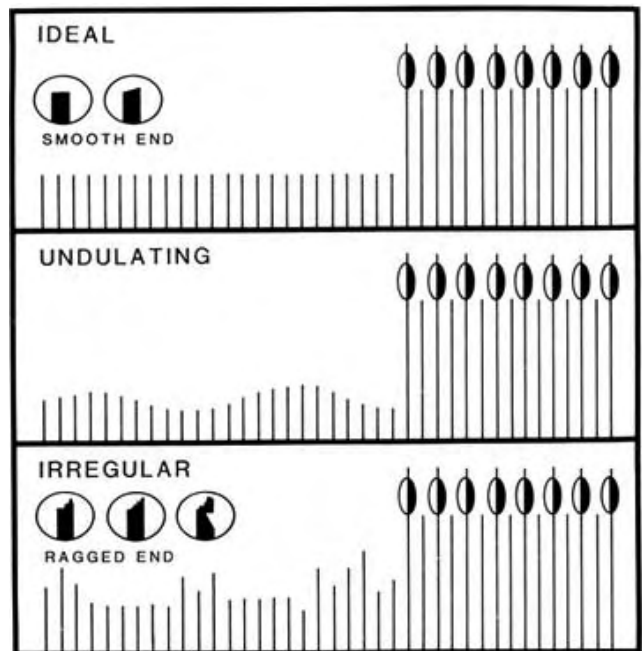
Cutterbar: Cutting ability was very good in cereal crops and straight standing oilseed crops. Stubble was usually ideal (FIGURE 3). In tangled green rapeseed crops, material collected on dull sections of the knife. In hard-to-cut crops, it was important to replace worn knife sections and guards.

FIGURE 3. Types of Stubble.

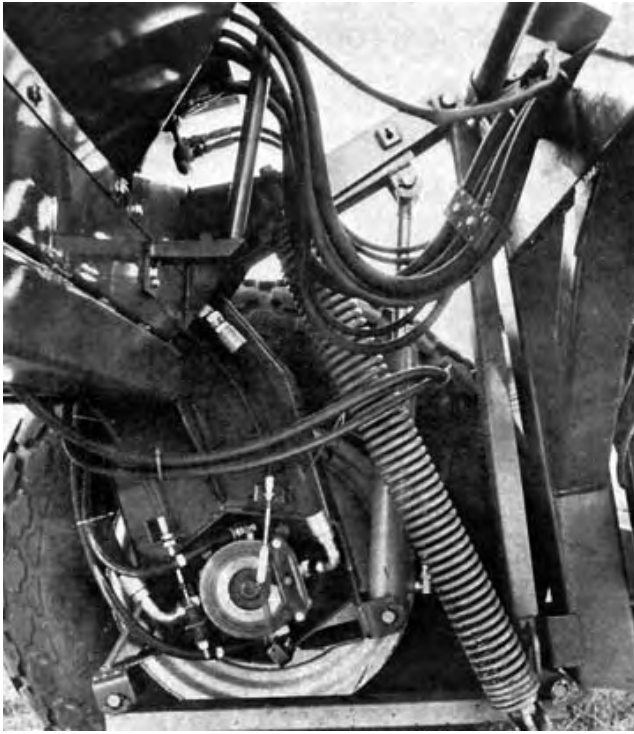
Header Flotation: Header flotation was very good. Flotation was provided by four tension springs on the traction unit (FIGURE 4) and two tension springs on each wing wheel (FIGURE 5). Header flotation minimized cutterbar damage in stony fields. The hinged wings enabled the header to follow most ground contours. Undulating stubble occurred only in very rough fields.

FIGURE 4. Header Flotation System Main Springs.

Windrow Uniformity: Windrows were uniform in most crops at speeds up to 6 mph (10 km/h). In rapeseed, bunched windrows resulted when the cutterbar plugged at the centre divider. In tall crops, some bunching occurred when material was dragged along

by the main header flotation springs in the windrow opening.

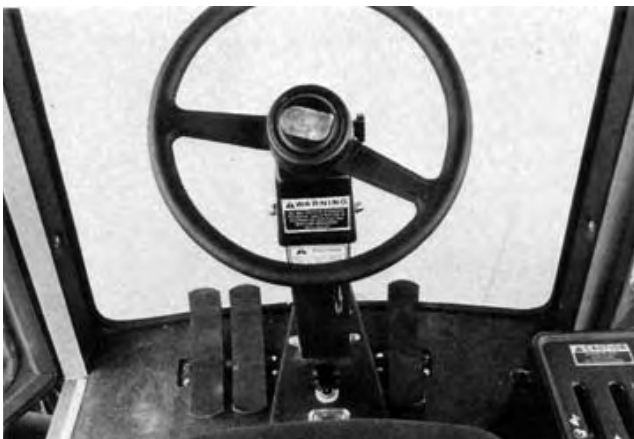
Controls: Most of the controls for the CI 742 (FIGURES 12 and 13) were conveniently located, properly identified and easy to operate. The range shifter was difficult to engage, as it had to be forced into place. The travel speed control lever was convenient to operate in both field and transport positions.

FIGURE 12. Steering Column and Foot Controls.

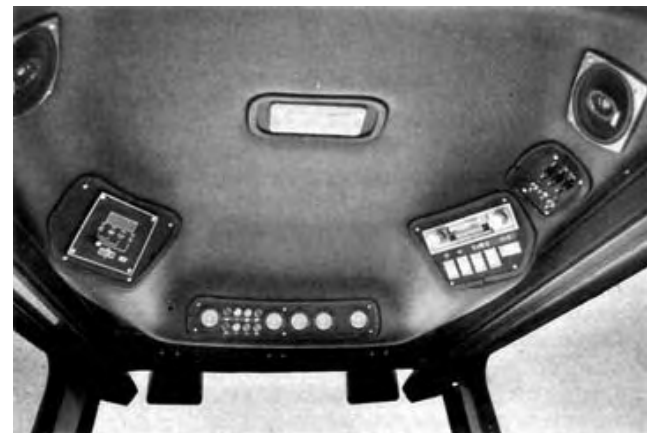
Instruments: The instrument console was located above the front windshield (FIGURE 14). It included gauges for fuel level, engine oil pressure, coolant temperature, battery voltage, and hydraulic oil temperature. Warning lights indicated neutral starting switch status, park brake engagement, engine, header and hydrostatic drive filter conditions and the hydrostatic oil pressure. An audible alarm signalled an unsafe starting or operating condition. The instruments were located out of the operator's line of sight and were not easily noticeable. In full transport, the gauges were behind the operator. It is recommended that the manufacturer consider relocating the instrument console for more convenient viewing or providing audible alarms for all instruments.

FIGURE 14. Instrument Panel.
