Evaluation Report

402

Sperry New Holland 1100 Self-Propelled Windrower

SPERRY NEW HOLLAND 1100 SELF-PROPELLED WINDROWER

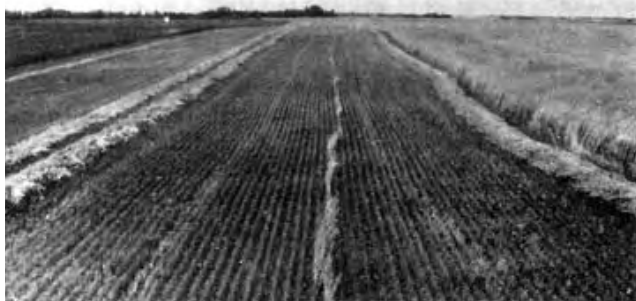
FIGURE 1. Crop Flattened by the Divider.

Dividers: Divider performance was fair. The wide divider flattened a strip of crop causing a slight crop loss (FIGURE 1). Cutting in the opposite direction on the next pass usually recovered most of the flattened crop. When double windrowing, this flattened crop could not be recovered because the windrower travelled in the direction of crop lean. The divider also flattened crop when making steering corrections or turning gradual corners. It is recommended that the manufacturer consider modifications to the dividers to reduce crop loss.

1. Divider losses are related to stubble length and crop density, which make it difficult to make one design to suit all conditions. Modifications to the divider shoe and rod will be considered.

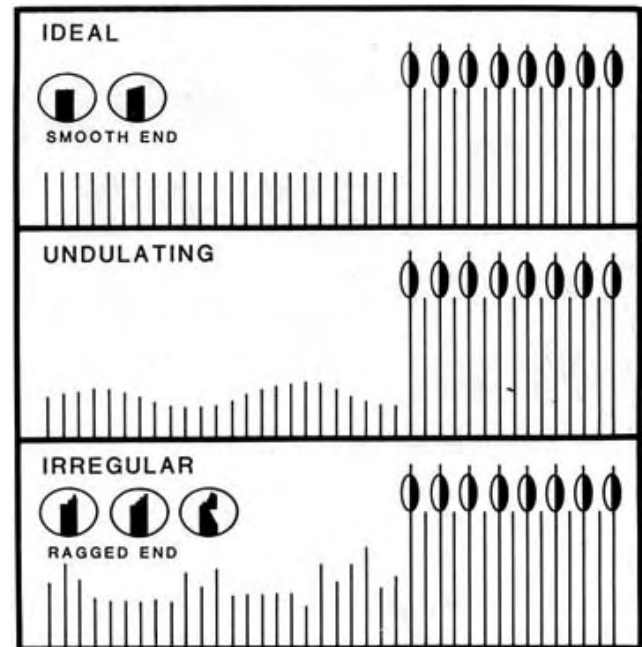
FIGURE 2. Types of Stubble.

Cutterbar: Cutting ability was very good in all crops provided the knife was maintained in good condition. Stubble was usually ideal (FIGURE 2). In rough fields undulating stubble resulted from excessive header bouncing. In tough green flax, material collected on dull sections and guards, plugging the knife.

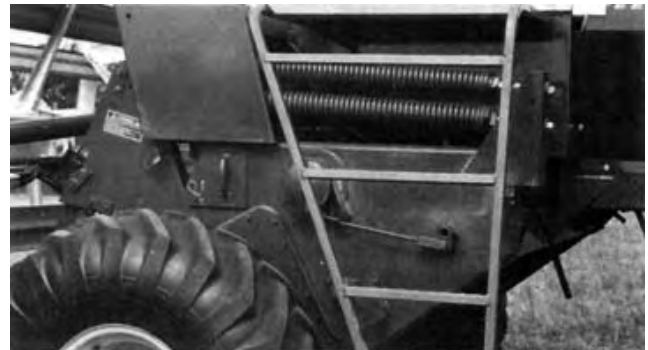
FIGURE 3. Header Flotation System.

Header Flotation: Header flotation was very good. Flotation was provided by four tension springs on the traction unit linkage (FIGURE 3). Good header flotation minimized cutterbar damage in stony fields and enabled the header to follow most ground contours. Undulating stubble occurred in rough fields.

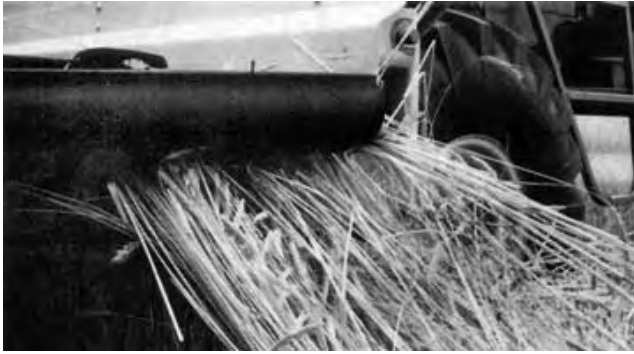
FIGURE 4. Plugged Draper in Fall Rye.

Drapers: Draper performance was fair. Draper speed could be varied from 0 to 500 fpm (0 to 2.5 m/s). In most crops, the drapers were run at full speed. Uniform windrows could usually be formed at this draper speed. However, in tall crops, such as fall rye and wheat and in heavy stands of Bromegrass and barley, the drapers frequently plugged when material caught on the rear shields at the windrow opening. It was then pulled under the drapers where it caught on the cross braces, stopping the draper (FIGURE 4). Plugging occurred when centre and end delivering, but was most severe when end delivering because of the greater quantity of material on one side of the opening.

Factory representatives modified the draper cross braces and shields to reduce plugging. In the centre delivery opening, the draper motor shields and the rear draper guide were trimmed down. In the end delivery openings, the rear roller mounts were enclosed in shielding and the draper support straps were rounded and shortened. These modifications were not adequate as plugging still occurred in wheat and barley crops. It is recommended that the manufacturer consider further modifications to reduce draper plugging.

3. Modifications have been made to the header structural members to eliminate draper plugging. These changes will also be implemented on past production machines.

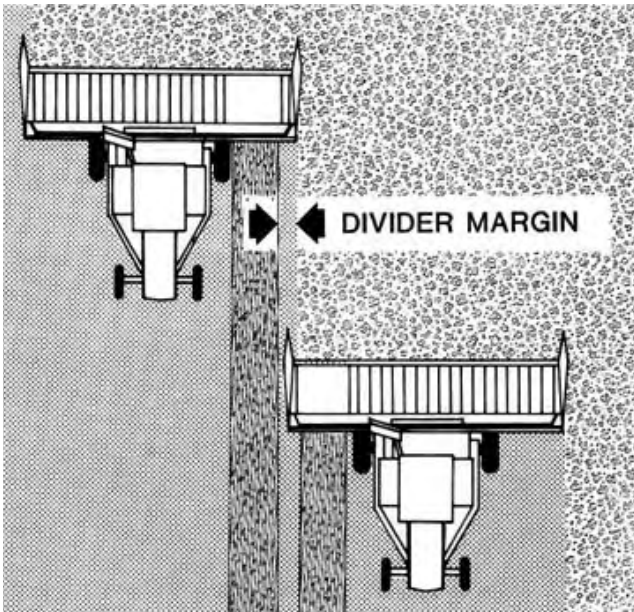
FIGURE 5. Double Windrowing.

The hydraulically driven drapers had adequate power to convey most crop materials. However, in one field of heavy green rapeseed, the drapers stopped due to lack of power. Since this crop condition is typical for the prairies, it is recommended that the manufacturer consider increasing the power of the hydraulically driven drapers. When double windrowing, the right divider draper kept the first windrow about 12 to 18 in (305 to 457 mm) from the standing crop edge (FIGURE 5). This kept the divider from snagging the windrow on the second pass.

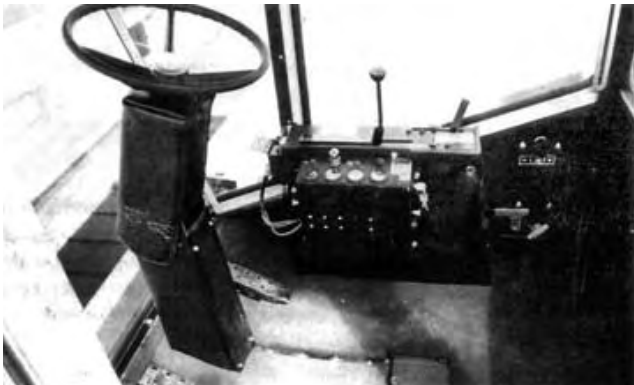
FIGURE 12. Operator Station Controls.

Controls: Ease of operating the controls was good. Most of the controls for the NH 1100 (FIGURE 12) were conveniently located and properly identified. The travel speed control lever and the range shifter were conveniently located and easy to engage.

Header height was controlled by two foot pedals on the left side of the steering column. Separate header lift pedals for each side permitted the cutting height to be varied across the width of the header. However, the two controls made it difficult to raise or lower the entire header uniformly. A pin supplied by the manufacturer to lock the pedals together was not useful because one end of the header dropped faster than the other. Also, the header dropped too fast. A restrictor was fabricated and installed by PAMI in the hydraulic line to slow down the lowering rate. It is recommended that the manufacturer consider modifications to the header lift system to make it more convenient to operate. The reel lift system was conveniently operated by one foot pedal on the right side of the steering column.

5. Modifications will be considered for future models.
6. A single header lift pedal, plus a "trim" pedal to allow header tilting from side to side will be retrofitted on past machines and included on future machines. The trim feature can be easily overridden or ignored if desired.

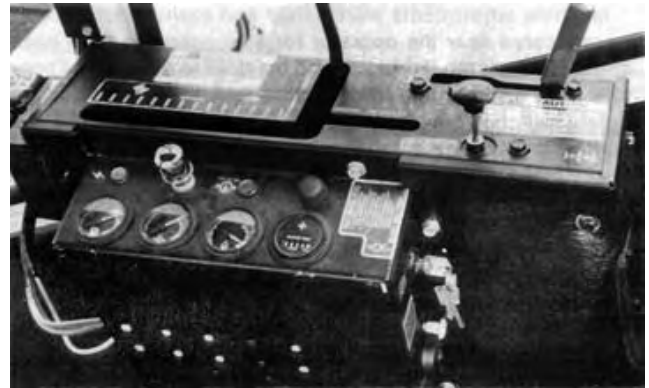
FIGURE 13. Instrument Panel.

Instruments: The instruments were very good as the console was conveniently located and easy to observe (FIGURE 13). It included gauges for fuel level, engine oil pressure, engine coolant temperature, and engine hours. Warning lights indicated alternator charge and hydrostatic oil pressure. An audible alarm signalled an unsafe operating condition. The instrument panel light shone in the operator's eyes, which was annoying at night.
