Evaluation Report

538

New Holland 116 Mower Conditioner

NEW HOLLAND 116 MOWER CONDITIONER

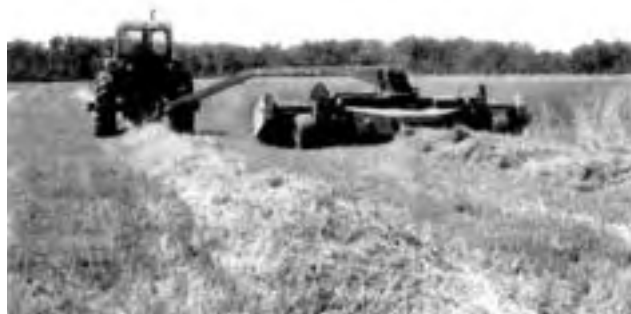
FIGURE 2. Typical Windrow.

quality windrows in all crops tested (FIGURE 2). The width and height of the windrows were controlled by two adjustable baffles situated at the rear of the conditioning rolls. The centre delivery or discharge allowed a continuous windrow to be formed around tight corners.

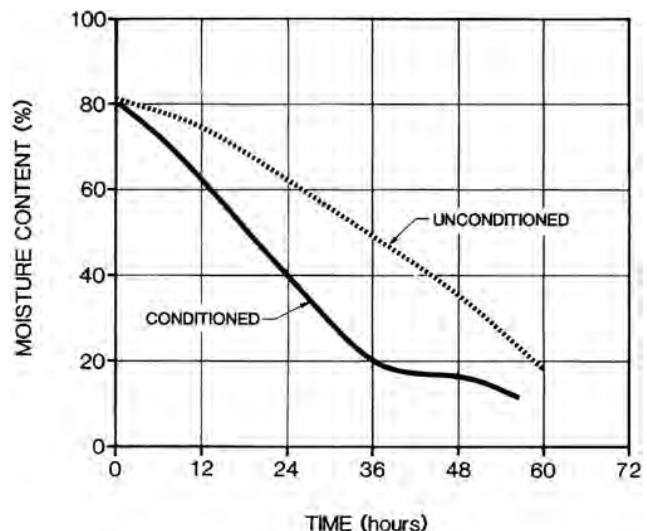
FIGURE 3. The effect of conditioning in alfalfa 3.5 ton/ac (1.5 t/ha) for the New Holland 116.

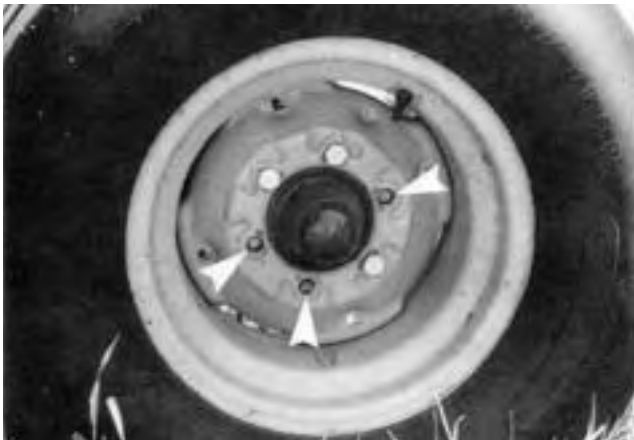
FIGURE 4. Broken Wheel Bolts.

When PAMI received the New Holland 116, it was noticed that the left ground wheel was bent and was wobbling slightly. After 60 hours of operation, 3 wheel mounting bolts broke off (FIGURE 4). The bolts were replaced, and at 68 hours cracks appeared in the wheel rim in the area of the bolt holes (FIGURE 5). The rim was replaced on warranty and no further problem occurred.

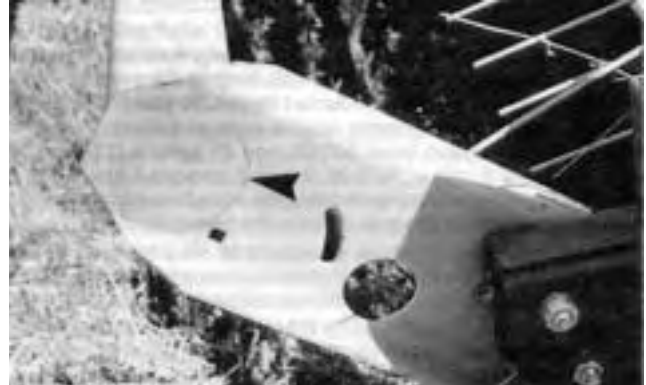
FIGURE 6. Cracks in Push Bar Mount Before Failure.

The push bar on the front of the mower conditioner separated from its mounting bracket at 193 hours due to metal fatigue in the area of the attaching weld. It was repositioned and rewelded, at a cost of \$30.00. At 212 hours the push bar broke away on the opposite side of the machine at the same location. It was repositioned and rewelded. No further problems were encountered (FIGURE 6). It is recommended that the manufacturer consider strengthening the pushbar mount brackets.

1. Supplying a heavier anti-torque chain that prevents the hydraulic pump from rotating with the tractor PTO shaft.
2. Providing a modification to prevent oil leakage when the hydraulic filter is removed for replacement.
3. Providing a method of continually lubricating the roller chain and sprocket that drive the feed auger.
4. Strengthening the push bar mounts.
