Evaluation Report

292

Leon 8200 (12.3 m) Rod Weeder

LEON 8200 ROD WEEDER

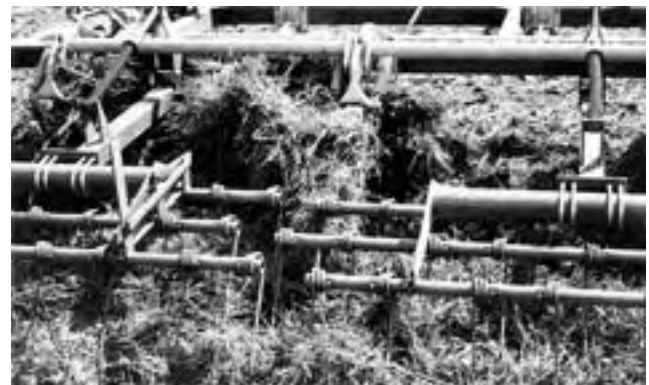
Plugging: The Leon 8200 cleared trash well in moderate trash conditions. Occasional plugging occurred at the wheel locations in heavy trash conditions (FIGURE 4).

FIGURE 4. Plugging at the Wing Wheel Location in Heavy Trash.

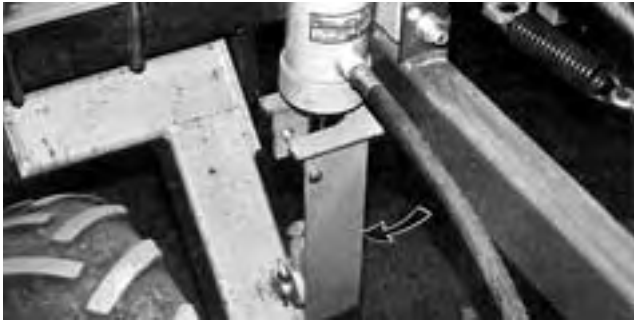
FIGURE 9. Transport Depth Control Lock.

Transporting: The Leon 8200 was easily placed into transport position in less than five minutes using the hydraulic wing lift system (FIGURE 8). The retaining straps between the hydraulic cylinders had to be replaced with shorter straps to provide easy installation of the transport lock pins. The transport locks for the depth control wheels on the centre section (FIGURE 9) were large and difficult to install or store when not in use. It is recommended that the manufacturer modify these transport locks to provide easier installation and storage.

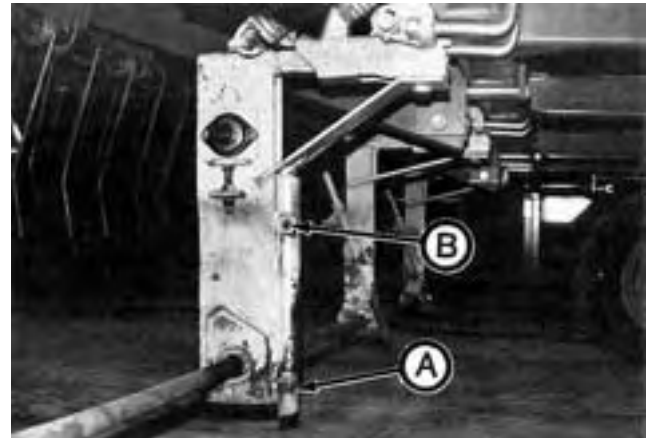
Rod Shank Wear Rod Adjustment: The Leon 8200 rod shanks were equipped with adjustable wear rods that required frequent adjustment in abrasive soils. The wear rods on the rod drive shanks were difficult to adjust due to rod binding and limited access to the top of the rods (FIGURE 10).

FIGURE 10. Rod Drive Shank (A) Wear Rod, (B) Set Screw Adjustment.

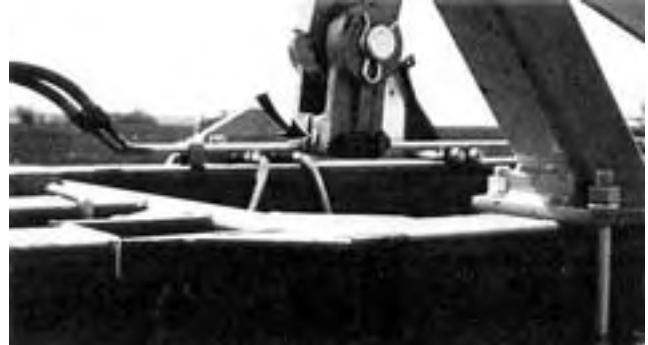
Hydraulics: A wing lift cylinder yoke (FIGURE 12) failed when lifting the wings into transport position.

FIGURE 12. Hydraulic Cylinder Yoke Failure.

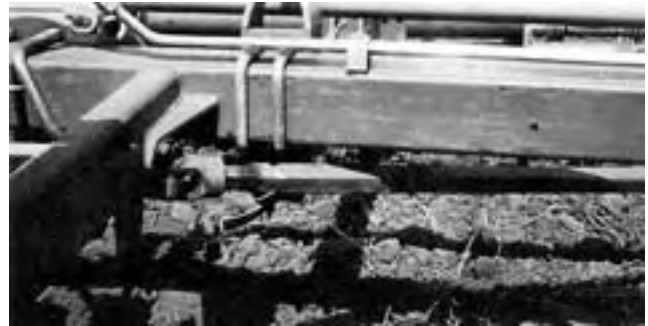
Frame Levelling: Adequate lateral levelling for the centre and wing sections was provided by adjusting the bolts at the top frame member of the depth control cylinders. However, lowering the wing sections too far caused damage to the rod drive shafts when working at greater depths (see "Durability Results").

Frame: The rod drive shafts interfered with the harrow mounting bolts when the lateral levelling adjustments exceeded the maximum setting stated in the operator's manual. When set at the maximum setting, the rod drive shaft may contact the rod weeder frame if the rod shanks trip to clear obstructions. It is recommended that the manufacturer modify the rod drive assembly to prevent possible damage to the rod drive shaft.

FIGURE 13. Interference of the Frame with the Rod Drive Shaft.

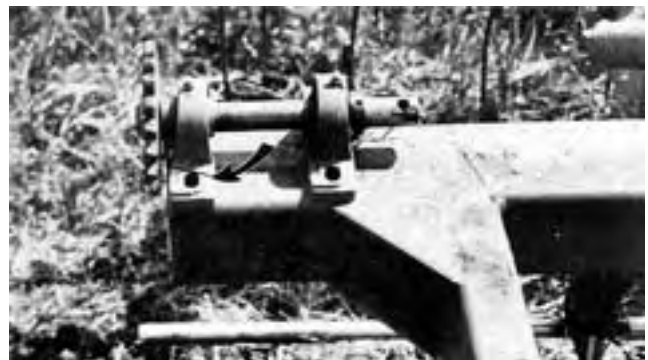
The pillow block for the rod drive shaft failed three times because it was mounted on an uneven surface (FIGURE 14). Shimming the pillow block with washers did not eliminate the problem.

FIGURE 14. Rod Drive Pillow Block Failure.
