Evaluation Report

305

Sperry New Holland Model 8500 Round Bale Wagon

SPERRY NEW HOLLAND MODEL 8500 ROUND BALE WAGON

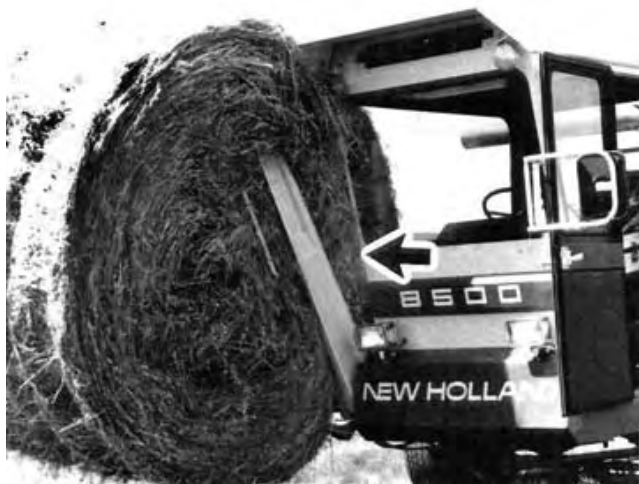
Bale Retrieval: The New Holland 8500 loaded firm, well formed bales effectively. When loading soft core bales, interference between the bale edge and the right operator's cab window caused damage to the window. When loading eight, 72 in (1830 mm) diameter bales, the rear tailgate was forced partially open.

When loading loosely formed or poorly tied bales, the cross conveyor arm occasionally slipped beneath the bale and failed to push the bale to the left side of the load deck. When loading 72 in (1830 mm) diameter soft core hay bales, the inside edge of the bale often interfered with the right side of the operator's cab (FIGURE 2). Modifications are recommended to eliminate this interference as damage to the operator's cab side window occurred on four occasions.

FIGURE 2. Bale Interference with the Operator's Cab while Loading 72 in (1830 mm) Soft Core Hay Bales.

1. Modifications to eliminate bale interference at the operator's cab side window while loading large, soft core hay bales.
2. Modifications to the load deck and rear tailgate to properly accommodate eight, 72 in (1830 mm) diameter bales.
3. Modifications to the gear shift lever and foot throttle location to eliminate operator fatigue.
4. Supplying an accurate coolant temperature gauge.
5. Modifications to the rear view mirror location to eliminate cab door interference and to improve rear visibility.

1. A soft core bale loading kit has been designed and is offered as an attachment.
2. to 5. These recommendations will be taken under advisement by our Engineering Department for future consideration.

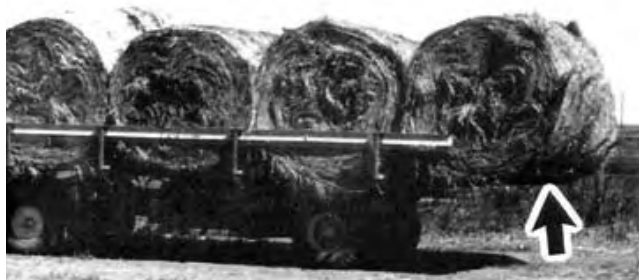
Load Quality: The New Holland 8500 formed a durable load, which transported well with little shifting or settling. Material loss during transporting was negligible. When handling 72 in (1830 mm) diameter bales, the tailgate was forced partially open during the last cycle of the pusher (FIGURE 3). The partially opened tailgate did not affect load quality. However, to ensure safe road transport, modifications to permit adequate accommodation of eight, 72 in (1830 mm) diameter bales are recommended.

FIGURE 3. Partially Opened Tailgate when Loaded with Eight, 72 in Diameter Bales.

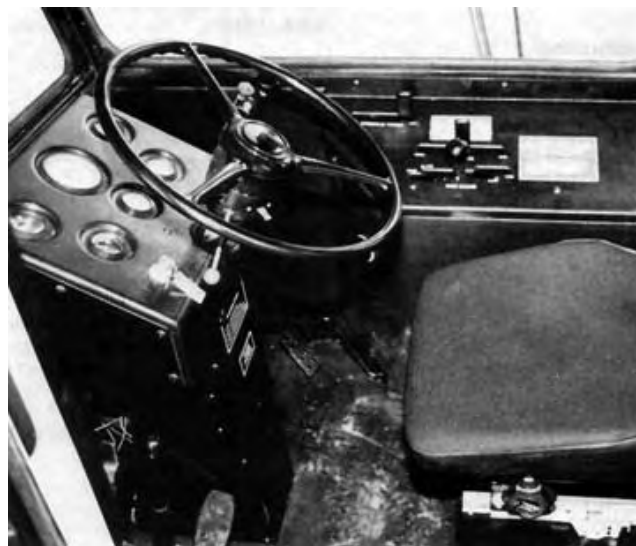
Instruments and Controls: FIGURE 6 shows the instrument and control arrangement of the New Holland 8500 operator's cab. Loader and load deck controls were easily accessible from the operator location. Visibility of the loader was very good. The gear shift lever and foot throttle were inconveniently located. The operator had to reach forward to shift gears while maintaining an awkward leg position. Operator fatigue occurred after several hours. Modifications to the gear shift lever and foot throttle locations are recommended.

FIGURE 6. New Holland 8500 Instrument and Control Arrangement.

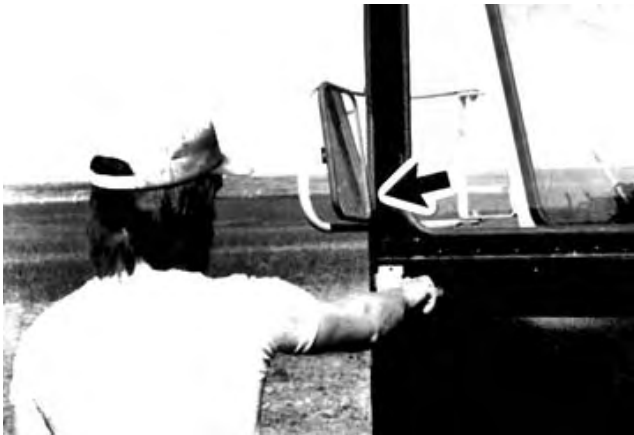
The rear view mirror provided poor rear visibility when loaded. Interference between the cab door and mirror (FIGURE 7) prevented the door from completely opening. Modifications to the rear view mirror location are recommended to eliminate door interference and to improve rear visibility when loaded.

FIGURE 7. Interference between Rear View Mirror and Cab Door.

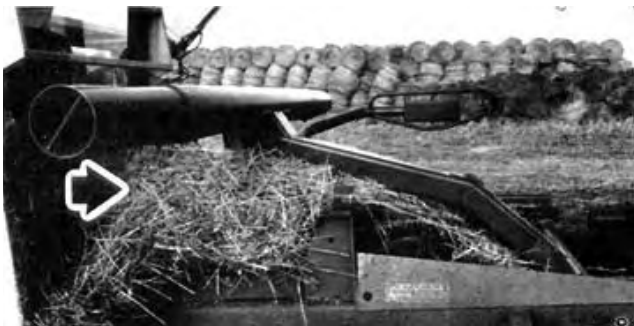
Loose material often collected below the pusher (FIGURE 8). Pusher operation was not affected but excessive build-up required occasional removal.

FIGURE 8. Collection of Loose Material below Pusher.

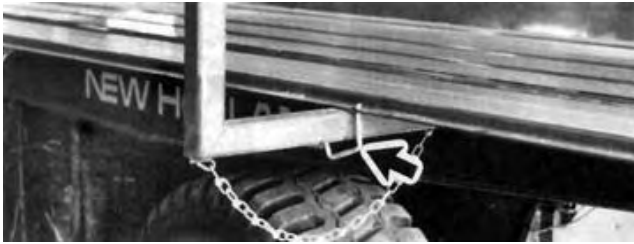
Several J-pins bent (FIGURE 10) when loose twine from poorly formed bales became entangled as the bale moved rearward along the load deck.

FIGURE 10. Bent Load Rack Extension J-Pins.

J-Pins: The J-pins were lost when the retaining pin clips were inserted from the rear. Bales sliding rearward along the load deck occasionally caught and removed the retaining pin clips. Inserting the retaining pin clips from the front eliminated the problem.

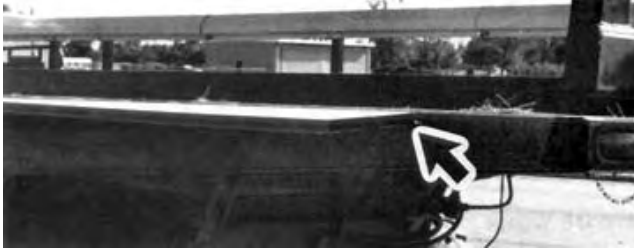
Load Rack Extensions: The load rack extensions bent (FIGURE 11) while attempting to unload on uneven ground. Unloading on uneven ground tended to slide bales off the corner rather than the end of the load deck.

FIGURE 11. Bent Load Rack Extensions.

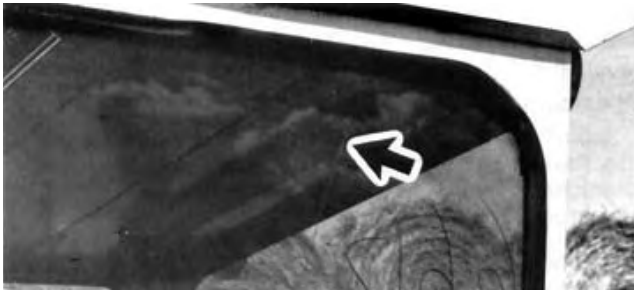
Cab Side Window: The right operator's cab window broke (FIGURE 12) due to bale interference when loading large, soft core bales.

FIGURE 12. Damaged Cab Window.
