# Evaluation Report

# 235

**Massey Ferguson Model 124 Baler**

# MASSEY FERGUSON MODEL 124 BALER

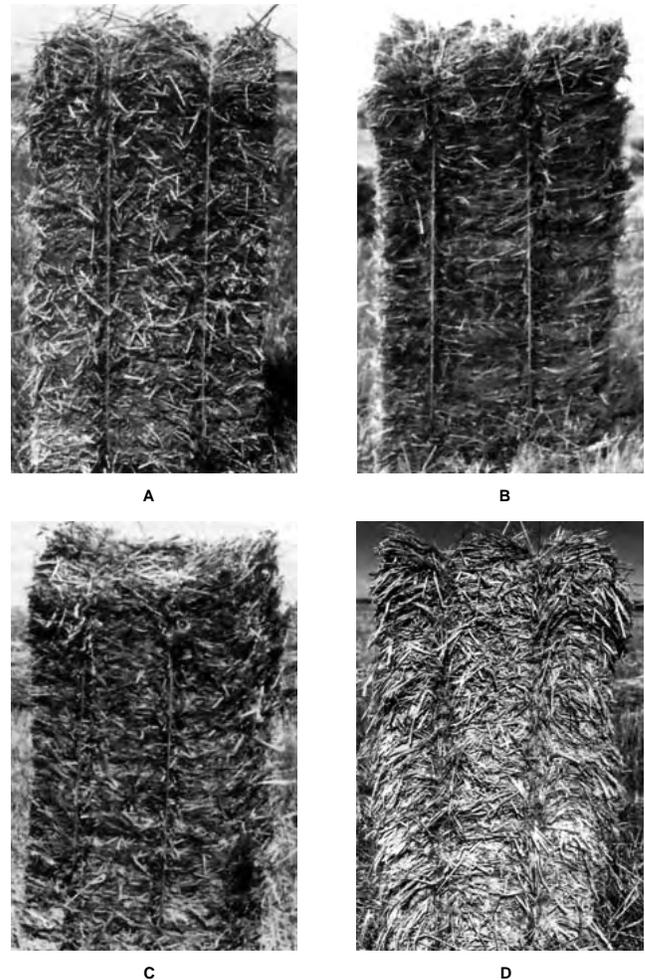
FIGURE 2. Typical Bales: (A) Alfalfa, (B) Bromegrass, (C) Greenfeed, (D) Straw.

**Bale Quality:** The Massey Ferguson 124 was capable of producing firm, durable bales with square ends in all crops (FIGURE 2). Average hay bales weighed 22 to 35 kg (48 to 77 lb), while average straw bales weighed 20 to 25 kg (44 to 55 lb). Average bale density varied from 142 to 235 kg/m<sup>3</sup> (8.5 to 14.1 lb/ft<sup>3</sup>) in hay and 127 to 145 kg/m<sup>3</sup> (7.6 to 8.7 lb/ft<sup>3</sup>) in straw.

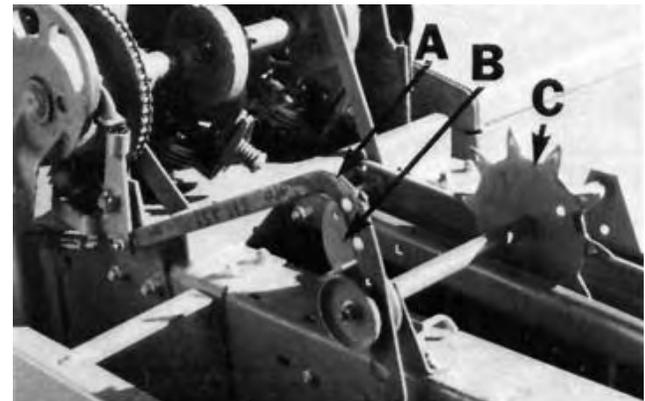
FIGURE 3. Bale Length Adjustment: (A) Metering Arm, (B) Adjustable Stop, (C) Metering Wheel.

**Metering Arm:** The metering arm began slipping on the metering drive wheel (FIGURE 3), causing extreme bale length variation. The friction edge of the metering arm was too smooth for the metering drive wheel to grip consistently in normal baling conditions. The metering arm and the metering arm tension spring

were replaced. No further problems were encountered.

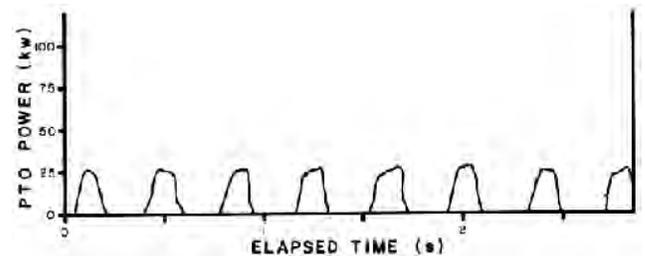
FIGURE 4. Instantaneous Power Take-off Requirements when Baling Alfalfa at 8 t/h Feedrate.

**Power Take-off Requirements:** FIGURE 4 shows typical instantaneous power take-off requirements for the Massey Ferguson 124. Power requirements fluctuated from 0 to 33 kW (0 to 44 hp) on each plunger stroke. Due to these wide power fluctuations, average power requirements were less than instantaneous requirements, varying from 7 to 21 kW (9 to 28 hp) over a full range of feedrates.

were usually less than 21 kW (28 hp) and power required to pull the baler on level ground was usually less than 4 kW (5 hp). A 40 kW (54 hp) tractor was, however, needed to fully utilize baler capacity in soft or hilly fields and to overcome the power fluctuations illustrated in FIGURE 4.

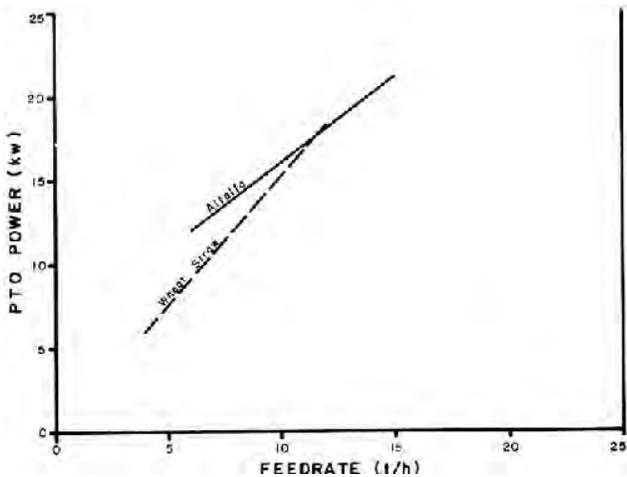
FIGURE 5. Average Power Take-off Requirements when Baling Alfalfa and Straw.

FIGURE 5 shows the average power take-off requirements at various feedrates in alfalfa and wheat straw.

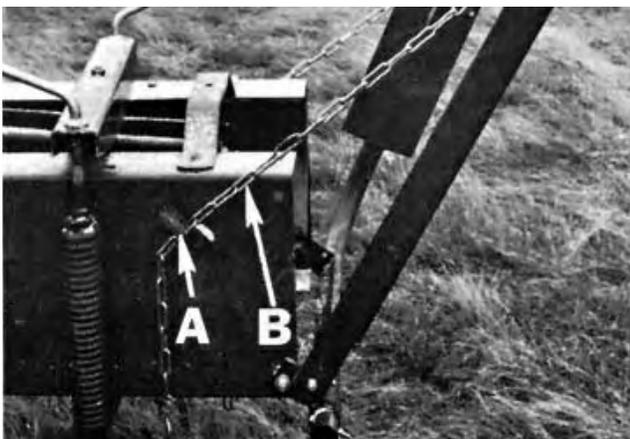
FIGURE 6. Bale Chute in Transport Position: (A) Hook, (B) Link.

The bale chute, in its folded position during transport (FIGURE 6) was inadequately secured. When transporting on rough roads, the bale chute chains easily became dislodged from their hooks. It is recommended that the manufacturer consider providing an improved means of securing the bale chute in its folded position. The baler towed well behind a tractor or suitable sized truck.

1. Providing an adequate means of securing the bale chute in transport position.
2. Providing improved lubrication access to the rear power shaft universal joint.

1. An improved means of securing the bale chute will be investigated.
2. Improved lubrication access to the rear power shaft universal joint will be included on all later model balers.

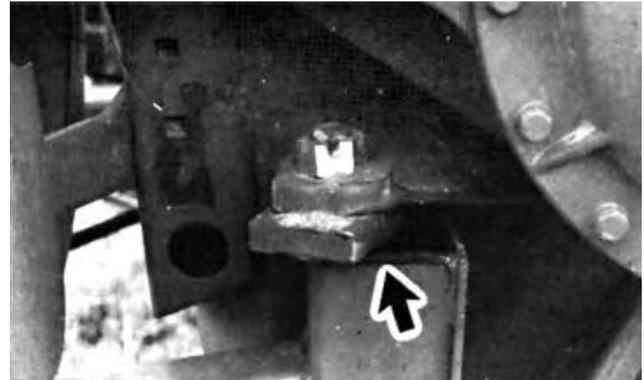
FIGURE 8. Broken Hitch Weld.

**Hitch:** A weld at the hitch pivot point failed (FIGURE 8), causing the baler to sag. The failure occurred because of an incomplete weld. The hitch was rewelded and no further problems were encountered.

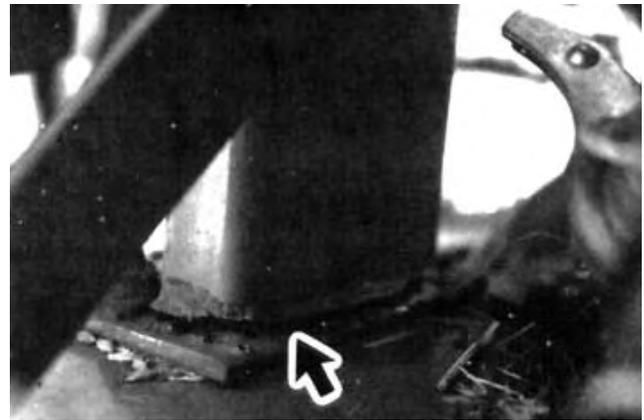
FIGURE 9. Broken Knotter Mounting Frame.

**Knotter Frame:** The weld on the left knotter mounting frame failed (FIGURE 9) as a result of a poor weld. The mounting frame was rewelded and no further problems were encountered.
