Evaluation Report

300

Krone KR180 Baler

KRONE KR180 BALER

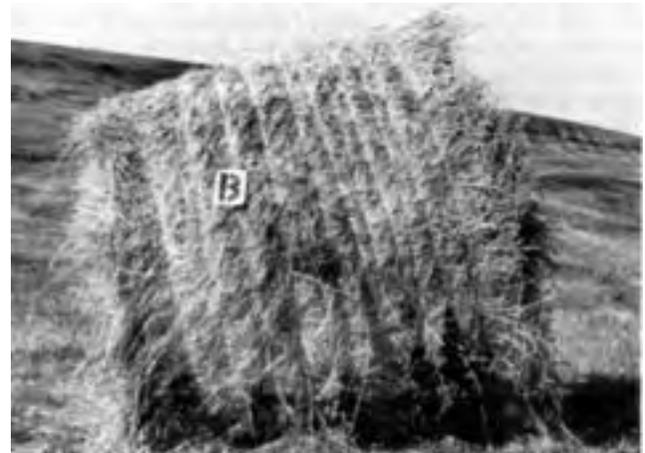
Bale Quality: The Krone KR180 produced firm, durable bales with flat ends and uniform diameter in most crops (FIGURE 2). Bales were of very good quality when baled in well formed windrows at the optimum moisture content. However, in light, dry conditions, irrespective of crop and in unconditioned greenfeed, bale quality was reduced to fair as it was difficult to consistently produce bales of uniform diameter and adequate durability (FIGURE 3). Similar to most round balers, it was also difficult to consistently produce uniform, durable bales in dry, short, chopped up straw, similar to that combined with rotary combines. In short straw conditions, bale quality was greatly improved if the straw was baled when slightly tough.

FIGURE 3. Inadequate Bale Density in Light Dry Material.

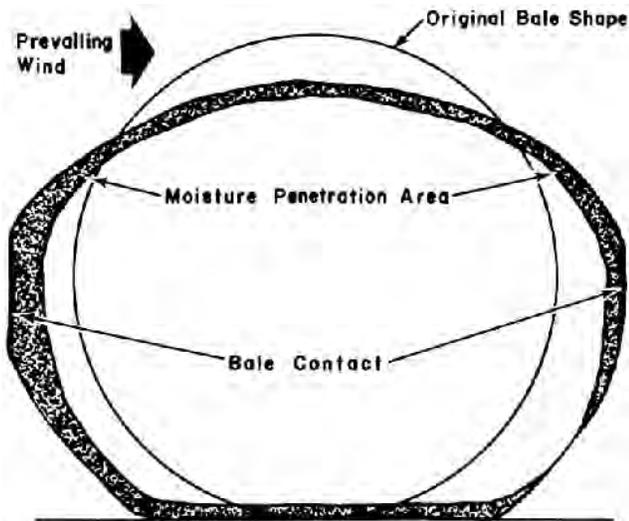
Bale Weathering: A common practice in the prairie provinces is to store round bales outside. Bales were closely stacked in rows, situated in a level area, with one side exposed to the prevailing winds. Bales were subjected to about 4.5 in (115 mm) of rain and above average wind conditions over a period of about 170 days. FIGURE 4 shows the condition of a typical Krone KR180 hay bale (alfalfa and bromegrass mixture) after 170 days of weathering. The condition of the weathered bales was good. Moisture had penetrated to a maximum of 5 in (127 mm) on the windward side in the area where another bale was touching. Spoilage occurred to a depth of about 1.5 in (40 mm) in the ground contact area and where other bales touched the sides.

FIGURE 4. A Typical Hay Bale After 170 Days of Weathering.

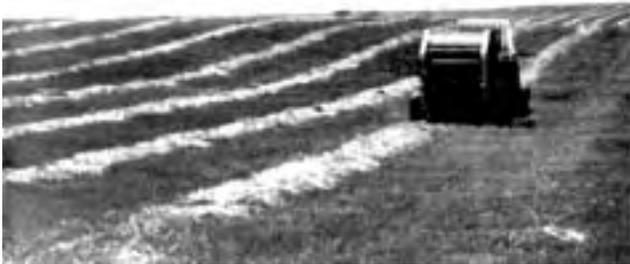
In light, dry crop conditions, the bales would often have to be wrapped and discharged prematurely. When the bale was nearing completion the rear gate would open slightly, allowing the windrow to drop back on the ground behind the baler (FIGURE 8) before the hydraulic pressure gauge indicated the bale was ready for wrapping. The bale would then have to be wrapped and discharged as the rolling bale would not take up any more hay. In these conditions, bale quality was only fair due to the inability to produce bales of adequate density. Also, since visibility to the rear was limited, the operator had difficulty in determining when hay would begin dropping out the back. It was inconvenient to rebale the portions of windrow left behind. The operator's manual indicated that the gate was to open slightly and drop the windrow back on the ground when the bale chamber was overfilled. However, the gate began to open before the hydraulic system relief pressure was reached. Increasing the relief pressure only improved the problem slightly. It is recommended that modifications be considered to prevent the rear gate from opening prematurely, allowing hay to drop out when baling in light, dry windrow conditions.

FIGURE 8. Windrow Dropping Out Behind the Baler in Light, Dry Crop Conditions.

1. Modifications to prevent the rear gate from opening prematurely, allowing hay to drop out when baling in light, dry windrow conditions.
2. Modifications to prevent the base of the hitchjack from unscrewing due to vibrations.
3. Modifications to improve pickup floatation to prevent pickup damage on rough or stony ground.
4. Supplying a slow moving vehicle sign as standard equipment.
5. Modifications to eliminate premature failure of the frame bolts.

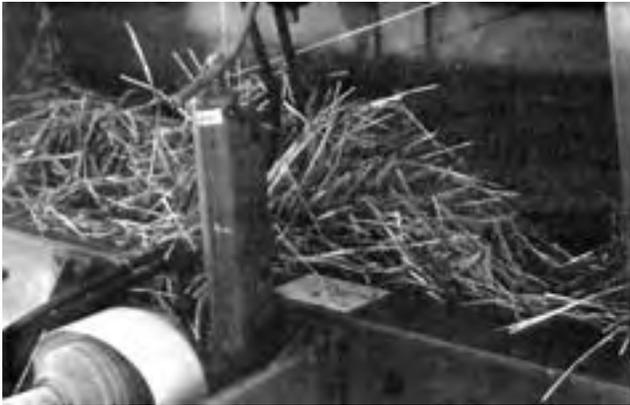
In dry straw, backfeeding presented several problems. Straw piled up on the windguard, jamming between the back panel of the twine box and the front bale chamber housing (FIGURE 9). Removing the pickup windguard allowed baling in these conditions. Also, at the beginning of the twine process, when the wrapping process begins on the right side, straw would continue to backfeed on the left side, piling up on the ground in front of the pickup. The result was a poor, lopsided bale. Baling straw when it was slightly tough, greatly reduced backfeeding and improved bale quality.

FIGURE 9. Dry Straw Piled On the Pickup Windguard Due to Backfeeding.

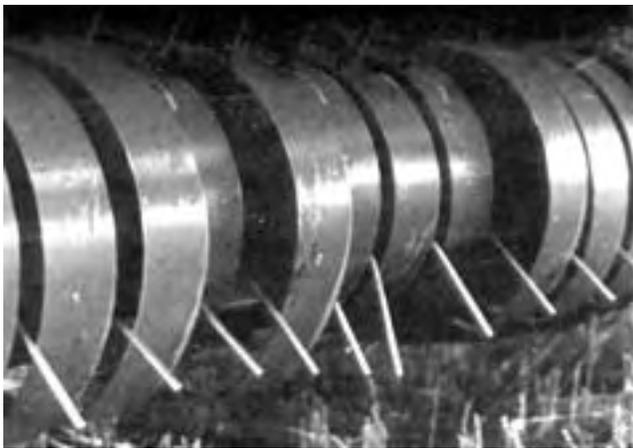
| Item | Operating Hours | Equivalent Bales |
|--|---|---|
| -The pickup was damaged, requiring repair of several pickup hoops, tooth bars and pickup teeth at | 26 | 220 |

Pickup: Poor pickup floatation allowed several pickup hoops, tooth bars and pickup teeth to be bent on rough ground (FIGURE 10). Care had to be taken to miss larger stones to prevent serious damage to the pickup. The pickup was not equipped with a floatation mechanism. It has already been recommended that the manufacturer consider modifications to improve pickup floatation.

FIGURE 10. Damaged Pickup.

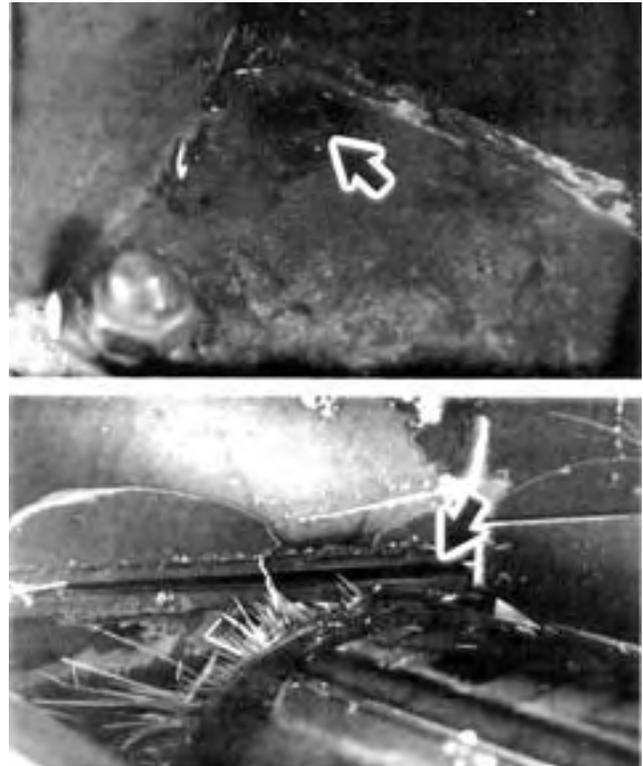
| Item | Operating Hours | Equivalent Bales |
|--|---|---|
| -Two bolts securing the front housing and the support brackets broke and a third was cracked, requiring replacement at | 115 | 875 |

Frame: A frame bolt securing the front housing and the roller support brackets broke on each side and a third bolt was cracked. The failures were due to high tension loads and fatigue. FIGURE 11 illustrates the broken bolt and spreading between the front housing and the roller support bracket on one side. The bolt heads were welded to the frame making it difficult to replace the bolts. It is recommended the manufacturer consider modifications to eliminate premature failure of the frame bolts.

FIGURE 11. Frame Failure: (Upper) Broken Bolt, (Lower) Spreading Between the Front Housing and the Roller Support Bracket.
