# Evaluation Report

# 306

## Willcar Autotran 2500 Pull-Type Windrower

# Willcar Autotran 2500 Pull-type Windrower

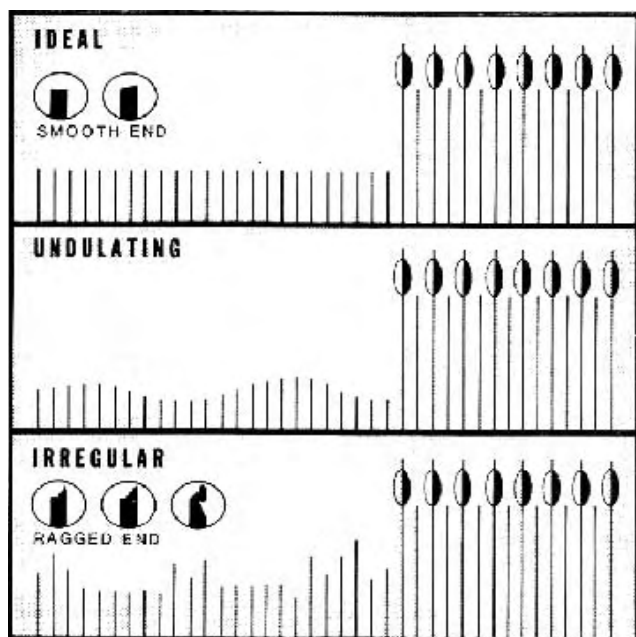
**FIGURE 1.** Types of Stubble.

**Stubble:** Stubble was usually slightly irregular (FIGURE 1). Ideal stubble was produced only in clean, ripe crops. Poor table flotation caused undulating stubble in rough fields.

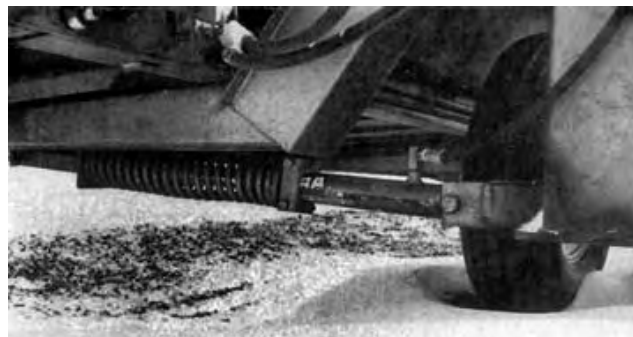
**FIGURE 2.** Table Flotation System.

**Table Flotation:** Table flotation was poor. Flotation was provided by a compression spring positioned around each of the two lift cylinders (FIGURE 2). The degree of flotation was easily adjusted by moving a single clamp to vary the spring compression. Moderate cutterbar damage resulted from poor flotation in stony fields. It is recommended that the manufacturer consider modifications to improve cutterbar flotation.

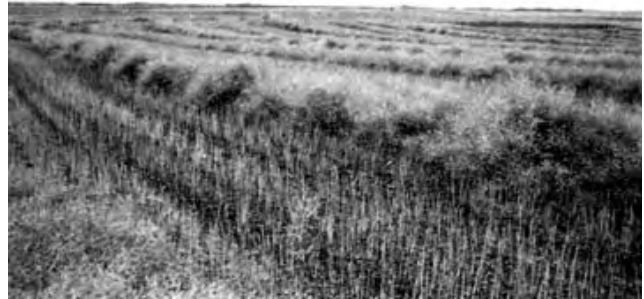
FIGURE 8. Rapeseed, Single Windrow, Bunchy; 22 bu/ac (1.2 t/ha).

**Uniformity:** Windrows were uniform in most crops. In rapeseed (FIGURE 8), bunchy windrows were formed when material caught on the right divider.

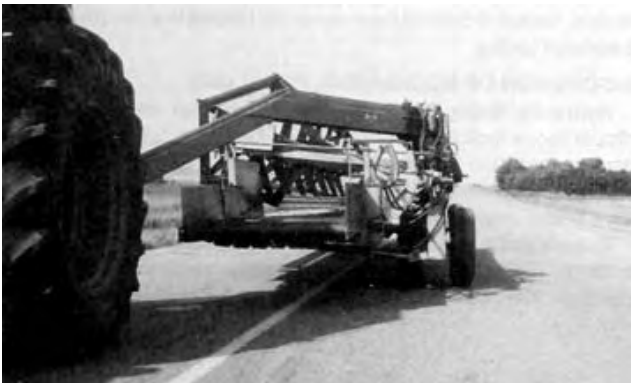
FIGURE 11. Transport Position.

**Transporting:** The Autotran 2500 transported very well at speeds up to 20 mph (32 km/h). Transport width was safe for most roads (FIGURE 11), though it was necessary to drive the tractor on the right shoulder of the road. Left turns were restricted by interference between the tractor tire and the hitch jack. Removing the hitch jack improved left turning.

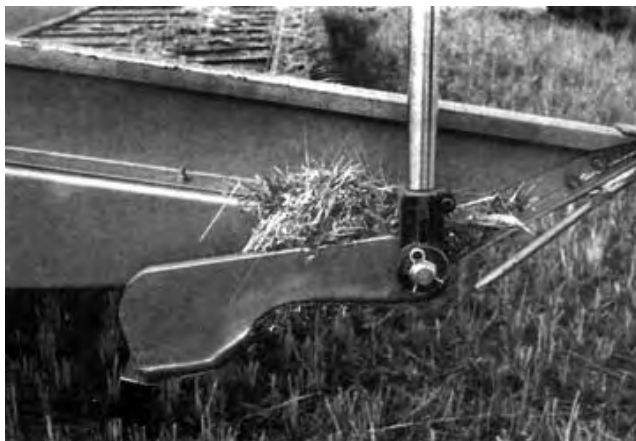
**Guards and Knife Sections:** Material build-up at the right end of the cutterbar (FIGURE 12) caused considerable guard and knife section damage. The manufacturer installed an additional knife hold-down clip near the right end, which reduced the damage. It is recommended that the manufacturer consider modifications to prevent build-up of material at the end of the cutterbar.

**FIGURE 12. Material Build-up at the Right End of the Cutterbar.**

9. Providing a more comprehensive operator manual.
10. Modifications to prevent build-up of material at the right end of the cutterbar.

9. The operator manual is being revised for 1983.
10. Modifications to eliminate cutterbar plugging are currently in progress.
