# Evaluation Report

**Lundell 760C Round Baler**

# LUNDELL 7600 BALER

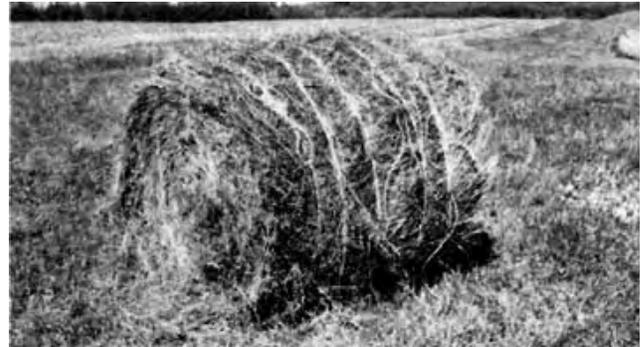
FIGURE 2. Typical Hay Bale.

**Bale Quality:** The Lundell 760C produced soft, low density hay bales (FIGURE 2) with irregular surfaces. Poor bale quality was more pronounced in non-uniform windrows. Bales usually had varying diameters throughout their length but had fairly flat ends. Hay bales averaged 1.6 m (63 in) in length and 1.8 m (71 in) in diameter. Average hay bales weighed from 350 to 630 kg (772 to 1389 lb) with an average density of 119 kg/m<sup>3</sup> (7.4 lb/ft<sup>3</sup>). Density was not uniform throughout the bale.

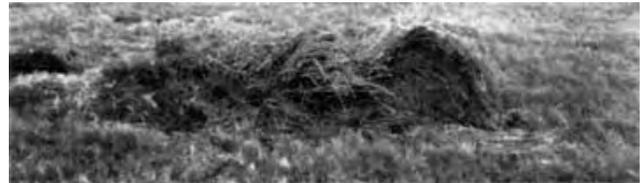
**FIGURE 6.** Formation of Double Bales when Encountering Wild Barley Patches. Ejected Bale (right) with Second Bale Core (left).

The Lundell 760C sometimes could not produce acceptable bales if crop conditions changed abruptly in a windrow. For example, in a field of alfalfa, bromegrass and crested wheatgrass mixture with

patches of wild barley, bale formation problems occurred as soon as wild barley patches were encountered. The short, slippery wild barley would not wrap into the bale and a second bale would begin forming between the original bale and the pickup. The operator could not see the second bale and was not aware of problems until the second bale became large enough to prevent the first bale from turning (FIGURE 6). As a result, both bales had to be discharged, unrolled and rebaled.

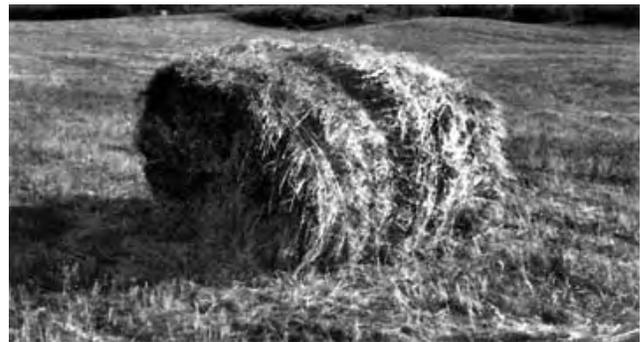
**FIGURE 7.** A Bale Wrapped with Twine After Going Out-of-Round.

Out-of-round bales could be wrapped with twine (FIGURE 7) but bales that completely collapsed and stopped turning had to be ejected without twine (FIGURE 8).

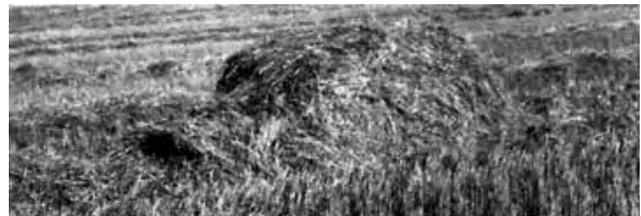
**FIGURE 8.** A Collapsed Bale that had to be Ejected Without Twine Wrapping.

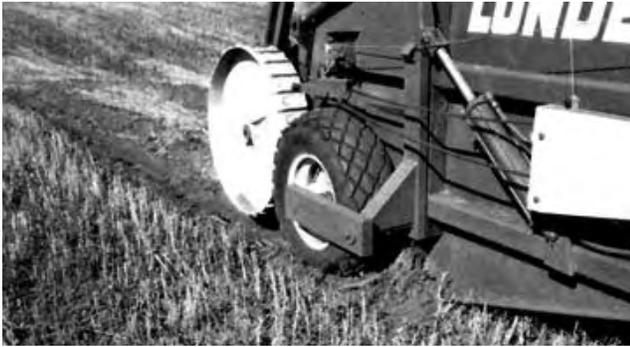
FIGURE 9. Skidding of the Drive Wheels on Rough, Irregular Ground Surfaces.

The Lundell 760C was very ineffective on rough or hilly fields. On rough or irregular ground, the pickup roller often contacted the soil and would either scrape soil into the bale or would turn backwards, tearing a portion out of the bale and discharging it behind the baler. Sometimes the pickup soil interference forced the baler drive wheels to turn backwards. The wheels dug deeply into the soil (FIGURE 9) lowering the baler and preventing the bale from turning. In soft or sandy soils, once the bale stopped turning, soil accumulated in front of the bale necessitating discharge without twine wrapping.

Forming a neat, full sized bale in grain straw was difficult. The amount of drag applied to the bale by the non-moving baler parts was greater than the rotational force applied by the ground or the pickup. As a result, the bale slid on the incoming windrow and had to be ejected without twine (FIGURE 3). Wide, irregularly shaped straw windrows left by large combines also prevented bale formation. Wide straw windrows would not completely fit into the bale chamber, resulting in straw being fed under the baler skids and tires. Straw decreased the traction of the baler drive wheels causing the wheels to skid and the bale to stop turning.

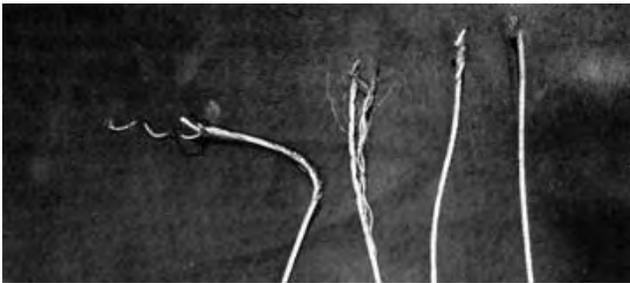
FIGURE 10. Damaged Bale Forming Cables.

during formation, providing drag to result in bale compression. The ends of the bale forming cables frequently became frayed or bent (FIGURE 10) requiring replacement. Damaged cables dragged heavily preventing free bale rotation. Modifications, to reduce the frequency of cable damage, are recommended.

**Bale Forming Cables:** The bale forming cable ends became badly frayed and bent, necessitating replacement, twice during the test. Proper baler operation depended on smooth, straight cables. Modifications to reduce cable bending and fraying are recommended.

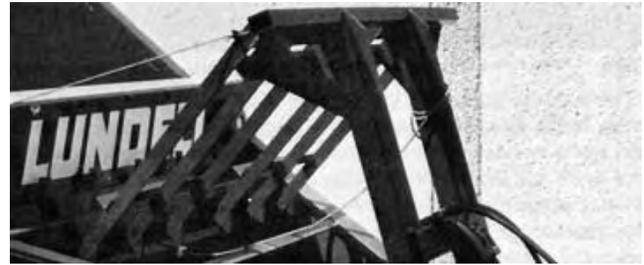
FIGURE 13. Second Bale Starter.

To start wrapping, the second bale starter (FIGURE 13) is partially lowered to allow the twine roller drive to contact the right baler tire and begin twine metering. Once the twine has wrapped into the bale with the incoming hay, the second bale starter is lowered completely to accumulate the incoming hay while the twines make two to three wraps around the bale.

In ideal windrows, the second bale starter performed well, effectively increasing baler capacity by collecting the second bale core while the first bale was wrapped. As a result, the only loss of baling time occurred while actually discharging the bale. The second bale starter was, however, ineffective in light windrows, short hay or very heavy windrows. In short hay or in light windrows, hay passed through the bale starter teeth and impaired twine wrapping. In heavy windrows, the second bale starter could not accumulate all the incoming hay during twine wrapping. In both conditions, the most effective method of wrapping was to move the baler out of the windrow, wrapping the twine on the previously baled field area and turning around to resume baling. This considerably lowered baler output.

Operation of the hydraulic cylinder on the second bale starter was very aggressive. It was difficult to raise or lower the second bale starter without abruptly reaching the limit of its movement. As a result the second bale starter mount weldment broke and the baler frame cross member bent during the test.
