Evaluation Report

234

International Harvester Model 425 Baler

INTERNATIONAL HARVESTER MODEL 425 BALER

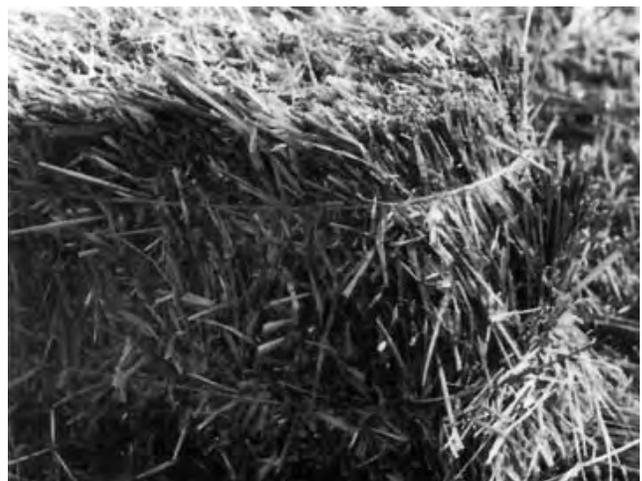
FIGURE 3. Poorly Formed Bale due to Inadequate Density Adjustment.

For most crops, the hand cranks provided insufficient adjustment range to produce dense bales unless additional bale wedges were installed in the bale chamber. The bale chamber had holes for installation of two sets of bale wedges. To obtain an adequate range of bale density adjustment, it was necessary to drill holes and install a third set of wedges. In dry conditions or very light windrows, the adjustment range, even with three sets of bale wedges installed, was insufficient to produce firm, durable bales suitable for bale wagon handling (FIGURE 3).

Only the top tension bar of the International Harvester 425 was adjustable. Most conventional balers involve both top and bottom tension bars in the bale density adjustment. In addition, the bale chamber length was about 130 mm (5 in) shorter than most comparable North American balers. It is recommended that the manufacturer consider modifications to the bale chamber density adjustment to improve bale density and durability.

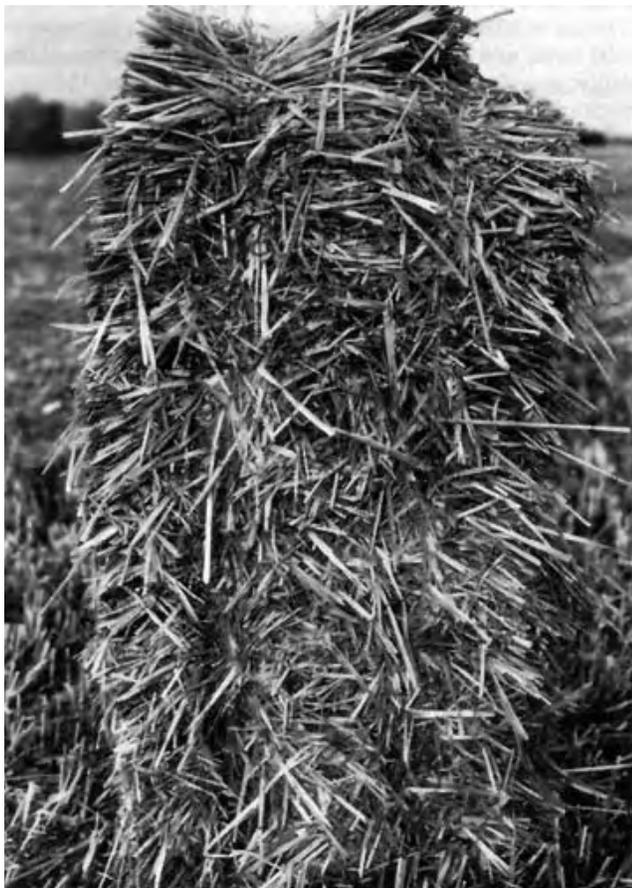
Feeding System: The packer fingers had three settings, which were adequate to provide well formed bales in most crops. However, in very dry greenfeed, packer finger adjustment was inadequate to produce well formed bales (FIGURE 7). The packer fingers were easily adjusted with a wrench.

FIGURE 7. Poorly Formed Bale in Greenfeed due to Inadequate Packer Finger Adjustment.

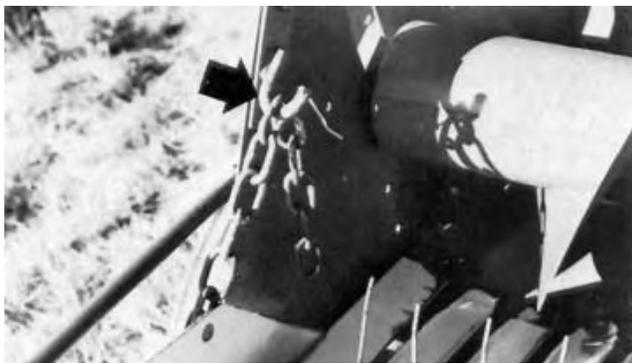
Pickup: The pickup height was easily set by positioning the chain on the hook (FIGURE 8). The pickup gauge wheel was positioned with the use of wrenches. The pickup windguard was not adjustable.

FIGURE 8. Pickup Height Adjustment.
