Evaluation Report

New Holland Model 310 Baler

NEW HOLLAND MODEL 310 BALER

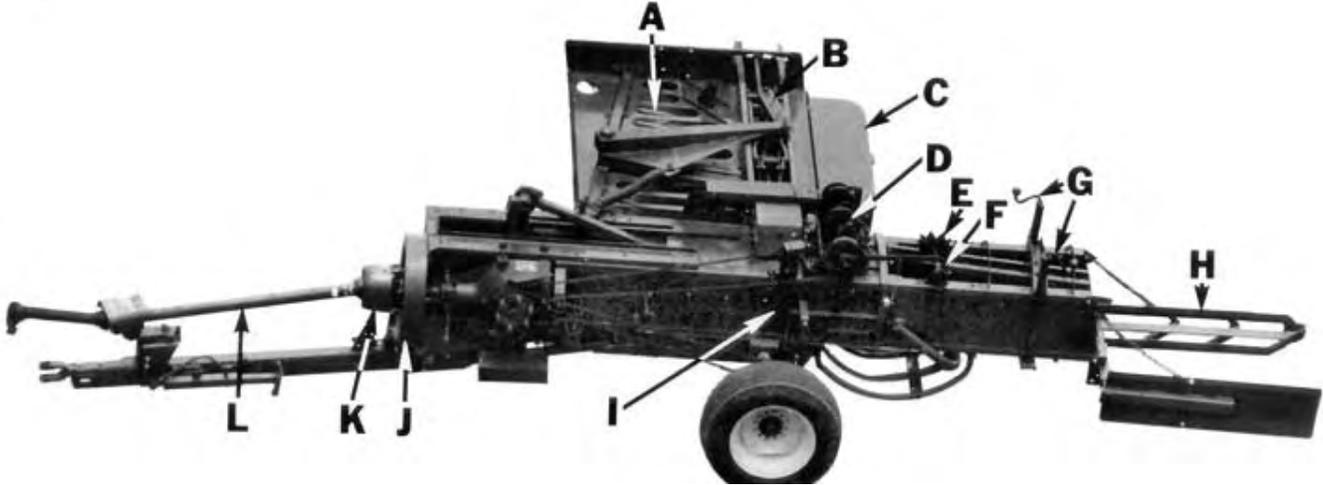
FIGURE 1. New Holland Model 310 Baler: (A) Pick Up, (B) Feeder Carriage, (C) Twine Box, (D) Knotters, (E) Metering Wheel, (F) Metering Arm, (G) Bale Density Adjustment, (H) Quarter Turn Bale Chute, (I) Bale Chamber, (J) Flywheel, (K) Slip Clutch, (L) Power Shaft.

FIGURE 1 shows the location of major components while detailed specifications are given in APPENDIX I.

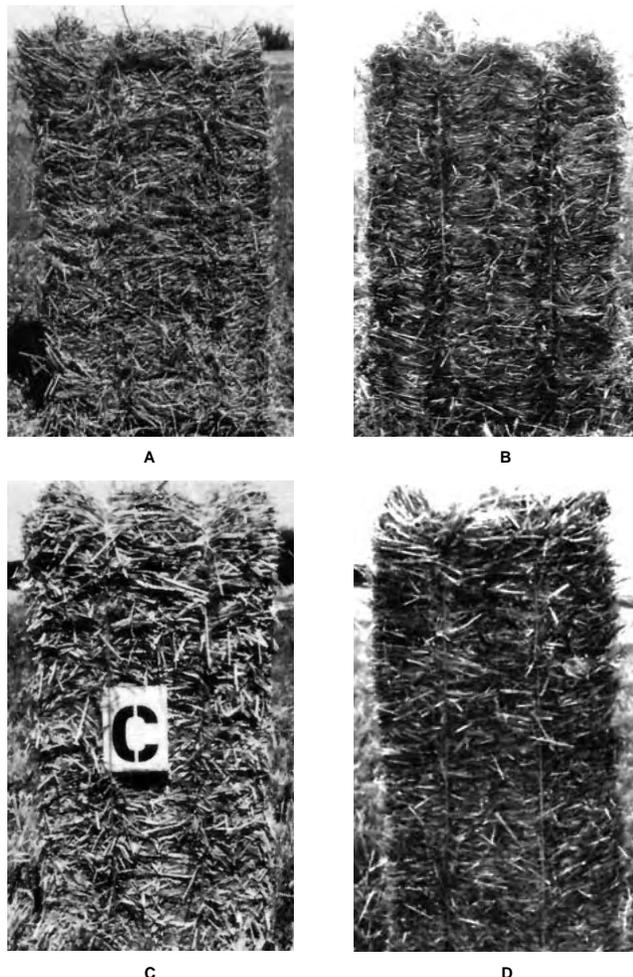
Bale Quality: At normal feedrates the New Holland 310 was capable of producing firm, durable bales with square ends in all crops (FIGURE 2). Average hay bales weighed 27 to 35 kg (59 to 77 lb), while average straw bales weighed 18 to 22 kg (40 to 48 lb). Average bale densities varied from 174 to 205 kg/m³ (10.4 to 12.3 lb/ft³) in hay and 115 to 123 kg/m³ (6.9 to 7.4 lb/ft³) in straw. Bale quality deteriorated at higher feedrates.

FIGURE 2. Typical Bales: (A) Alfalfa, (B) Bromegrass, (C) Greenfeed, (D) Straw.

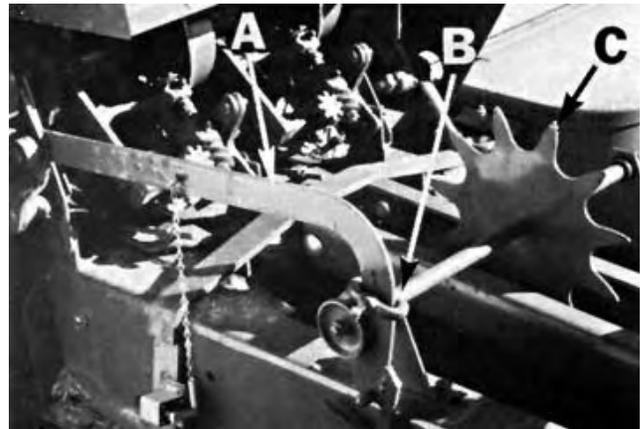
Bale length is adjusted by positioning the metering arm stop (FIGURE 3). The metering wheel advances the metering arm with each plunger stroke. Bale length uniformity depends on a consistent number of plunger strokes to form each bale. If the metering arm trips at the beginning of the last plunger stroke, rather than at the end of the stroke, bale length is increased by the length of compressed hay delivered during the last plunger stroke. Uniform feedrates are therefore important in reducing bale length variation.

FIGURE 3. Bale Length Adjustment: (A) Metering Arm, (B) Metering Wheel, (C) Adjustable Stop.

Bale Length: Bale length was conveniently adjusted with a wrench. Bale length settings from 305 to 1320 mm (12 to 52 in) were possible. Obtaining a consistent bale length was difficult, since bale lengths varied, depending on windrow uniformity and feedrate.

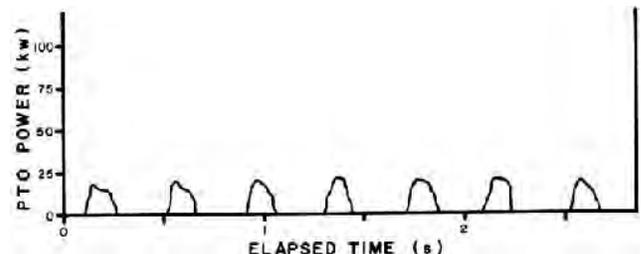
Power Take-off Requirements: FIGURE 4 shows typical instantaneous power take-off requirements for the New Holland 310. Power requirements fluctuated from 0 to 28 kW (0 to 38 hp) on each plunger stroke. Due to these wide power fluctuations, average power requirements were less than instantaneous requirements, varying from 5 to 19 kW (7 to 25 hp) over a full range of feedrates. FIGURE 5 shows the average power take-off requirements at various feedrates in alfalfa and wheat straw.

FIGURE 4. Instantaneous Power Take-off Requirements when Baling Alfalfa at an 8 t/h Feedrate.

required to pull the baler on level ground was usually less than 4 kW (5 hp). A 40 kW (54 hp) tractor was, however, needed to fully utilize baler capacity in soft or hilly fields and to overcome the power fluctuations illustrated in FIGURE 4.

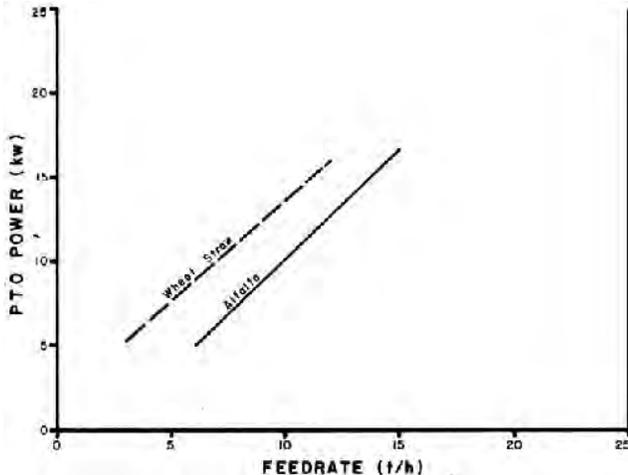
FIGURE 5. Average Power Take-off Requirements when Baling Alfalfa and Straw.

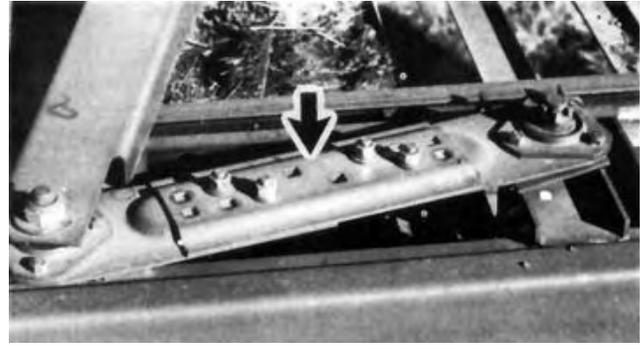
Feeding System: Feeder carriage penetration was easily adjusted by lengthening or shortening the feeder sled link (FIGURE 6). The feeder sled link had five settings which required the use of

wrenches. This adjustment was usually sufficient to produce square, well formed bales in most crops. Additional adjustment of the feeder back could also be used to improve bale shape. The feeder back was easily adjusted with wrenches.

FIGURE 6. Feeder Sled Link Adjustment.

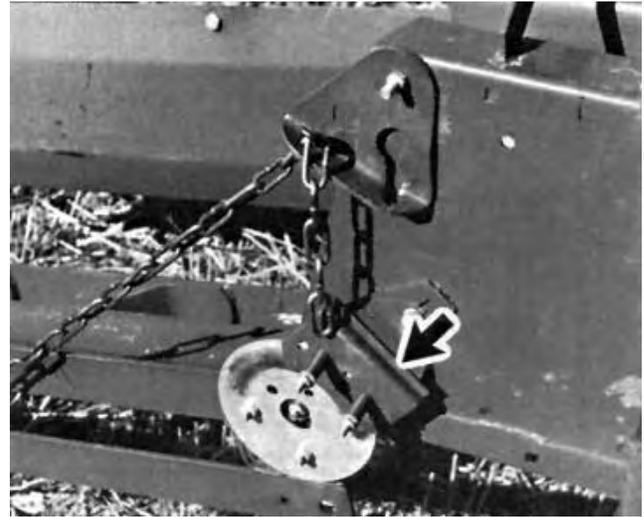
The right bale chute chain support bracket broke (FIGURE 7) and the frame at the base of the bale chute deflector arm cracked due to excessive bale chute bouncing. The anti-bounce brake (FIGURE 8) was improperly adjusted. The brake was disassembled, cleaned and adjusted to minimize bouncing. It is recommended that the manufacturer consider including instructions for the bale chute anti-bounce brake adjustment in the operator’s manual.

FIGURE 8. Bale Chute Anti-bounce Brake.

1. Including adjustment instructions for the bale chute anti-bounce brake in the operator's manual.

The operator's manual was clear, well written and contained much useful information on operation, servicing, adjustments and safety procedures. It did not include information on adjustment of the bale chute anti-bounce brake. It is recommended that the manufacturer consider including adjustment instructions for the anti-bounce brake in the operator's manual.

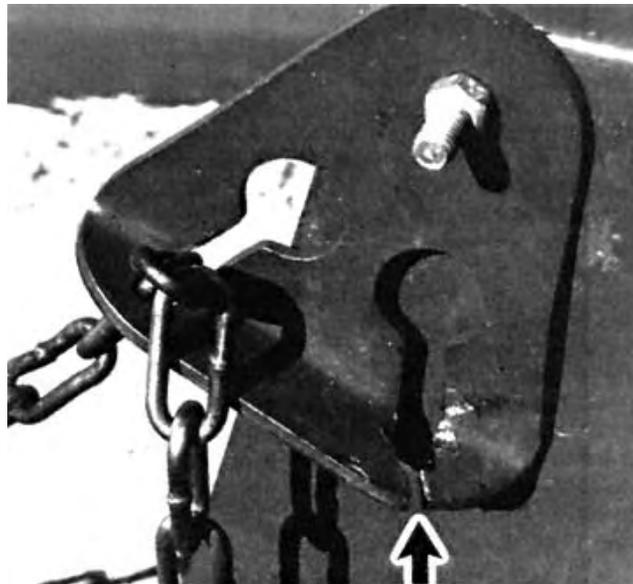
FIGURE 7. Broken Chain Support Bracket.
