Evaluation Report

279

International Harvester Model 445 Baler

INTERNATIONAL HARVESTER MODEL 445 BALER

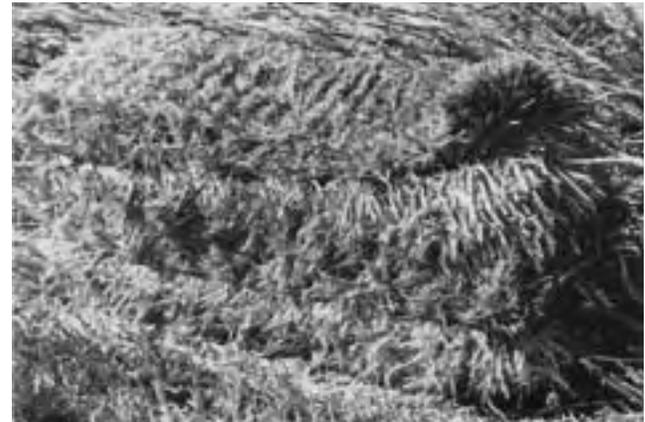
At higher feedrates when producing bales with less than 12 charges per 1000 mm (39.4 in) long bales, bale quality was reduced, due to non-creased bale ends. Bale quality was also reduced in very light, dry barley straw due to twine slipping off the bale as shown in FIGURE 3.

FIGURE 3. Twine Slipping Off Bale in Light, Dry Barley Straw.

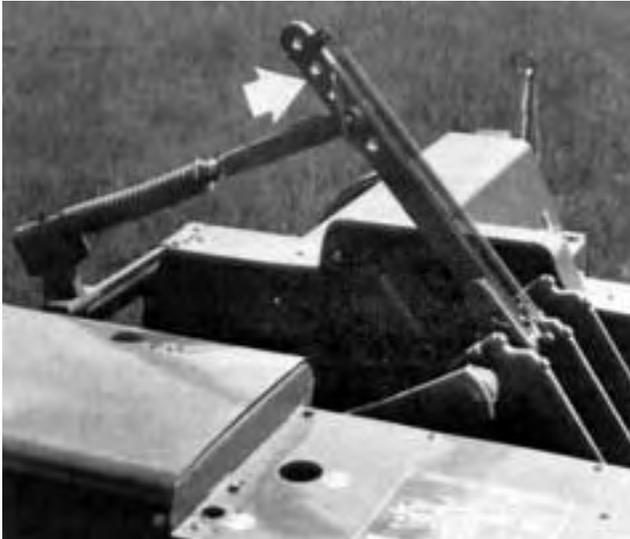
Feeding System: The packer fingers had five settings (FIGURE 7), which were adequate to produce square, well formed bales in most crops. The packer fingers were easily adjusted by hand. Occasionally in very light dry straw, further adjustment was required by changing the packer fingers from the right to the left side of the packer finger bearing. This required the use of wrenches.

FIGURE 7. Packer Finger Adjustment.
