# Evaluation Report

# 554

**New Idea 486 Round Baler**

## NEW IDEA 486 ROUND BALER

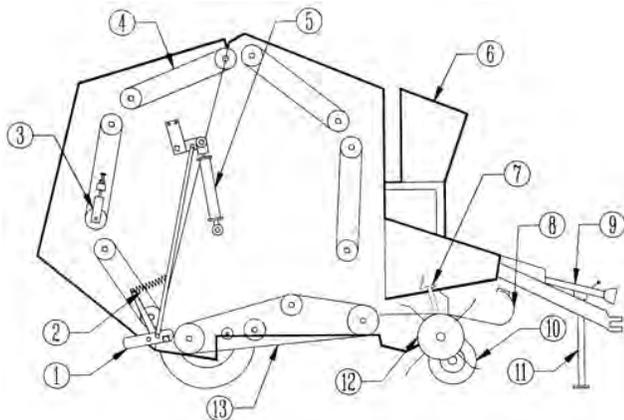
FIGURE 1. New Idea 486 Round Baler: (1) Tailgate Latch, (2) Bale Density Spring, (3) Belt Tension Adjusting Block, (4) Forming Belt, (5) Hydraulic Gate Cylinder, (6) Twine Box, (7) Pickup Transport Arm, (8) Windguard, (9) PTO Drive Shaft, (10) Gauge Wheel, (11) Jack, (12) Pickup, (13) Platform Belt.

Detailed specifications are given in APPENDIX I, while FIGURE 1 shows the locations of major components.

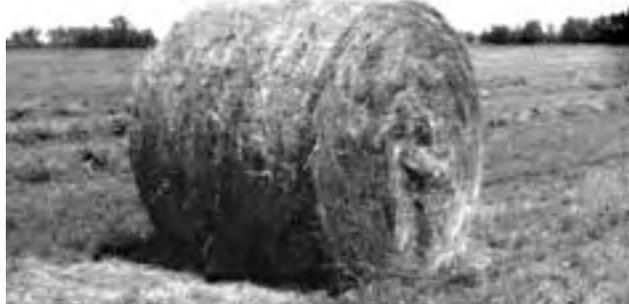
**Bale Quality:** The New Idea 486 produced firm, durable bales with flat ends and uniform diameter in all hay crops (FIGURE 2). Handling the bales when transporting did not present a problem. The overall bale quality depended greatly on the operator's experience. Failure of the operator to evenly feed both sides of the baler in light windrows resulted in barrel or cone-shaped bales.

A typical hay bale averaged 5.0 ft (1.5 m) in width and 6.0 ft (1.8 m) in diameter. Bales usually settled to about 92% of their original height after 100 days. Average hay bales weighed from 1200 to 1500 lb (550 to 680 kg) with average densities ranging from 85 to 10.3 lb/ft<sup>3</sup> (138 to 167 kg/m<sup>3</sup>). Average straw bales weighed from 800 to 1000 lb (360 to 450 kg) with average densities ranging from 5.7 to 7.1 lb/ft<sup>3</sup> (92 to 115 kg/m<sup>3</sup>).

FIGURE 2. Typical Hay Bale.

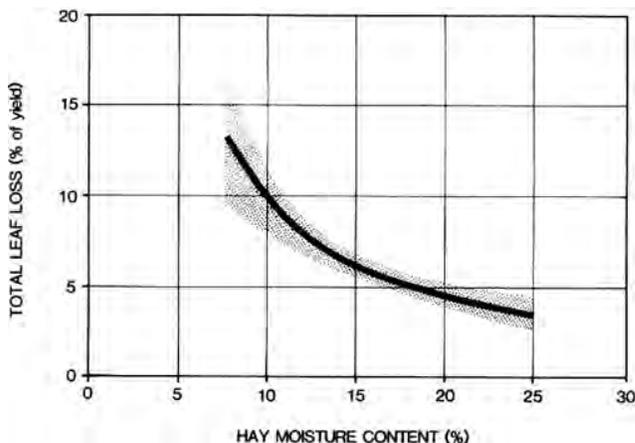
The importance of baling at a high moisture content on losses can be noted in FIGURE 3. This figure represents an accumulation of previous data for several round balers showing the total measured leaf and stem loss over a range of moisture contents, in fields of mixed alfalfa-crested wheatgrass and bromegrass. Although the New Idea 486 was tested in a different crop, its performance was better than that presented in the figure, i.e. losses were lower.

FIGURE 3 does not include relative effects of baling unconditioned or light windrows. Heavy, conditioned windrows were important to minimizing losses.

FIGURE 3. Typical Round Baler Leaf Loss in Mixed Alfalfa, Crested Wheatgrass and Bromegrass.

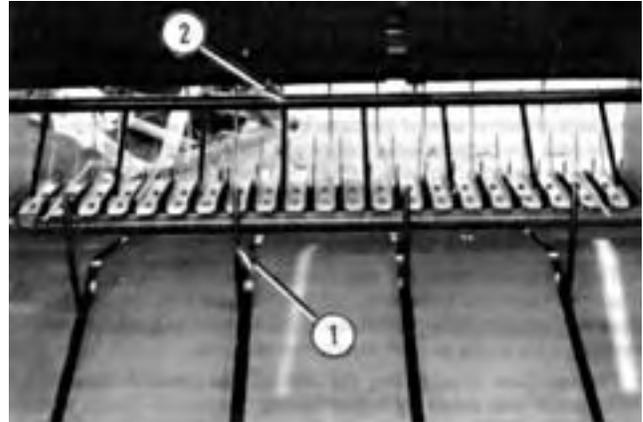
FIGURE 5. (1) Gate Fingers, (2) Crop Retainer.

**Crop Retainer:** Shortly after being installed, the crop retainer (FIGURE 5) bent due to overfeeding the bale chamber with short straw. There was insufficient pressure within the bale chamber to trigger the flashing light on the control box even though maximum bale diameter had already been reached. Loosening the bale density springs may have prevented this. The crop retainer was removed and not replaced for the remainder of the test.

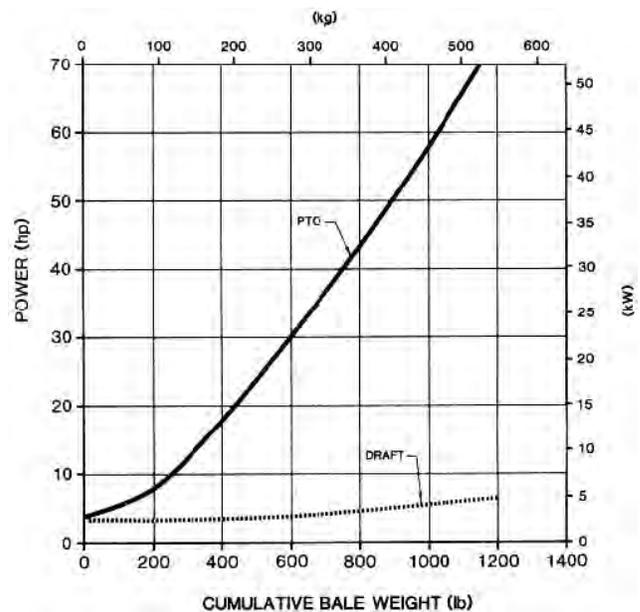
**Power Requirements:** FIGURE 6 shows the PTO and drawbar requirements for the New Idea 486. The power input is plotted against bale weight to show the power requirements while a bale is formed. The PTO requirements varied from 4.0 hp (3.0 kW) at no load to a maximum of 70 hp (52 kW) in alfalfa. Drawbar requirements at 6.6 mph (10.7 km/h) on flat firm fields were about 4.0 hp (3.0 kW) when the bale reached maximum size. Although maximum horsepower requirements did not exceed 74 hp (55 kW) additional power was needed to suit field conditions especially in soft hilly fields. The manufacturer suggested a tractor of at least 70 hp (52 kW). To fully utilize baler capacity, PAMI recommends a tractor of at least 90 hp (67 kW) in order to have sufficient power reserve in all field conditions.

FIGURE 6. Power Consumption During Bale Formation in Alfalfa.

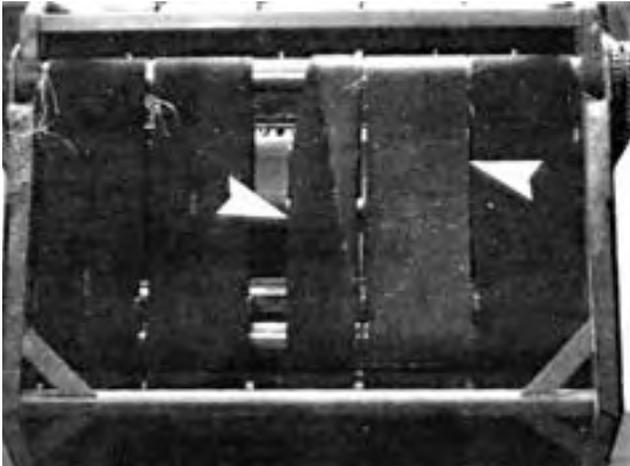
**Forming Belts:** Two of the inside forming belts at the top rear of the baler turned inside out (FIGURE 7) due to improper tension. The idler roller was removed, the belts returned to their proper position and were properly tensioned. No further problems occurred. Baling did not have to be halted when the belts started to turn inside out. Turning the belts took two people about one hour.

FIGURE 7. Forming Belts Turned Inside Out.
