Evaluation Report

611

Deutz-Allis GP 2.50 Round Baler

DEUTZ-ALLIS GP 2.50 ROUND BALER

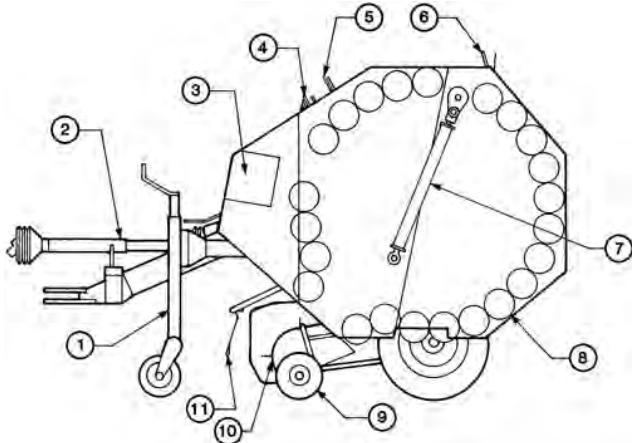
FIGURE 1. Deutz-Allis GP 2.50 Round Baler: (1) Wheeljack, (2) PTO Shaft, (3) Twine Box, (4) Twine Wrapping Mechanism, (5) Bale Size Indicator, (6) Tail Gate Closed Indicator, (7) Tail Gate Hydraulic Cylinder, (8) Rollers, (9) Pickup Gauge Wheels, (10) Pickup, (11) Optional Pickup Baffle Plate.

Detailed specifications are given in APPENDIX I, while FIGURE 1 shows the location of major components.

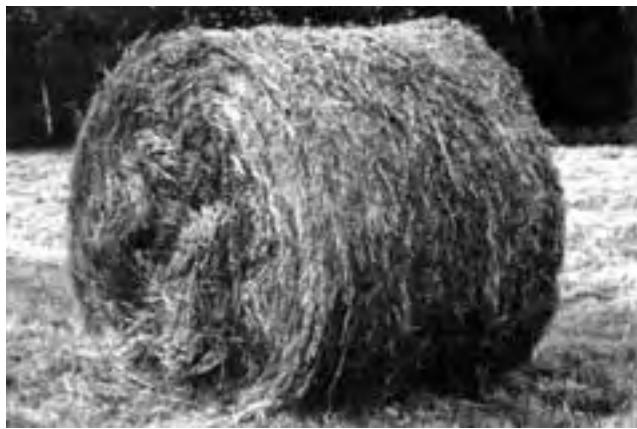
FIGURE 2. Typical Hay Bale.

Bale Quality: Bale quality was very good. The Deutz-Allis 2.50 produced firm, durable bales with flat ends and uniform diameter in all hay crops (FIGURE 2). Handling the bales when transporting did not present a problem. The overall bale quality depended greatly on the operator's experience. Failure of the operator to evenly feed both sides of the baler in light windrows sometimes resulted in barrel or cone-shaped bales.

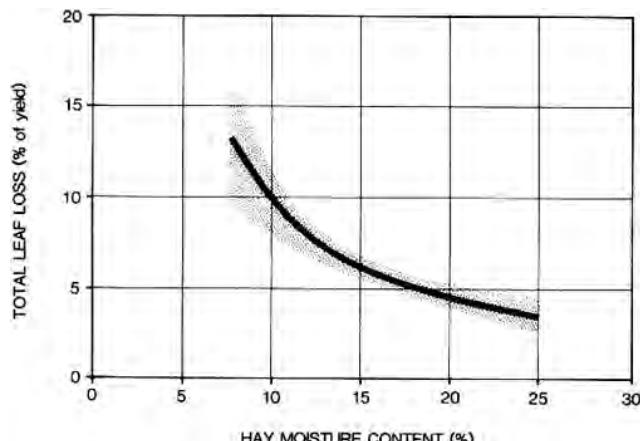
FIGURE 3. Typical Round Baler Leaf and Stem Loss in Mixed Alfalfa, Crested Wheatgrass and Bromegrass.

The importance of baling at a high moisture content on losses can be noted in FIGURE 3. This figure represents an accumulation of previous data for several round balers showing the total measured leaf and stem loss over a range of moisture contents, in fields of mixed alfalfa, crested wheatgrass and bromegrass. Although the Deutz-Allis 2.50 was tested in a different crop, it had average leaf and stem losses when compared to most other balers tested.

FIGURE 3 does not include the relative effects of baling unconditioned or light windrows. Heavy, conditioned windrows are important to minimize losses. Lowering PTO speed is also effective in reducing the number of times the bale is turned in the chamber, and consequently reduces leaf loss.

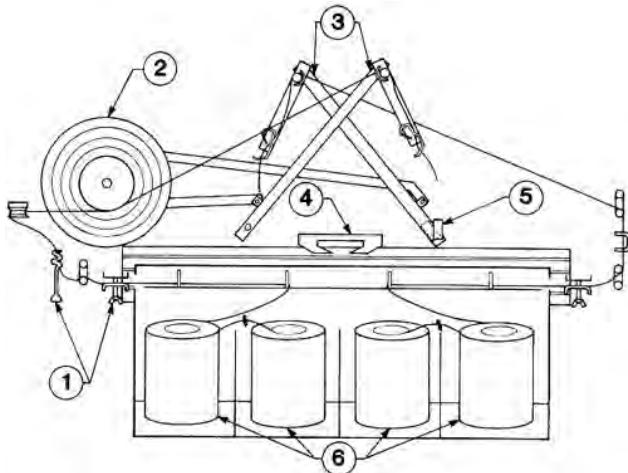
FIGURE 5. Tying Mechanism: (1) Twine Tensioners, (2) Stepped Pulley, (3) Swing Arms, (4) Twine Knife, (5) Single or Double Wrap Switch, (6) Twine.

When the full size bale reached the predetermined density a buzzer sounded and the red control lamp lit up telling the operator to stop so the bale could be tied. The swing arms (FIGURE 5) dropped down so the free ends of twine fell into the rotating bale. The swing arms moved the twine back and forth across the baler as the bale turned in the bale chamber thus wrapping it. The operator could select either single or double tying by moving a lever on the baler. Either single or double tying overlapped the twine on about the centre 18 in (460 mm) of bale. The rate of movement of the swing arms was determined by a stepped pulley, which the twine was wrapped around. A large pulley diameter resulted in closely spaced twine wraps. The distance from the edge of the bale to the outside wraps could be adjusted by moving a guide arm on either side of the baler.

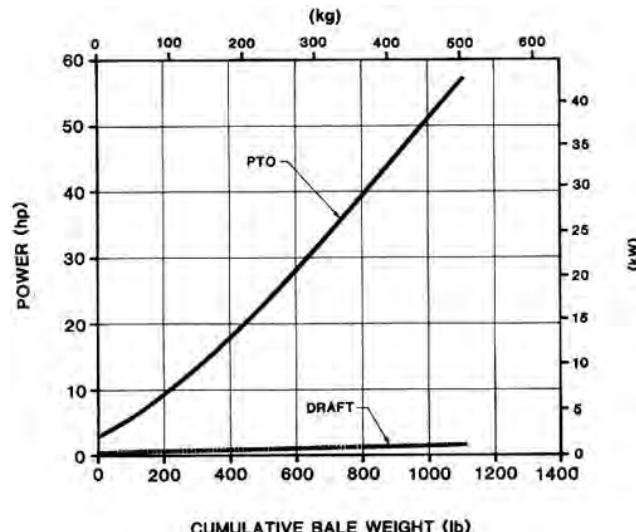
FIGURE 6. Power Consumption During Bale Formation in Alfalfa.

Power Requirements: FIGURE 6 shows the PTO and drawbar power requirements for the Deutz-Allis 2.50. The power input is plotted against bale weight to show the power requirements while a bale is formed. PTO requirements varied from 3.3 hp (2.5 kW) at no load to a maximum of 58 hp (43 kW) in alfalfa. Drawbar requirements at 2.2 mph (3.5 km/h) on flat firm fields were about 1.7 hp (1.3 kW) when the bale reached maximum size. Although maximum horsepower requirements did not exceed 60 hp (45 kW) additional power was needed to suit some field conditions such as soft hilly fields. To fully utilize baler capacity, PAMI recommends a tractor of at least 80 hp (60 kW) in order to have sufficient power reserve in all field conditions.
