# Evaluation Report

# 587

## New Holland 900 Forage Harvester

# NEW HOLLAND 900 FORAGE HARVESTER

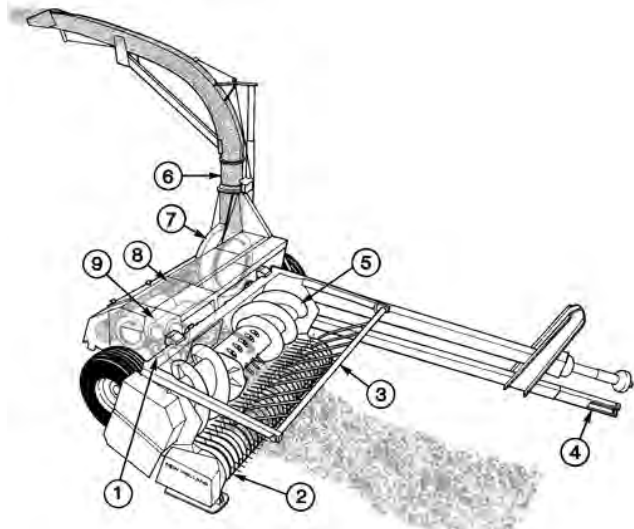
FIGURE 1. New Holland 900: (1) Feed Rolls, (2) Windrow Pickup, (3) Windguard, (4) Hitch, (5) Feed Auger, (6) Discharge Spout, (7) Fan, (8) Transfer Auger, (9) Cutterhead.

The New Holland 900 is a power take-off driven, pull-type forage harvester. The cylindrical cutterhead is fed by a reversible feedroll assembly. The cut length may be set either by changing feedroll drive chain sprockets or varying the number of cutterhead knives. Chopped forage is delivered from the cutterhead to the discharge fan, by a transfer auger.

The test machine was equipped with a 6.3 ft (1.9 m) windrow pickup and a three-row row crop header. Detailed specifications are given in APPENDIX I, while FIGURE 1 shows the location of the major components.

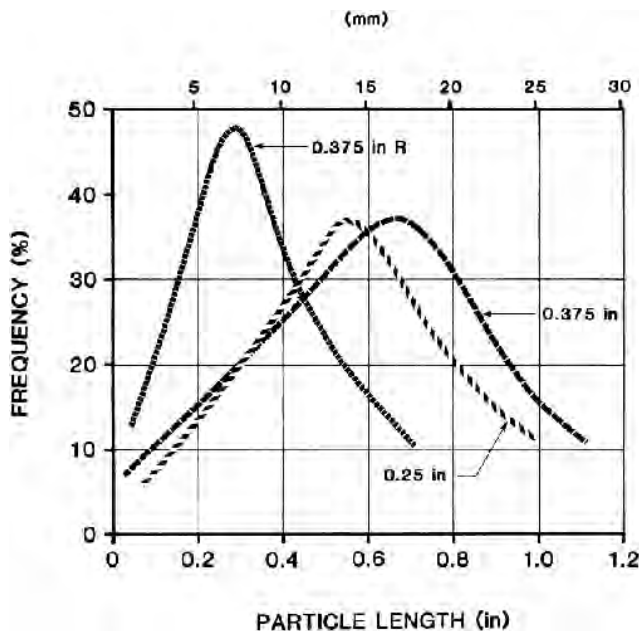
FIGURE 2. Particle Length Distribution in Alfalfa (R: with slotted hole progressive size recutter screen.)

**Uniformity of Cut:**<sup>2</sup> FIGURE 2 presents typical particle length distributions in second-cut, one half bloom alfalfa, harvested at 47% moisture content. Particle length variations are given for 0.25 and 0.375 in (6 and 9 mm) cut settings, with and without the use of a slotted hole, progressive size recutter screen. At a 0.25 in (6 mm) setting, only 7% of the silage had a length greater than 1.0 in (25 mm), while at the 0.375 in. (9 mm) setting, 12% had a length greater than 1.0 in (25 mm). The slotted hole recutter screen greatly decreased the percentage of longer particles at each cut length setting.

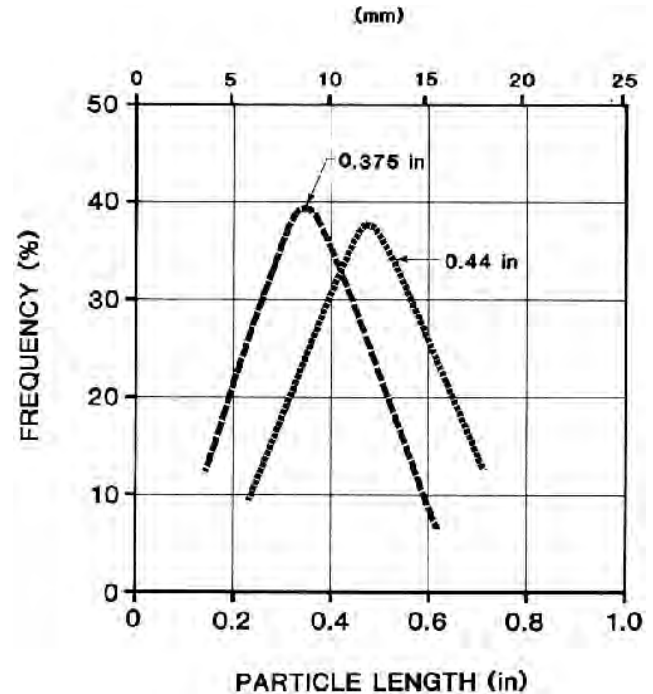
FIGURE 3. Particle Length Distribution in Corn.

FIGURE 3 presents typical particle length distributions in corn, harvested at 50% moisture content, for 0.375 and 0.44 in (9 and 11 mm) settings (APPENDIX III, FIGURE 7). None of the chopped corn

had a length greater than 1 in (25 mm) at both 0.25 in and 0.44 in (9 and 11 mm) settings. The smaller percentage of longer particles in corn, compared to alfalfa, was due to perpendicular feeding of the row crop header.

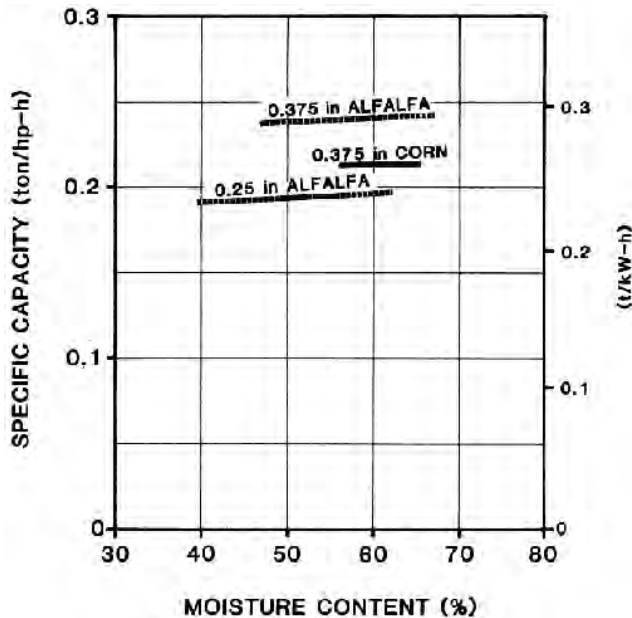
FIGURE 4. Specific Capacity.

**Specific Capacity:** FIGURE 4 shows the specific capacity of the New Holland 900. Specific capacity is a measure of how efficiently a machine operates. A high specific capacity indicates efficient energy use, while a low specific capacity indicates less efficient operation. As shown in FIGURE 4, a 10% increase in crop moisture content increased the specific capacity by about 10% in alfalfa. Changing cut length settings from 0.375 to 0.25 in (9 to 6 mm) reduced specific capacity by about 35%. The use of a slotted hole recutter screen reduced specific capacity by 60% at a 0.375 in (9 mm) cut setting.

In corn, specific capacity was 0.237 ton/hp-h (0.285 t/kW-h) at 50% moisture content.

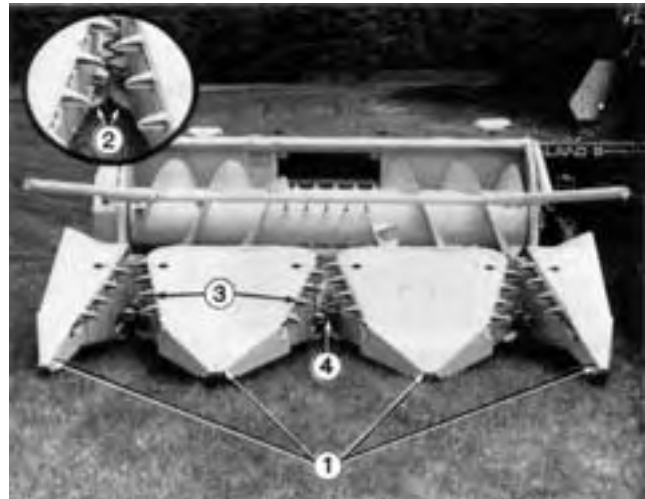
FIGURE 5. Three-row Row Crop Header: (1) Divider Points, (2) Rotary Sickle, (3) Upper Gathering Chains, (4) Lower Gathering Chains.

**Three-row Row Crop Header:** Performance of the row crop header was fair. The three-row row crop header (FIGURE 5) was equipped with lower gripping chains, upper gathering chains and rotary sickles which operated at a row spacing of 38 in (960 mm).

Four header chain speeds were possible by changing header drive sprockets. This matched gathering chain speed to ground speed up to 9 mph (14 km/h).

The lower gathering chains plugged several times during the test in short corn and weed infested crops. Adjustments to the header did not alleviate the problems. It is recommended the manufacturer consider modifications to prevent row crop header plugging.

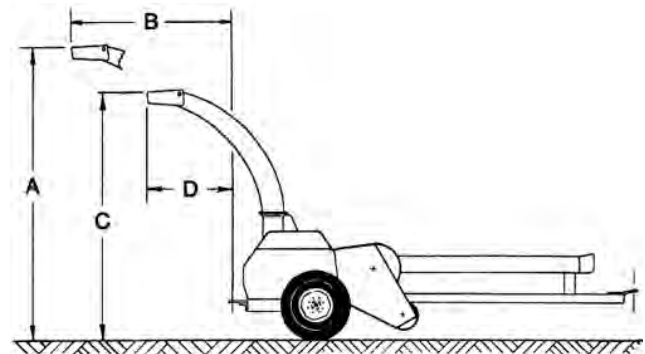
FIGURE 6. Discharge Spout Dimensions: (a) Lift with Extension 10.8 ft (3.3 m), (b) Reach with Extension 5.4 ft (1.6 m), (c) Lift 10.7 in (3.2 m), (d) Reach 3.4 ft (1.0 m).

**Discharge Spout:** The lift and reach of the discharge spout could be adjusted by adding or removing pipe sections as shown in FIGURE 6 or by tilting the spout at its base. The extension used for testing was a 24 in (600 mm) horizontal. Several other extensions were available. The dimensions in FIGURE 6 were determined at the maximum ground clearance setting of the adjustable axle, which could be positioned to give discharge heights 3 in (75 mm) and 6 in (150 mm) lower than those shown. Tilting the spout would give discharge heights 6 in (150 mm) higher or lower than those shown. The forage discharge direction was controlled by spout rotation and deflector cap angle, which were operated by the remote controls. The range of adjustments was adequate for operation with wagons and trucks.
