Evaluation Report

International Harvester 1460 Self-Propelled Combine

INTERNATIONAL HARVESTER 1460 SELF-PROPELLED COMBINE

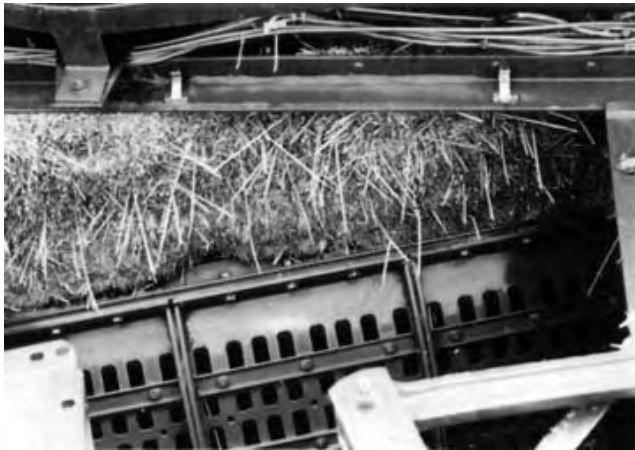
FIGURE 4. Bridging Between Concave and Sidewall.

Straw and chaff bridged between the left side sheet of the combine and the separating concave (FIGURE 4), thus decreasing separating area. Plugging was caused by straw hairpinning around a concave support member. This problem was eliminated by installing a cover, which prevented hairpinning. It is recommended that the manufacturer consider modifying the separating concave to prevent bridging of straw and chaff.

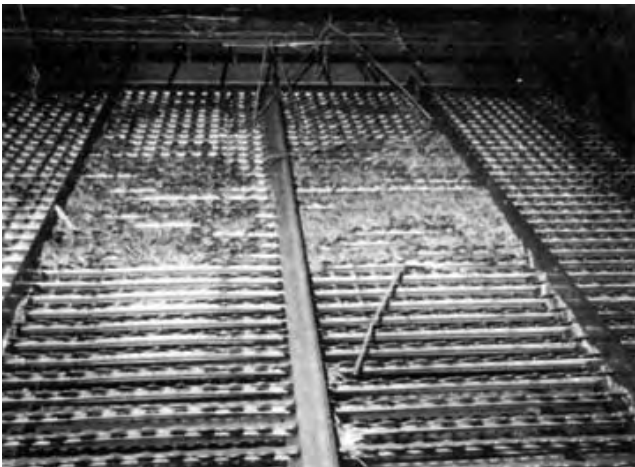
FIGURE 5. Chaffer Plugging in Wildoats.

The chaffer sieve centre section plugged (FIGURE 5) when combining wild oat infested crops. This was attributed to the lip design which retained the wild oat seeds, and also to lower air velocities at the centre of the chaffer, it is recommended that the manufacturer consider modifications to reduce centre-section chaffer plugging in wild oat infested crops.

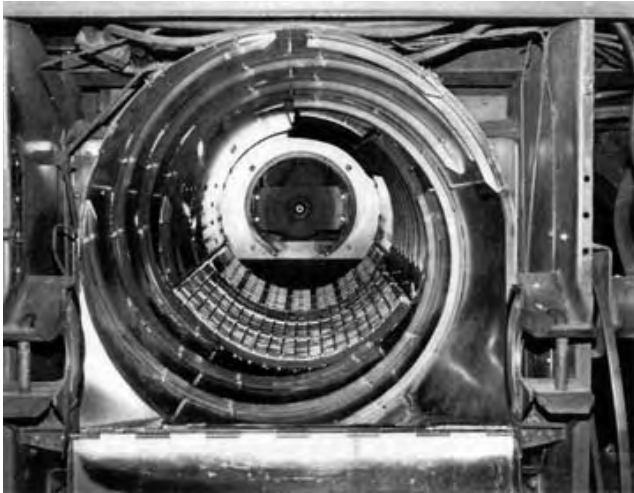
FIGURE 8. Threshing and Separating Concaves.

Concave Adjustment: The rotor was equipped with an adjustable threshing concave and a stationary separating concave (FIGURE 8). Access to the concave was through doors on both sides of the combine.

Levelling and adjustment of initial concave clearance was quite convenient. The front threshing concaves were removable in three individual segments so one segment was removed while initial adjustments were made using the other two segments for reference. Suitable initial concave settings (FIGURE 9) were 55 mm at the leading bar and 2 mm at the trailing bar. The concave stops were then secured and the indicator set to the zero position.

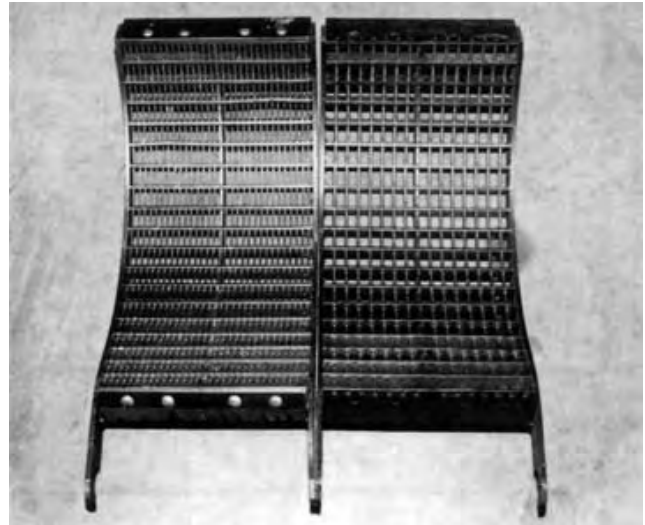
FIGURE 10. Narrow and Wide Spaced Concaves.

Capacity tests in wheat were conducted with all narrow spaced

concaves (FIGURE 10), while in barley tests were conducted with the narrow spaced concave in the first position, and wide spaced concaves (FIGURE 10) in the second and third position.

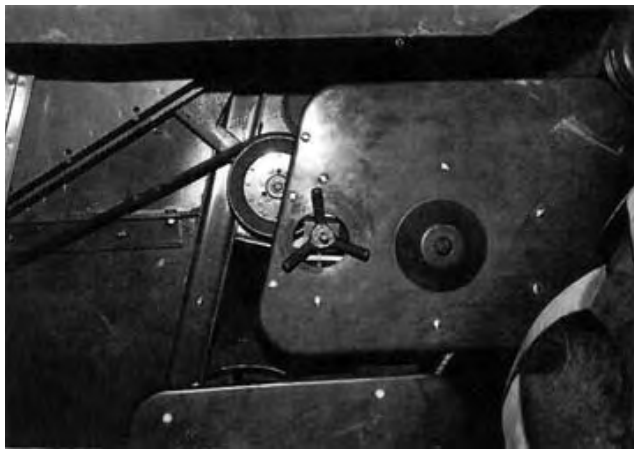
FIGURE 13. Fan Adjustment.

Fan speed was varied with a hand wheel (FIGURE 13) while the chaffer, chaffer extension and clean grain sieves were adjusted with levers at the rear of the shoe. There was no provision to safely and conveniently sample tailings to aid in machine adjustment.

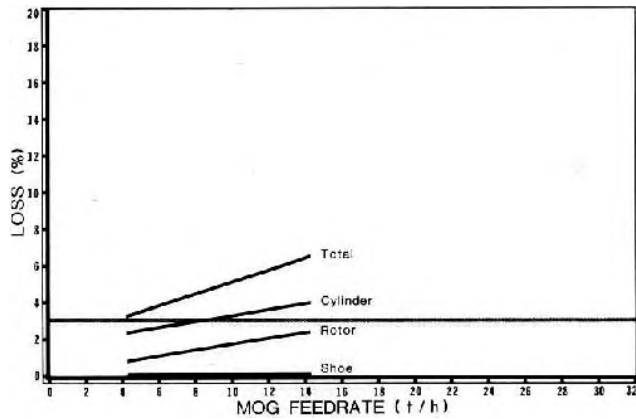
FIGURE 14. Grain Loss in Canuck Wheat.

Cylinder Loss: Cylinder loss was low in all dry and well matured crops, but became significant if concave clearances were too large in difficult-to-thresh spring wheat (FIGURE 14). Although cylinder loss increased in tough and damp crops, it was usually acceptable. The good threshing performance of the rotor in most crop conditions was attributed to the large number of times the straw passed by the concaves. More complete threshing might occur if the rear separating concaves were bar and wire grate rather than smooth pressed metal.

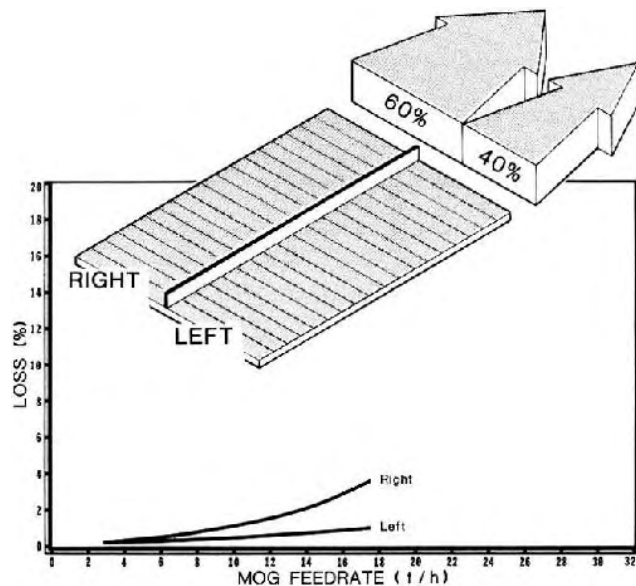
FIGURE 19. Chaff Load and Shoe Loss in Bonanza Barley.

Shoe Loss: Shoe loss rarely limited combine capacity, but losses became significant in barley crops at high feedrates. High losses could occur on uneven terrain or with improper settings. Shoe loss in a Midas rapeseed crop was acceptable, averaging from 0.75 to 1.5% of yield, but lower shoe losses were seldom attainable due to uneven air, chaff and seed distribution.

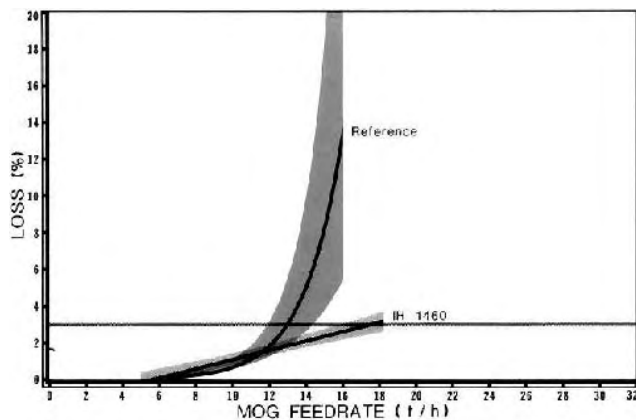
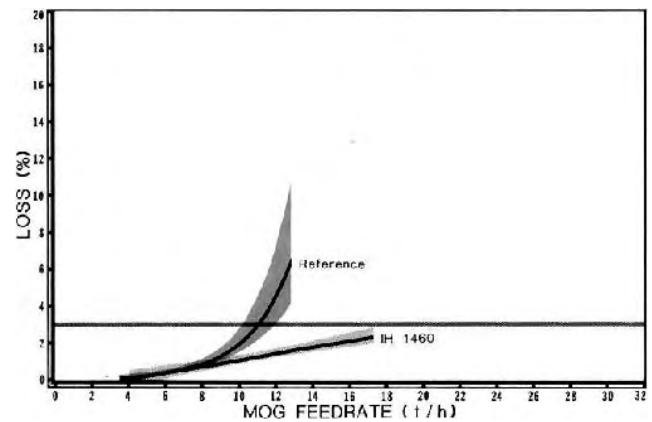
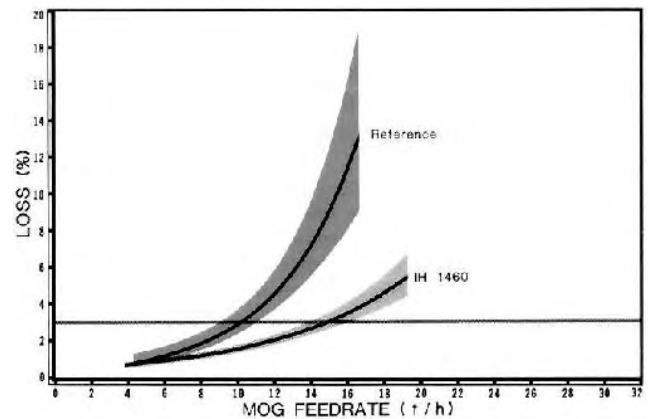
FIGURES 20 to 23 compare the total grain losses of the International Harvester 1460 and the PAMI reference combine in four of the crops described in TABLE 4. The shaded areas on the figures are 95% confidence belts. If the shaded areas overlap, the loss characteristics of the two combines are not significantly different whereas if the shaded areas do not overlap, the losses are significantly different. The capacity of the International Harvester 1460 was much greater than the capacity of the reference combine and the International Harvester 1460 had much lower grain losses than the reference combine when operating at the same feedrate.

FIGURE 20. Total Grain Losses in Canuck Wheat.

FIGURE 21. Total Grain Losses in Lemhi Wheat.

FIGURE 22. Total Grain Losses in Neepawa Wheat.

FIGURE 23. Total Grain Losses in Bonanza Barley.
