Evaluation Report

Massey Ferguson 760 Self-Propelled Combine

MASSEY FERGUSON 760 SELF-PROPELLED COMBINE

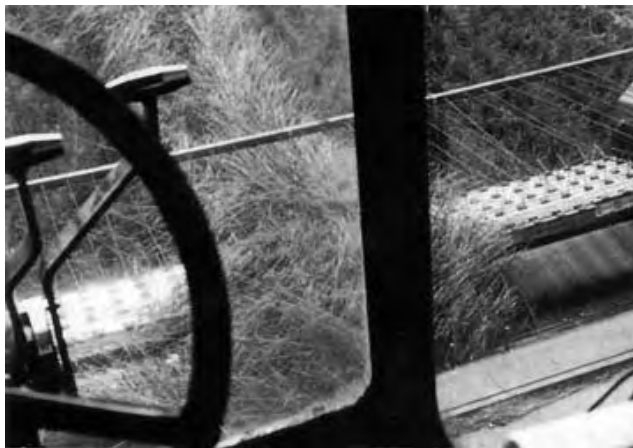
FIGURE 2. Operator's View of the Windrow.

The right cab corner post obstructed the operator's view of the incoming windrow (FIGURE 2) and it is recommended that the manufacturer consider modifications to improve visibility.

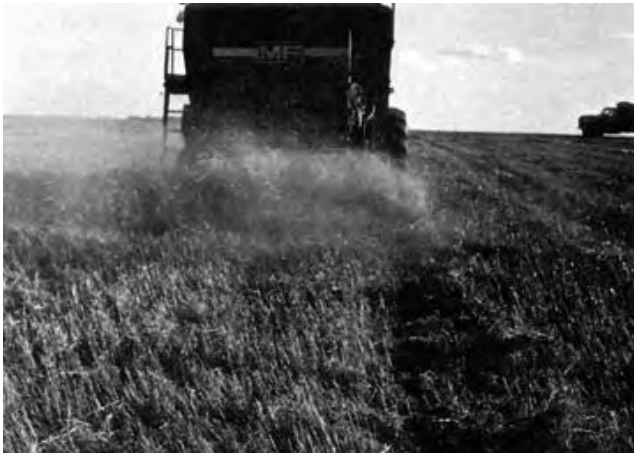
FIGURE 6. Spreading of Chopped Straw.

Straw Chopper: The optional straw chopper attachment performed well in most crops although the knives could not be fully engaged in some crops as belt slippage occurred. Maximum spreading width varied from 4 to 5 m, depending on straw and wind conditions, and spreading was inadequate for swath widths greater

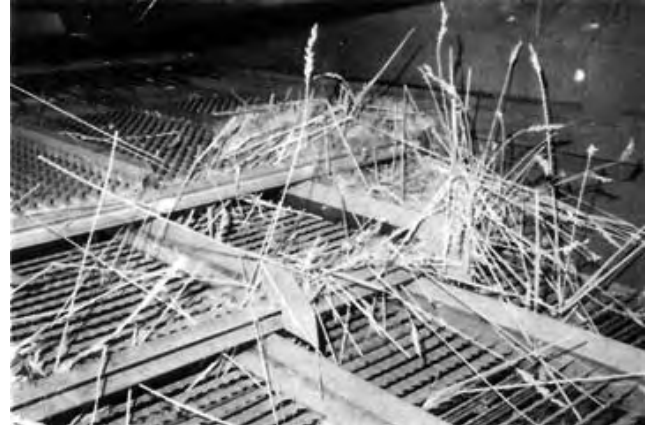
FIGURE 8. Spearing in Shoe.

Straw and chaff accumulated between the clean grain pan and the bottom sieve immediately in front of the return elevator trough and had to be removed periodically. Spearing of straw in the shoe occurred in fall rye, winter and durum wheat (FIGURE 8) and straw removal was time consuming. It is recommended that the manufacturer consider modifications to the shoe to eliminate spearing.

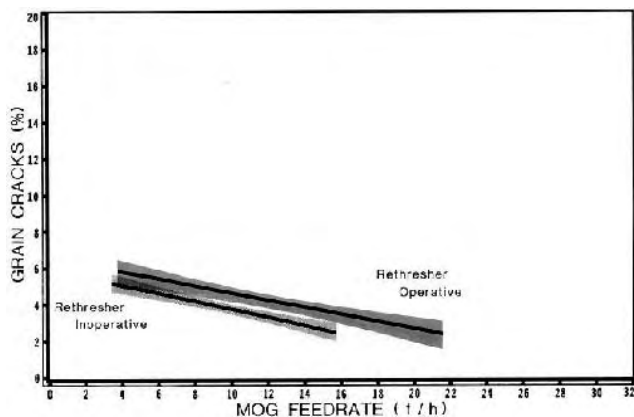
FIGURE 13. Grain Damage with Retresher Operative and Inoperative.

Return tailings were delivered to a rethresher (FIGURE 12), which discharged to the straw walker grain pan. The rethresher concave packed with soil and plant residue during normal operation, and required frequent cleaning. To determine the grain damage caused by the rethresher, tests were run in Neepawa wheat with the rethresher operative and inoperative (FIGURE 13). Grain damage was slightly higher with the rethresher operative.

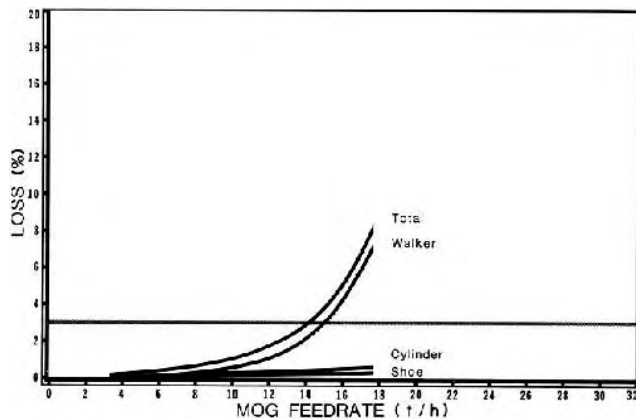
FIGURE 16. Grain Loss in Lemhi Wheat.

The grain loss characteristics for the Massey Ferguson 760 in the six crops described in TABLE 4 are presented in FIGURES 14 to 19.

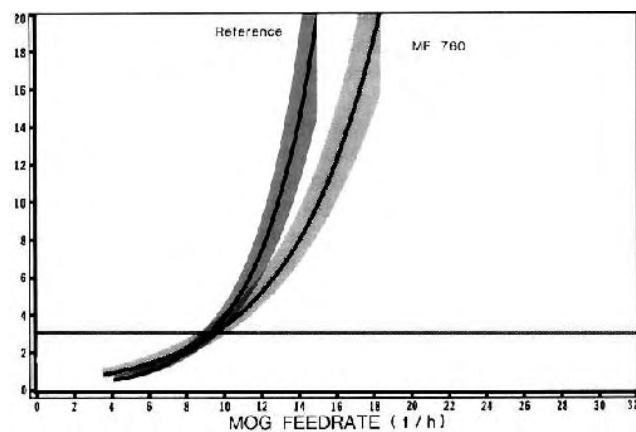
FIGURE 22. Total Grain Losses in Neepawa Wheat.
