# Evaluation Report

## John Deere 7721 Pull-Type Combine

# JOHN DEERE 7721 PULL-TYPE COMBINE

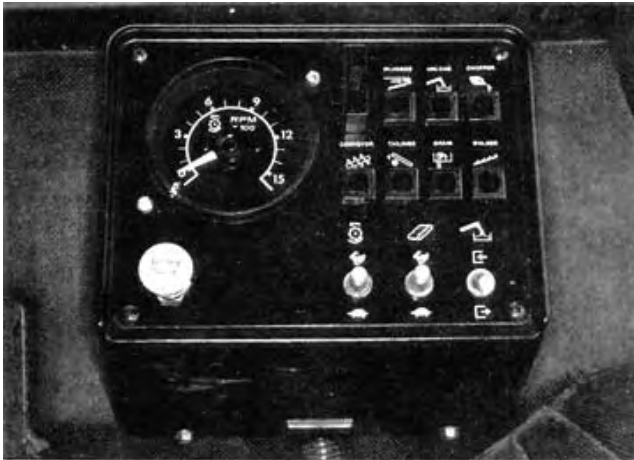
**Controls:** The separator drive was controlled with the power take-off clutch. Electromagnetic clutches activated from the control box (FIGURE 2) controlled the header drive and the unloading auger drive. The tractor hydraulics were used to control header height and unloading auger position. Cylinder and pickup speeds were hydraulically operated and also electrically controlled from the control box. The control box also contained a cylinder tachometer and shaft speed monitors for the straw chopper, shoe supply augers, tailings return, clean grain elevator, and straw walkers as well as

FIGURE 2. Tractor Mounted Control Box.

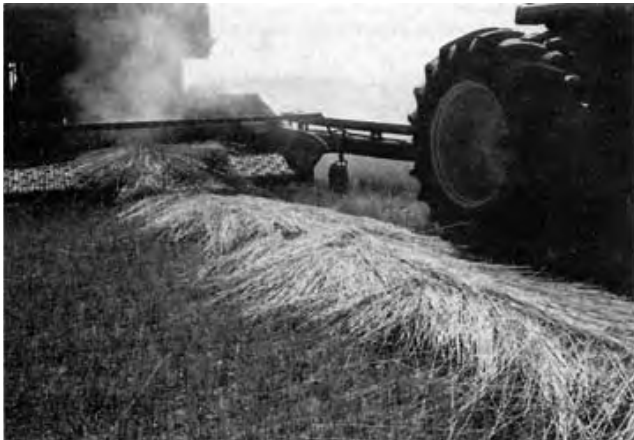
The tractor and combine lights were adequate for night-time harvesting, however, in some crops the dust coming from the feeder restricted night visibility (FIGURE 3). It is recommended that the manufacturer consider modifications to reduce dust at the feeder entrance. Warning lights and the taillight were adequate for safe road travel.

FIGURE 3. Excessive Dust at Feeder Entrance.

6. Modifications to reduce header twist when the table is locked in transport position.
7. Providing inspection ports for the front of the concave and improving the accessibility of the concave front levelling bolt.
8. Modifications to improve the ease and safety of sampling return tailings.
9. Supplying a straw chopper belt shield.
10. Modifying the combine ladder to improve safety.
11. Supplying a lock for the grain tank extensions.
12. Modifying the torque sensing unit on the variable cylinder drive to provide proper belt tension over the entire speed range and to reduce grease loss from the housing.
13. Revising the operator's manual to include more appropriate recommended cylinder speeds for rapeseed.
14. Modifying the concave front levelling bolt support member to eliminate bending of the support during operation.
15. Modifications to reduce dust at the feeder entrance.

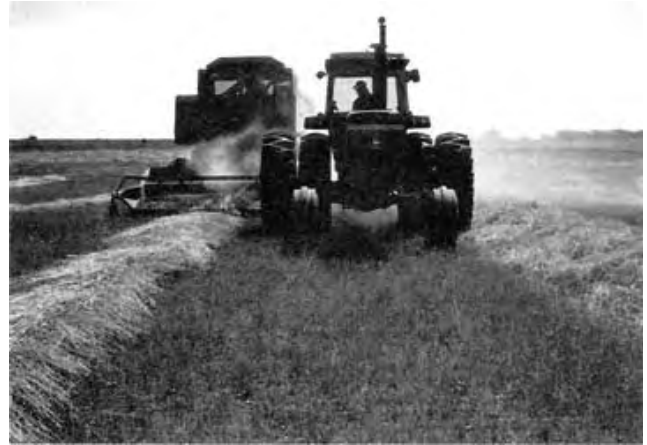
FIGURE 4. Direct Feeding of Windrow.

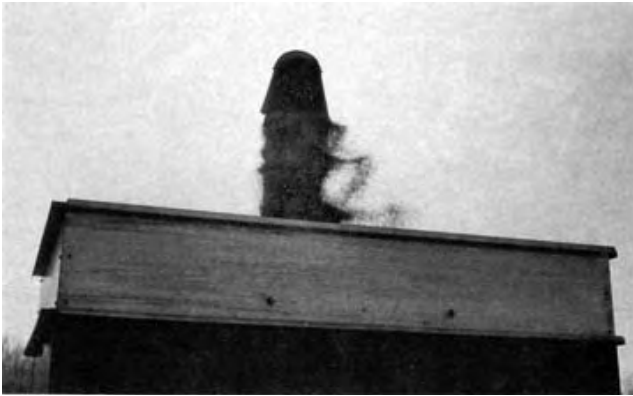
The unloading auger had ample reach and clearance for easy on-the-go unloading. It could be hydraulically positioned from the tractor seat. In dry wheat, the 7.1 m<sup>3</sup> (195 bu) tank could be unloaded in 105 seconds. The auger discharge characteristics (FIGURE 7) and high discharge height often resulted in grain loss when unloading in windy conditions. The unloading auger also continued to run for about 5 seconds after the clutch was disengaged, which made topping-off a load inconvenient. It is recommended that the manufacturer consider modifications to eliminate auger run-on after disengagement and to concentrate the stream of grain at the auger discharge to reduce wind losses.

FIGURE 7. Unloading Auger Discharge.

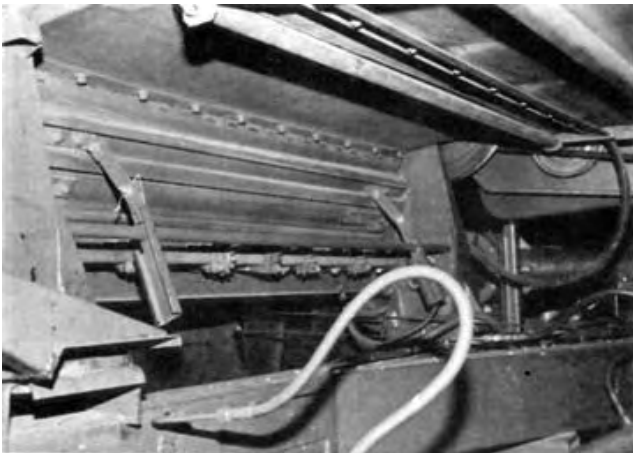
**Stone Trap:** The stone trap located in front of the cylinder prevented most stones and roots from entering the cylinder. The stone trap opened easily by tripping the overcentre levers (FIGURE 8). Complete cleaning required hand removal of objects, which was inconvenient.

FIGURE 8. Stone Trap.

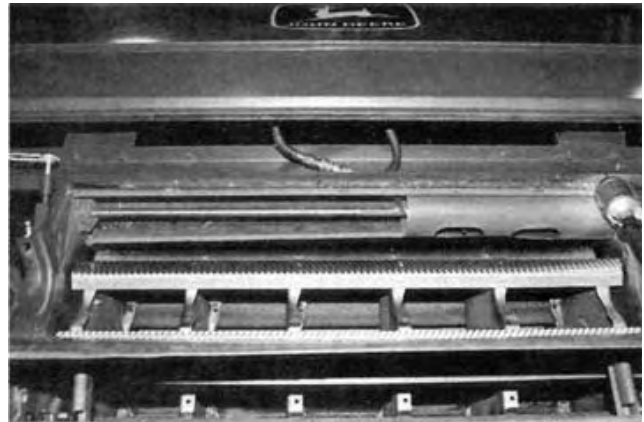
FIGURE 9. Deformed Return Auger Housing & Cylinder Housing.

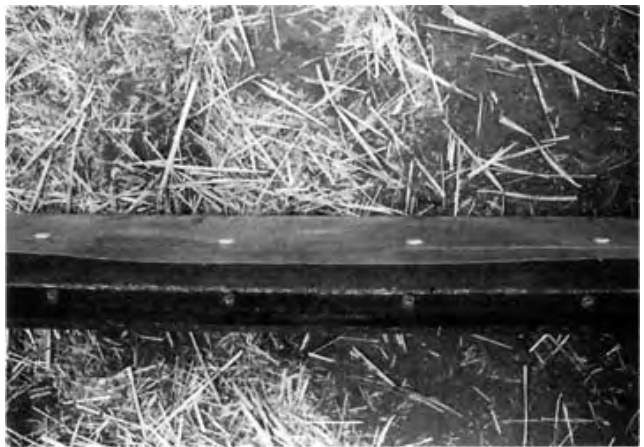
FIGURE 10. Deformed Front Panel Stripper.

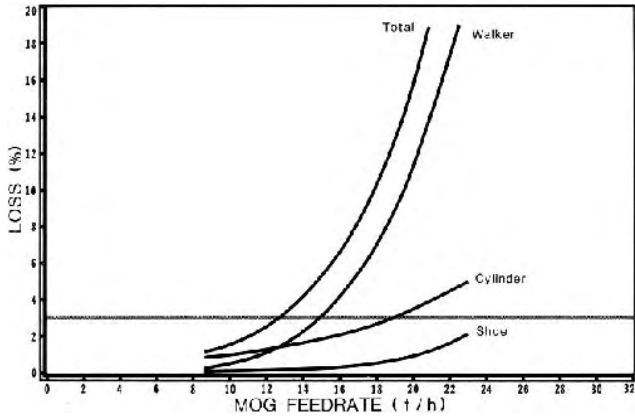
FIGURE 14. Grain Loss in Klages Barley.

FIGURE 15. Grain Loss in Neepawa Wheat (Field A).

FIGURE 16. Grain Loss in Neepawa Wheat (Field B).

**Cylinder Loss and Grain Damage:** Cylinder loss was low in most dry and well matured crops (FIGURES 14 to 17 and 19). Grain cracks in Fergus and Klages barley ranged from 2 to 4% and in easier threshing Neepawa wheat (fields A, B and C) from 2 to 3.5%. In field D in difficult-to-thresh Neepawa wheat (FIGURE 18), the final cylinder and concave adjustments were a compromise between cylinder loss and grain damage. In this case grain cracks varied from 6 to 7% (FIGURE 20) while cylinder loss ranged from 1 to 4.5%.

FIGURE 17. Grain Loss in Neepawa Wheat (Field C).

FIGURE 18. Grain Loss in Neepawa Wheat (Field D).

FIGURE 19. Grain Loss in Fergus Bailey.

APPENDIX II					
REGRESSION EQUATIONS FOR CAPACITY RESULTS					
Regression equations, for the capacity results shown in FIGURES 14 to 19 are presented in TABLE 6. In the regressions, C= cylinder loss in percent of yield, S = shoe loss in percent of yield, W = walker loss in percent of yield. F = the MOG feedrate in t/h, while $\ln$ is the natural logarithm. Sample size refers to the number of loss collections. Limits of the regressions may be obtained from FIGURES 14 to 19 while crop conditions are presented in TABLE 4.					
TABLE 6. Regression Equations					
Crop - Variety	Fig. No.	Regression Equations	Simple Correlation Coefficient	Variance Ratio	Sample Size
Barley - Klagas	14	$C = -0.1926 + 0.06618F$ $\ln S = -7.8331 + 3.4469\ln F$ $\ln W = -8.1007 + 4.2317\ln F$	0.46 0.82 0.98	1.85 14.43 <sup>2</sup> 149.95 <sup>2</sup>	9
Wheat - Neepawa (Field A)	15	$C = -0.1555 + 0.02215F$ $\ln S = -5.8072 + 0.33401F$ $\ln W = -11.4549 + 4.4156\ln F$	0.90 0.94 0.98	28.57 <sup>2</sup> 57.17 <sup>2</sup> 14431 <sup>2</sup>	9
