Evaluation Report

Massey Ferguson 751 Pull-Type Combine

MASSEY FERGUSON 751 PULL-TYPE COMBINE

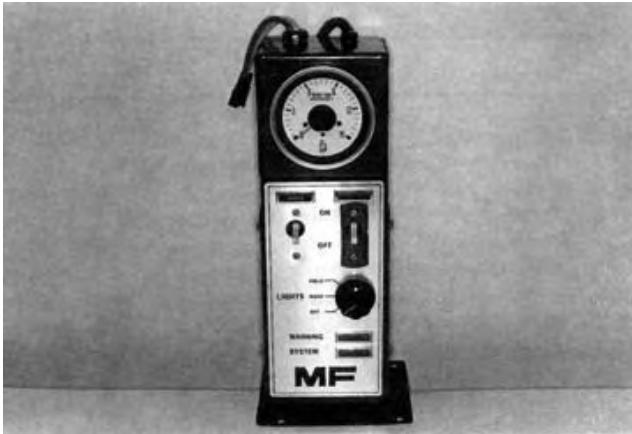
Controls: The separator drive was controlled with the tractor power take-off clutch, while header height was controlled by the tractor hydraulics. The combine control box (FIGURE 2) contained a cylinder tachometer, warning lights and switches for engaging the header drive and the grain unloading auger, as well as a switch for the combine lights. A visual and audible warning system was supplied for the rethresher and straw chopper. The warning horn was very loud and annoying to the operator. The range of ground speeds available depended upon the tractor transmission.

FIGURE 2. Tractor Mounted Control Box.

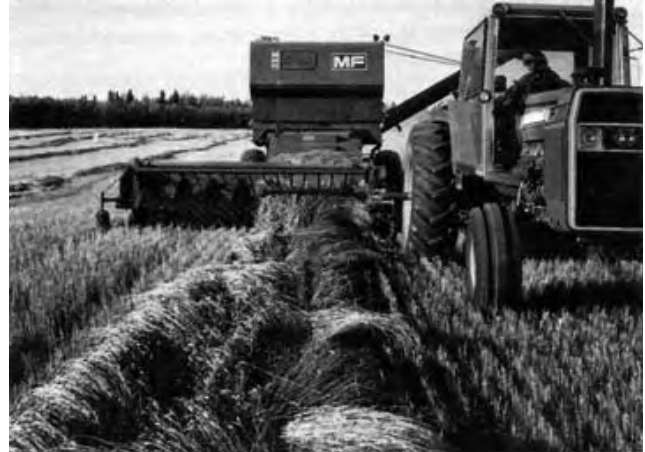
FIGURE 3. Feeding of Windrow.

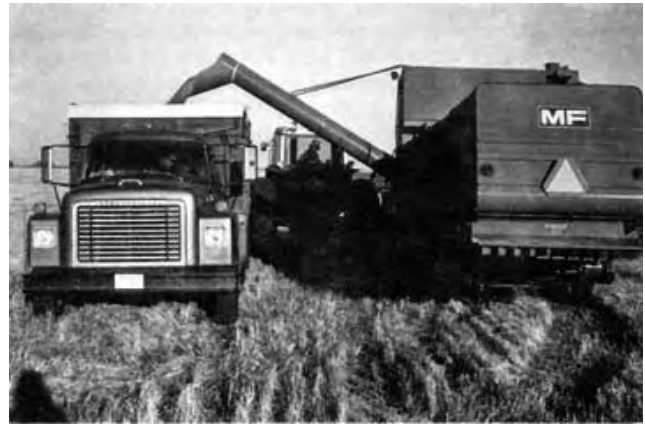
when operating empty. Although auger clearance was satisfactory when unloading into trucks with high boxes or box extensions (FIGURE 5), the unloading auger had insufficient lateral reach for easy unloading. The auger delivered a concentrated stream of grain and unloaded the 5.1 m³ (140 bu) tank of dry wheat in 78 seconds. Some grain leaked from between the spout and the unloading auger tube as the spout did not fit tightly against the tube. This was eliminated by wrapping tape around the auger tube at the spout connection. It is recommended that the manufacturer consider modifications to the unloading auger to increase reach and to eliminate leakage between the spout and auger tube.

FIGURE 5. Unloading Auger Clearance.

4. The unloading auger was extended 914 mm (3 ft) commencing machine serial No. 1001.
5. No modifications are planned as the Massey Ferguson Model 67 Pickup has been discontinued from our product line.

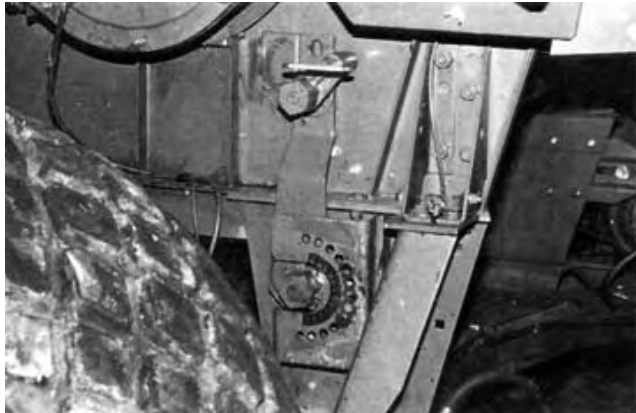
Once the concave had been initially set, threshing clearances were set with a cam assembly (FIGURE 9). Adjustment was inconvenient, requiring both a hand wrench and the cylinder rocking wrench. The control linkage was designed so that the leading concave bar opened faster than the trailing bar. Leading bar clearances could be varied from 2 to 20 mm (0.1 to 0.8 in) while trailing bar clearances could be varied from 0 to 6 mm (0 to 0.25 in).

FIGURE 9. Concave Clearance Adjustment.

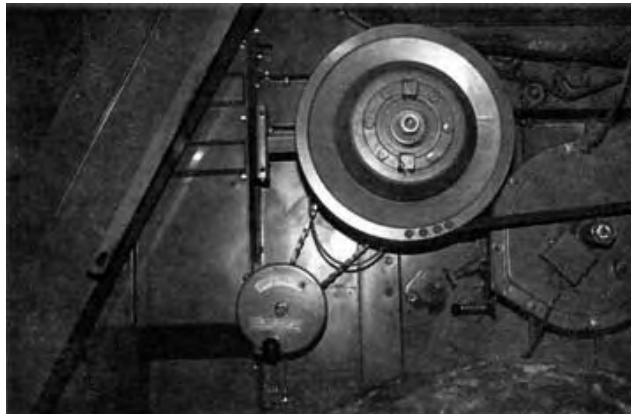
FIGURE 10. Cylinder Speed Adjustment.

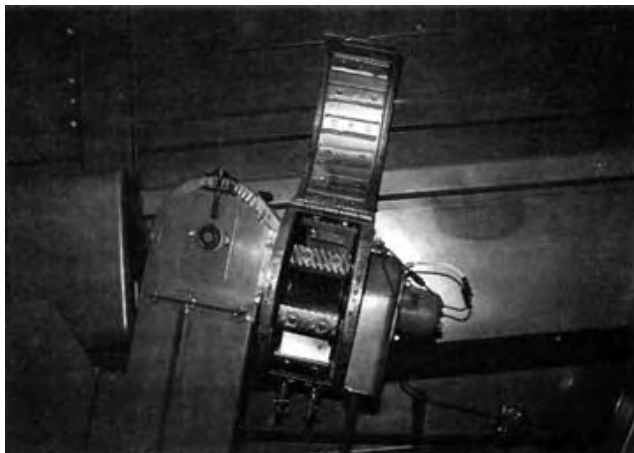
were readily accessible from the rear of the combine. Return tailings were delivered to the rethresher (FIGURE 13), which discharged to the straw walker grain pan. The rethresher concave packed with soil and plant residue during normal operation and required frequent cleaning. In addition, stone damage caused concave channel deformation.

FIGURE 13. Retresher.

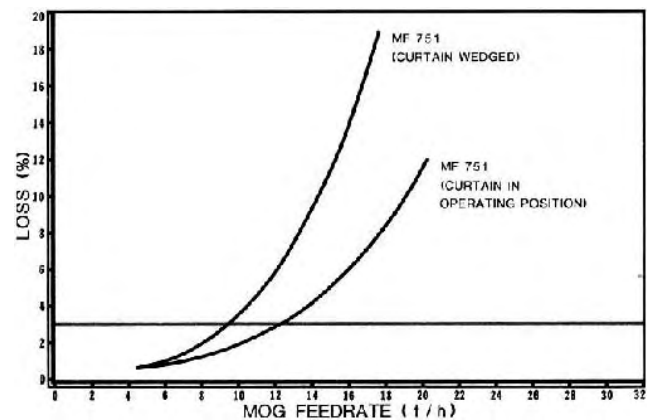
against the top of the straw walker housing, increasing straw walker loss. TABLE 5 and FIGURE 19 show that a 23% reduction in capacity occurred in Neepawa wheat when the curtain wedged, due to the straw and grain being discharged further back on the walkers. A rod was installed by PAMI to prevent the curtain from wedging. It is recommended that the manufacturer consider modifications to prevent the back beater curtain from lifting and wedging against the straw walker housing.

FIGURE 19. Total Losses with Back Beater Curtain Wedged Open and With Curtain in Normal Operating Position.

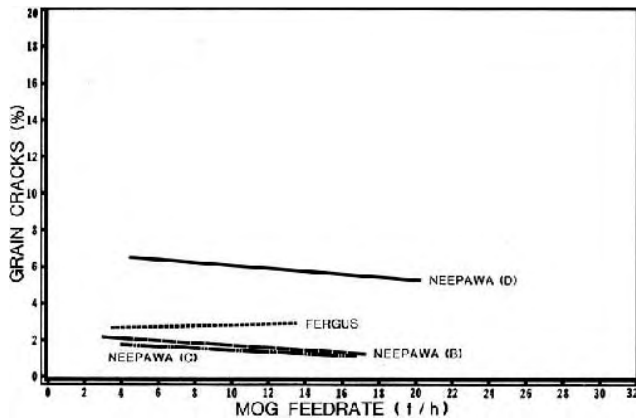
Cylinder Loss and Grain damage: Cylinder loss was usually low in most crops. In Fergus barley (FIGURE 18) when cylinder losses were negligible, grain cracks (FIGURE 20) varied from 2.5 to 3%. Neepawa wheat in fields B and C (FIGURES 15 & 16) was relatively easy-to-thresh and while cylinder loss ranged from 0 to 3%, grain cracks varied from 1 to 2%.

FIGURE 20. Grain Damage.

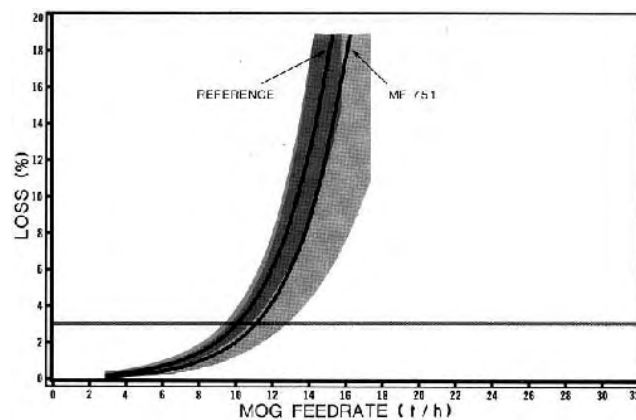
FIGURES 21 to 23 compare the total grain losses of the Massey Ferguson 751 and the PAMI reference combine in three of the crops described in TABLE 4. The shaded areas on the figures are the 95% confidence belts. If the shaded areas overlap, the loss characteristics of the two combines are not significantly different whereas if the shaded areas do not overlap, losses are significantly different. The capacity of the Massey Ferguson 751 was somewhat greater than the capacity of the reference combine and the Massey Ferguson 751 usually had lower grain losses than the reference combine when operating at the same feedrate.

FIGURE 21. Total Grain Losses in Neepawa Wheat (Field B).
