Evaluation Report

International Harvester 1480 Self-Propelled Combine

INTERNATIONAL HARVESTER 1480 SELF-PROPELLED COMBINE

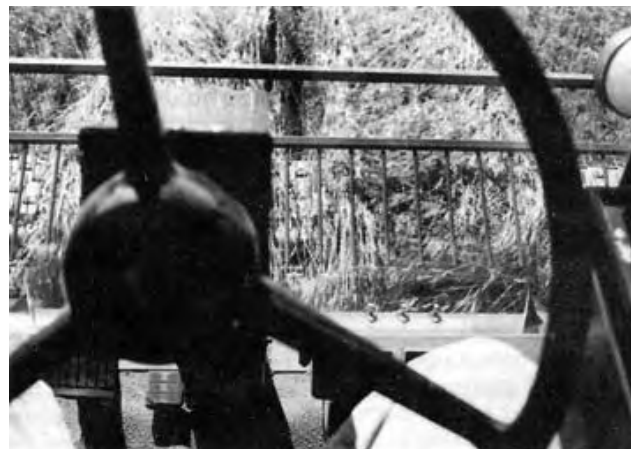
Operator Location: The cab was positioned ahead of the grain tank and slightly left-of-centre. Visibility forward, left and right were very good while rear visibility was restricted. Although rear view mirrors were provided, caution was needed when maneuvering in confined areas and while transporting. It is recommended that the manufacturer consider improving rear visibility. Header visibility was good (FIGURE 2). The grain level was visible through the rear window until the grain tank was nearly full.

FIGURE 2. View of Incoming Windrow.

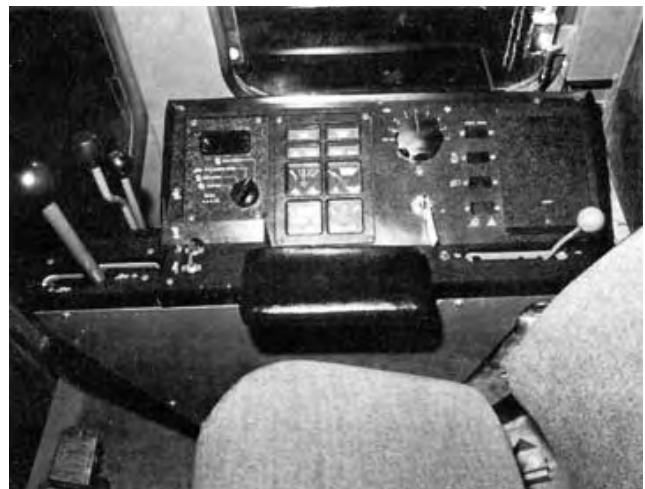
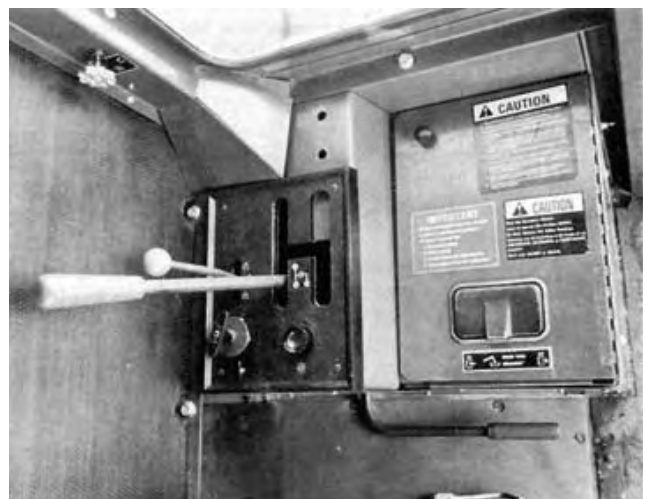
Controls: The control arrangement is shown in FIGURE 3. Most controls were conveniently located, responsive and easy to use.

Instruments: The right instrument console (FIGURE 3b) included gauges, warning lights and a digital display. The gauges displayed engine oil pressure, coolant temperature, battery voltage, fuel level, engine hours, engine, ground, rotor and fan speed. The warning lights indicated low engine oil pressure, battery discharge, excessive coolant temperature and park brake engagement. The optional shaft speed monitor (FIGURE 3a) warned of reduced fan, shoe, tailings auger, clean grain auger, discharge beater and rotary screen speeds. It is recommended that the manufacturer consider supplying a shaft speed monitor to warn of reduced rotor speed.

FIGURE 3. Instrument and Control Consoles.

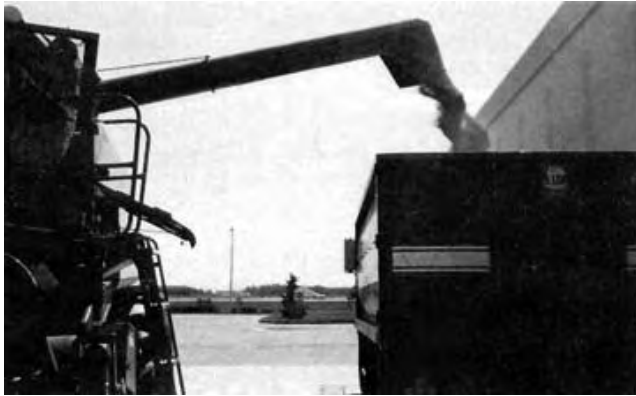
The unloading auger had ample reach and clearance for easy unloading on-the-go (FIGURE 4). The hydraulic swing was convenient for topping loads and adjusting auger reach. If the full unloading auger was swung back into transport position about 1.5 L (0.05 bu) of grain spilled from the unloader tube.

FIGURE 4. Unloading Auger Clearance.

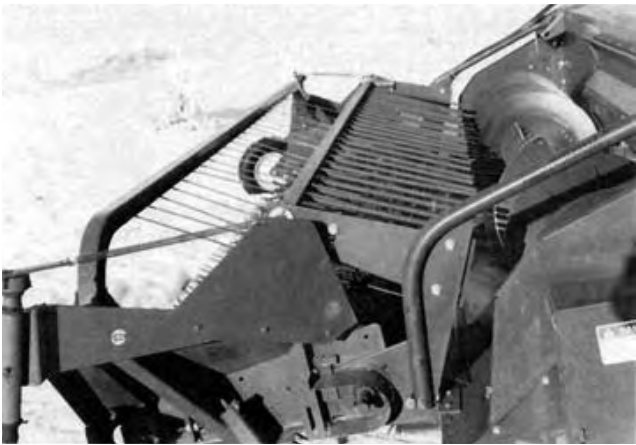
3350 mm (132 in) International Harvester, two roller, draper pickup with nylon teeth (FIGURE 5).

FIGURE 5. Pickup with Windguard and Crop Deflector.

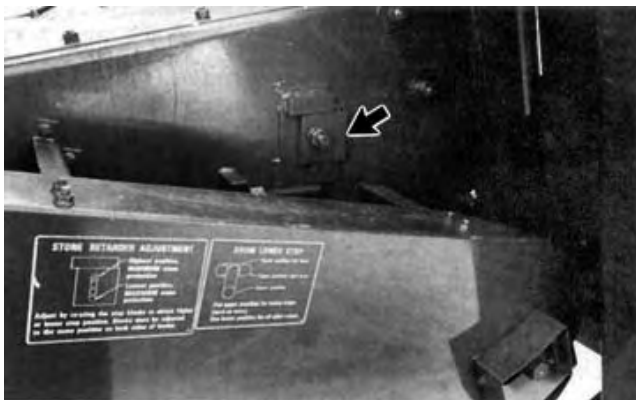
Stone Protection: The test machine was equipped with an optional stone retarder drum located at the front of the feeder (FIGURE 6). Adjustable stops controlled feeder drum travel and

FIGURE 6. Stone Retarder Stop Block.

In bunchy rapeseed windrows, the stone retarder stops had to be set to their highest position to increase feeder capacity. In this position, only limited stone protection was provided.

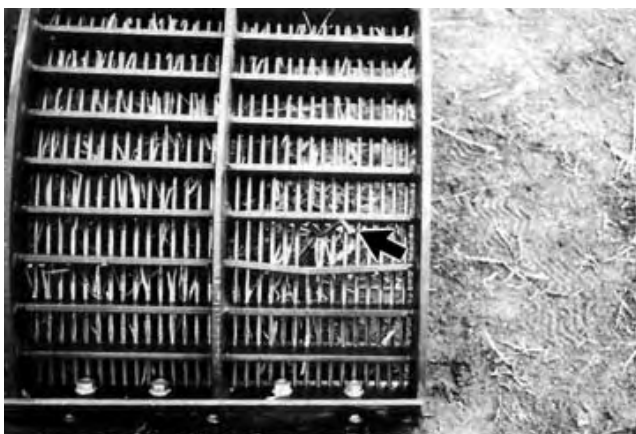
limited the size of object, which could pass up the feeder. Although this prevented large objects from entering the rotor small stones passed through, causing minor damage to the concaves (FIGURE 7).

FIGURE 7. Concave Damage.

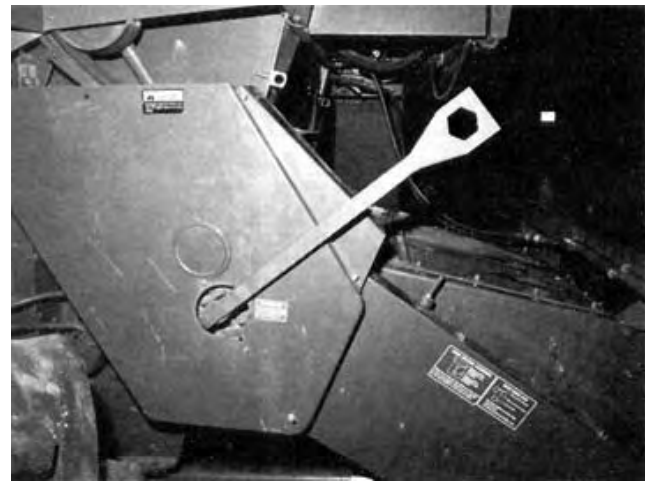
Feeder conveyor plugging was infrequent. A rocking wrench and hub on the upper drive shaft were provided to facilitate unplugging (FIGURE 9).

FIGURE 9. Feeder Conveyor Rocking Hub and Wrench.

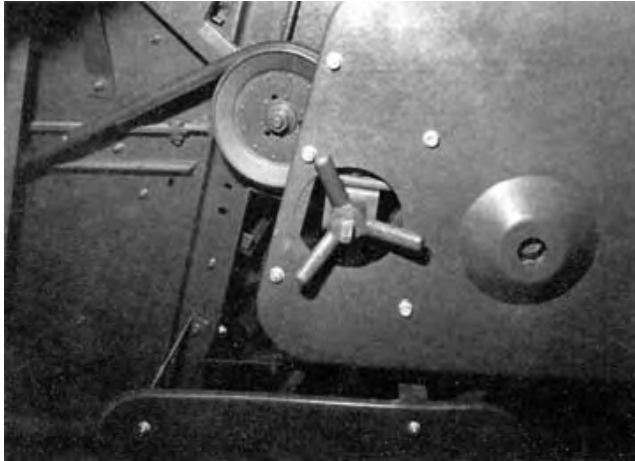
FIGURE 13. Fan Adjustment.

Most machine adjustments could be made safely. However, when adjusting the fan, an operator's fingers were often injured on the sheet metal opening behind the adjusting wheel (FIGURE 13). It is recommended that the manufacturer consider modification to prevent operator hand injury when adjusting fan speed.

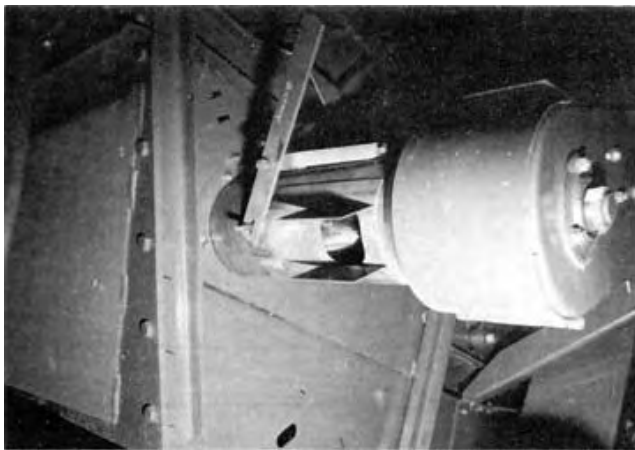
The return tailings could not be conveniently inspected. This prevented the operator from understanding the affects of the settings. It is recommended that the manufacturer consider supplying a safe, convenient apparatus for sampling the return tailings.

FIGURE 14. Tailings Sampling Mechanism Installed by PAMI.

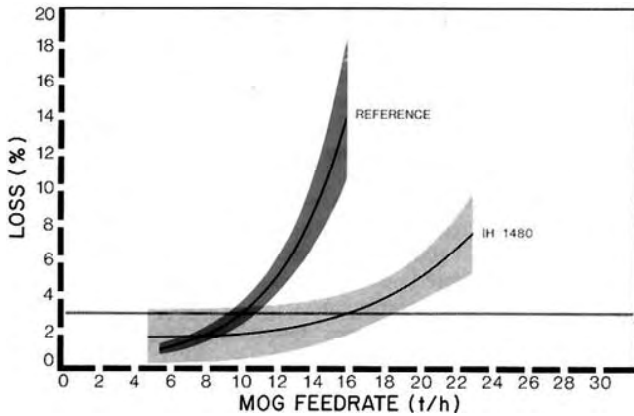
FIGURES 20 to 23 compare the total grain losses of the International Harvester 1480 to the PAMI reference combine in the four crops described in TABLE 4. The shaded areas on the figures are 95% confidence belts. If the shaded areas overlap, the loss characteristics of the two combines are not significantly different, whereas if the shaded areas do not overlap, losses are significantly different. The capacity of the International Harvester 1480 was much greater than the reference combine capacity in wheat and barley.

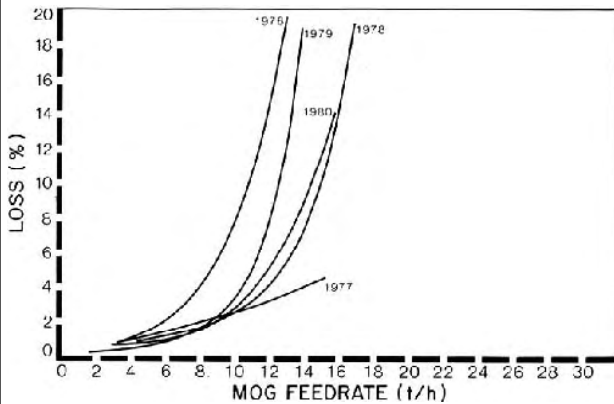
FIGURE 26 shows capacity differences in Neepawa wheat for the five years. Most 1980 Neepawa wheat crops shown in TABLE 7 were of average straw yield and better than average grain yield. Most of the crops were average-to-thresh while the grain moisture content was slightly lower than other years and straw moisture content was average to lower than normal.

FIGURE 26. Total Grain Loss for the PAMI Reference Combine in Neepawa Wheat.
