# Evaluation Report

## Allis-Chalmers Gleaner N-6 Self-Propelled Combine

# ALLIS-CHALMERS GLEANERS N-6 SELF-PROPELLED COMBINE

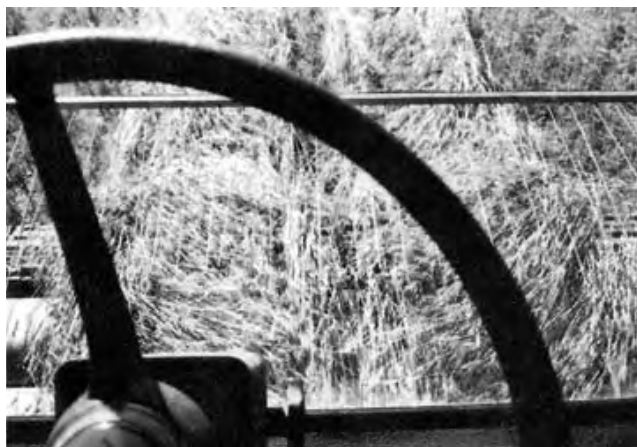
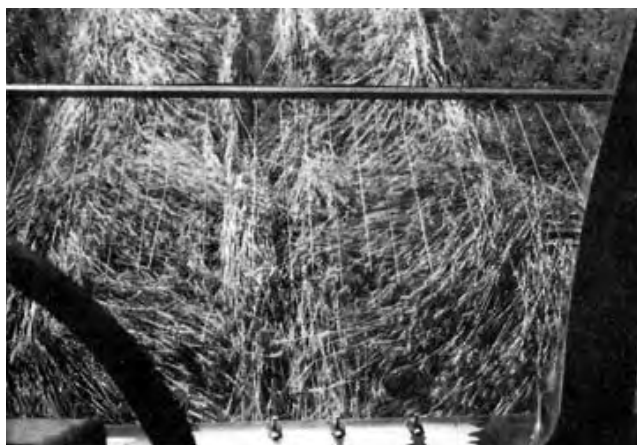
FIGURE 2. View of Incoming Windrow (a) Normal Seated Position (b) Leaning Right.

**Operator Location:** The cab was positioned ahead of the grain tank, centered on the combine body, while the feeder house was offset to the right. Visibility forward and to both sides was very good; rear visibility was restricted. Two rear view mirrors were provided, but caution was needed when operating in confined areas. Header visibility was very good (FIGURE 2). The grain level was visible through the rear window until the tank was nearly full.

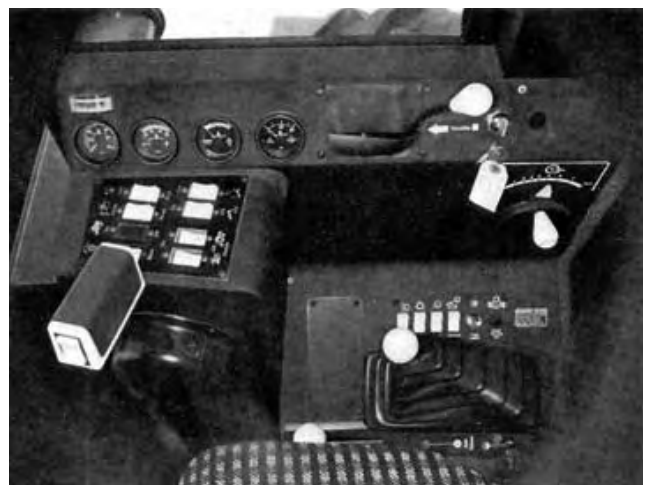
FIGURE 3. Controls and Lower Instrument Console.

**Controls:** The control arrangement is shown in FIGURE 3. The controls were conveniently located and most were easy to use.

The gear selector lever was very difficult to shift. The hydrostatic speed control lever usually had to be momentarily activated to enable shifting. It is recommended that the manufacturer consider improving the ease of shifting the transmission.

When adjusted for suitable full range raise and drop rate, header response was abrupt when making small height adjustments. It is recommended that the manufacturer consider modifications to provide smoother, more accurate header height control.

**Instruments:** The instruments were located on two consoles, one to the right of the operator and one above the windshield. The lower console (FIGURE 3) had gauges for engine oil pressure, coolant temperature, battery voltage and turbocharger boost pressure. The upper console (FIGURE 4) had a grain loss monitor, engine and separator hour meters, an acre estimator, and readout for fuel level, rotor speed, engine speed and ground speed as well as a series of warning indicators. As standard equipment, warning indicators were provided for stone trap door opening, oil, air and fuel filter restrictions, parking brake engagement, hydraulic oil temperature, coolant level, transmission oil pressure and reduced speeds of major combine drives. It is recommended that the manufacturer consider including a warning for rotor speed reduction. Optional equipment on the test machine included warning devices for battery voltage, engine oil pressure, grain tank level, coolant temperature and unloading auger position. All warning indicators were displayed with a warning light and most were accompanied with a four-second audio alarm.

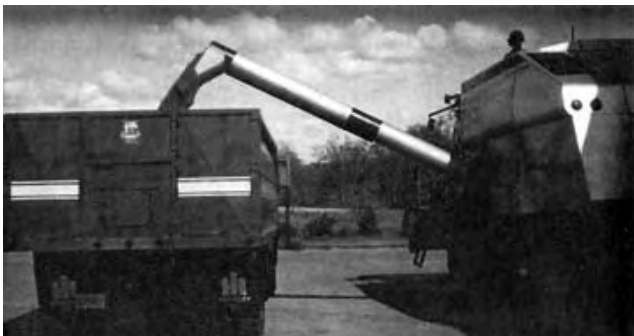
The unloading auger had ample reach and clearance for easy unloading on-the-go (FIGURE 6). Unloading a full tank of dry wheat took about 135 seconds.

FIGURE 6. Unloading Auger Clearance.

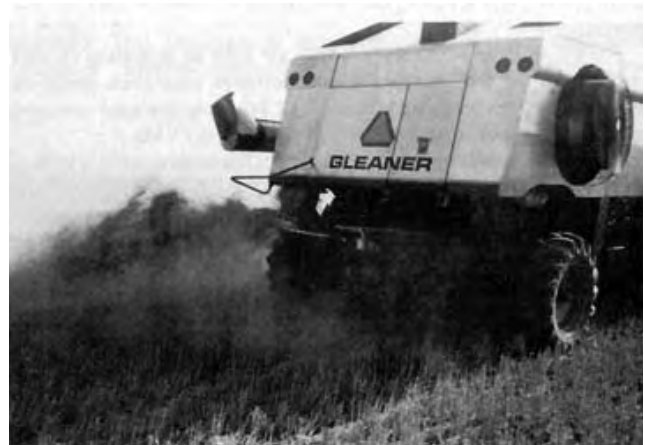
**Straw Spreader:** The combine was equipped with a single four bat straw spreader. Spreading width was up to 4 m (13 ft) in calm conditions (FIGURE 7). Wind greatly reduced spreading effectiveness. The spreader was easily removed to permit windrowing the straw. As is common with most rotary combines, the rotor broke the straw into short lengths and a straw chopper was not needed. As a result, the straw usually was unsuitable for baling.

FIGURE 7. Straw Spreader Operation.

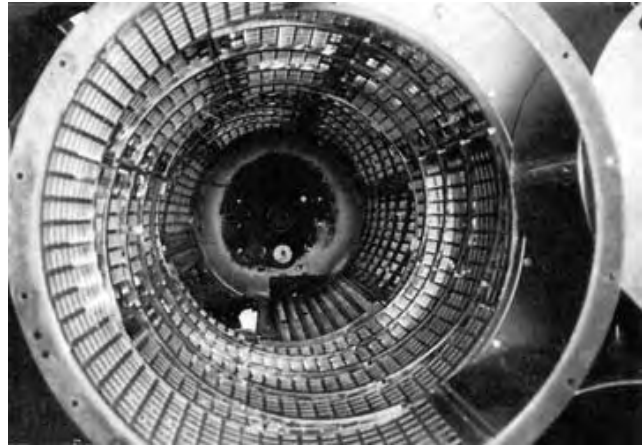
**Concave Adjustment:** The Gleaner N-6 had a single segment adjustable threshing and separating concave (FIGURE 8) and a 360 degree stationary separating cage (FIGURE 9).

FIGURE 9. Rotor Cage.

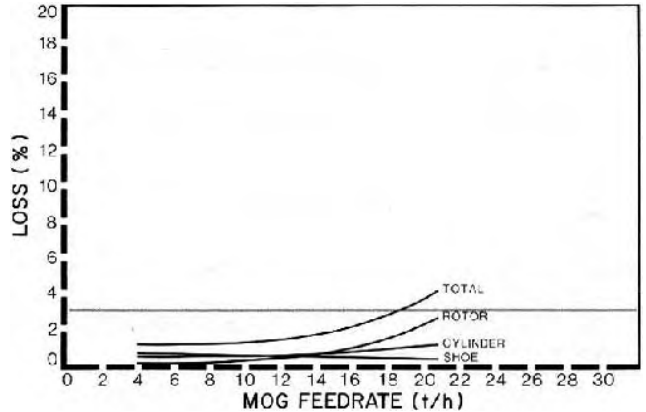
FIGURE 11. Grain Loss in Neepawa Wheat (Field C - Double Windrow).

APPENDIX II REGRESSION EQUATIONS FOR CAPACITY RESULTS					
Regression equations for the capacity results shown in FIGURES 10 to 13 are represented in TABLE 6. In the regressions, C = cylinder loss in percent of yield, S = shoe loss in percent of yield, R = rotor loss in percent of yield, F = the MOG feedrate in t/h, while $\ln$ is the natural logarithm. Sample size refers to the number of loss collections. Limits of the regressions may be obtained from FIGURES 10 to 13 while crop conditions are presented in TABLE 4.					
<b>TABLE 6.</b> Regression Equations					
Crop - Variety	Fig. No.	Regression Equations	Simple Correlation Coefficient	Variance Ratio	Sample Size
Barley - Hector	15	$C = 0.30 + 3.0 \times 10^{-6}F^4$ $S = 0.19 + 3.0 \times 10^{-6}F^4$ $R = 5.3 - 0.72 + 0.03F^2$	0.88 0.80 0.92	27.25 <sup>2</sup> 14.57 <sup>2</sup> 18.89 <sup>2</sup>	10
Wheat - Neepawa	16	$\ln C = -1.15 + 0.06F$ $S = 0.72 - 0.02F$ $R = 0.07 + 1.4 \times 10^{-5}F^4$	0.94 0.79 0.99	55.10 <sup>2</sup> 11.76 345.00 <sup>2</sup>	9

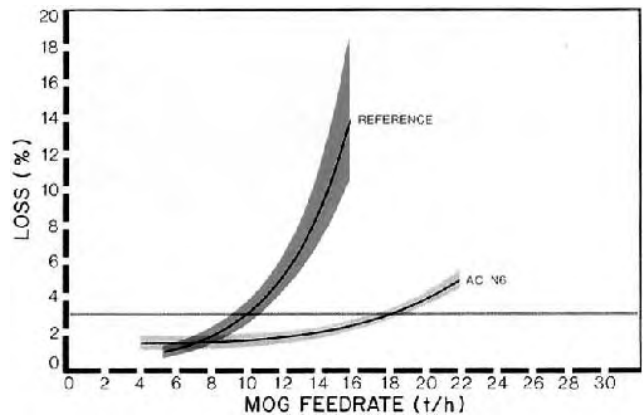
FIGURES 15 to 18 compare the total grain losses of the Gleaner N-6 and the PAMI reference combine in the four crops described in TABLE 4. The shaded areas on the figures are 95% confidence belts. If the shaded areas overlap, the loss characteristics of the two combines are not significantly different whereas if the shaded areas do not overlap, losses are significantly different. The capacity of the Gleaner N-6 was much greater than the reference combine capacity in wheat and barley.

FIGURE 18. Total Grain Loss in Neepawa Wheat (Field D - Double Windrow).
