Evaluation Report

John Deere Sidehill 6600 Self-Propelled Combine

A Co-operative Program Between

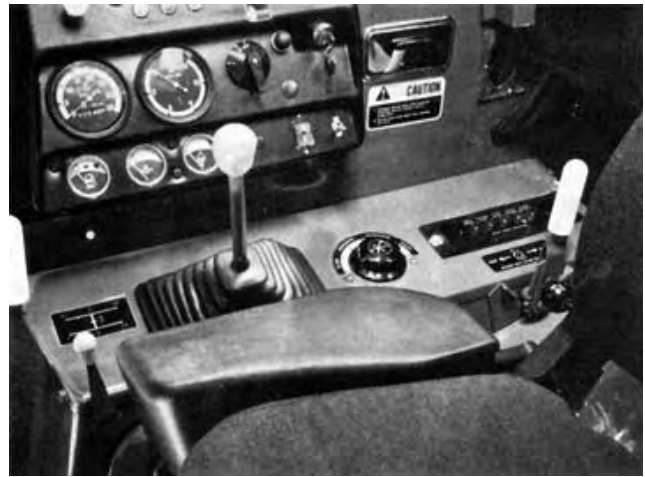
Figure 4. Instrument Console on the JD 6600.

The optional shaft speed monitors were very useful in detecting component blockage. They monitored the tailings elevator, clean grain elevator, grain conveyor augers, straw walkers and straw chopper and indicated, with lights, if any of these systems were operating less than 70% of rated speed. A warning horn also

signalled the operator if the straw walkers plugged or if the engine coolant temperature was too high.

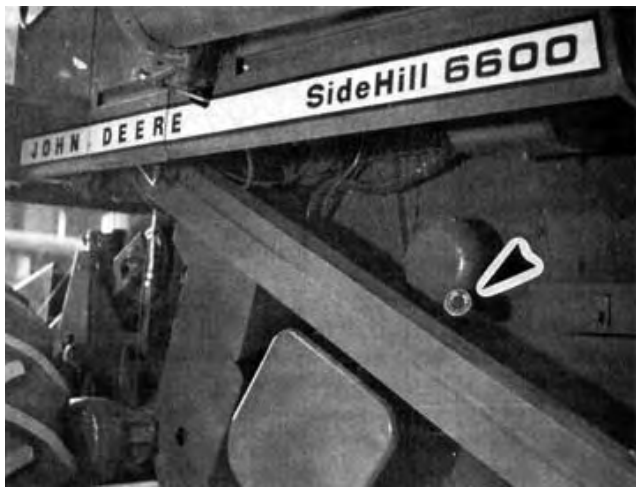
Figure 7. Fan Adjustments on the JD 6600.

Shoe Adjustments: The shoe was convenient to adjust. Fan speed was varied with a calibrated hand wheel (Figure 7) while the chaffer and chaffer extension were adjusted with levers at the rear of the shoe. Access to the clean grain adjusting lever was through a door at the rear of the shoe. Return tailings could conveniently be inspected at the top of the return elevator under the operator's seat. The fan speed reference decal was incorrectly affixed to the combine and could be used as a reference only, as it did not indicate correct fan speed.

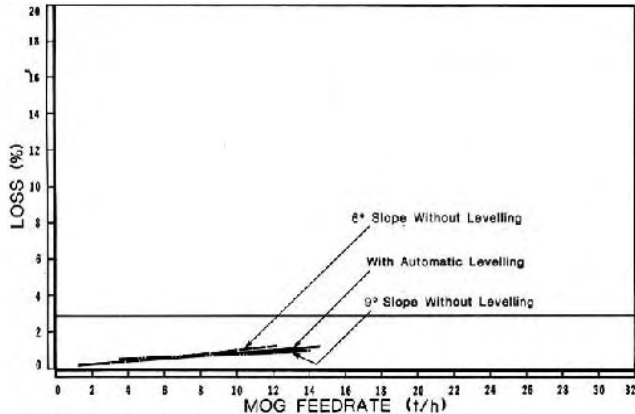
Figure 12. Cylinder Losses for the JD Sidehill 6600 with and without Automatic Side Levelling.

Table 5 gives comparisons of the capacity of the JD 6600 at a 3% loss level, with and without automatic side levelling. These results, as well as those in Figures 12 to 15, were collected in a crop of damp Betzes barley averaging 1.97 t/h (37 bu/ac). Width of cut was 5.5 m (18 ft) while grain moisture content was 18.6%. Average MOG/G Ratio was 1.28.

Figures 12 to 15 show cylinder, shoe, straw walker and total losses at various side slopes, with and without side levelling. Side slopes, up to 9° did not appreciably affect straw walker or cylinder performance. Shoe losses, without automatic levelling, increased rapidly on side slopes greater than 3°. Automatic side levelling, by reducing shoe losses on side slopes, permitted the JD 6600 Sidehill to be operated at the same feedrates on side slopes, up to 9°, as on level fields.

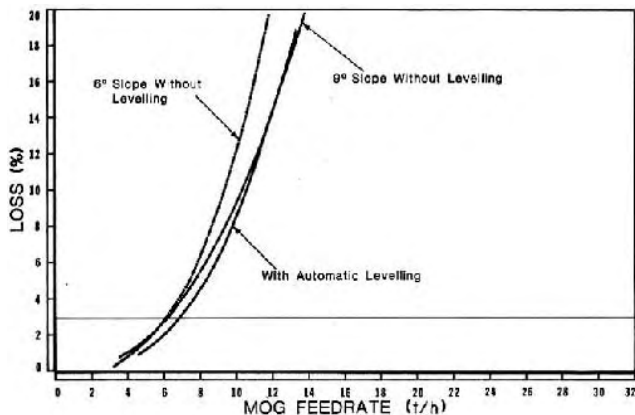
Figure 14. Walker Losses for the JD Sidehill 6600 with and without Automatic Side Levelling.
