# Evaluation Report

## Belarus Niva SK-5 Self-Propelled Combine

# BELARUS NIVA SK-5 SELF-PROPELLED COMBINE

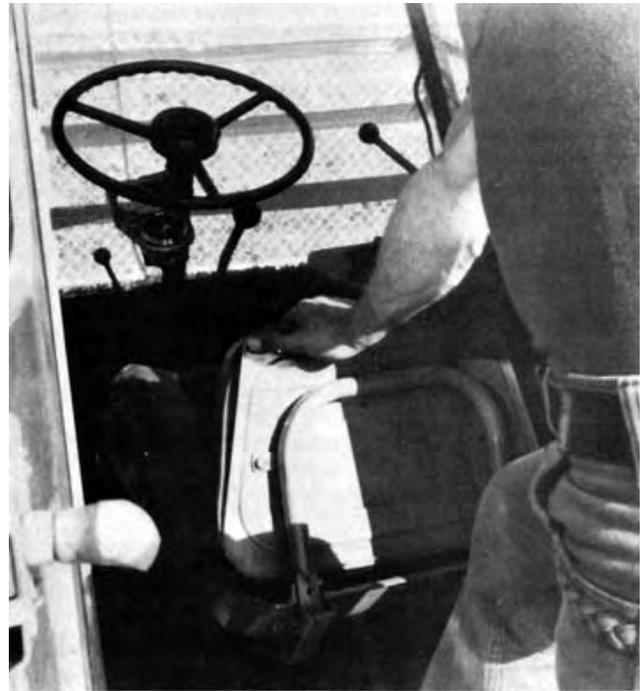
The operator's seat was fairly comfortable and had an ample range of adjustment, however, seat adjustments were inconvenient. The folding backrest was hazardous. Most operators, when stepping down into the cab, would lean on the backrest for support and would fall forward as the backrest folded (FIGURE 2). The cab was high enough to permit standing operation.

FIGURE 2. Folding Seat Backrest.

The flexible seat backrest (FIGURE 2) was hazardous. The operator would often lean upon the backrest for support when stepping down into the cab and would fall forward as the backrest pivoted. It is recommended that a lock be provided on the seat backrest.

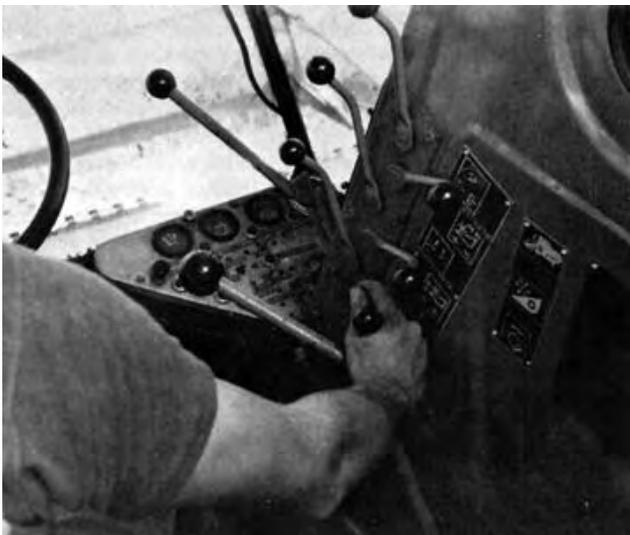
Although the concave adjusting lever and separator drive lever were conveniently positioned, when the concave was closed interference occurred among the concave lever, separator drive lever and header height control lever (FIGURE 4).

FIGURE 4. Interference Among Control Levers.

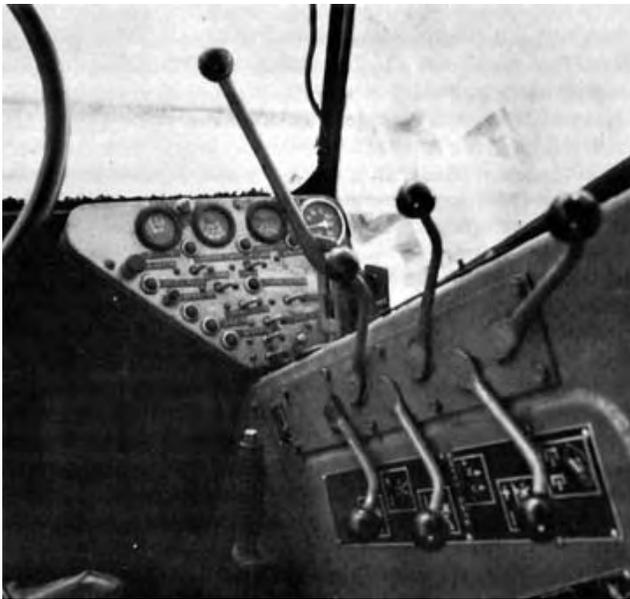
**Instruments:** The instrument console (FIGURE 7) included gauges for engine oil pressure, battery charging rate, coolant temperature, ground speed, and cylinder speed. Indicator lights were provided for engine oil temperature, grain tank level return and clean grain elevator slip clutches, turn signals, parking brake, and for the main power switch. The main power switch was inconveniently located outside the cab on the side of the combine and could only be conveniently reached from the ground. The main power switch

FIGURE 7. Instrument Console on Niva SK-5.

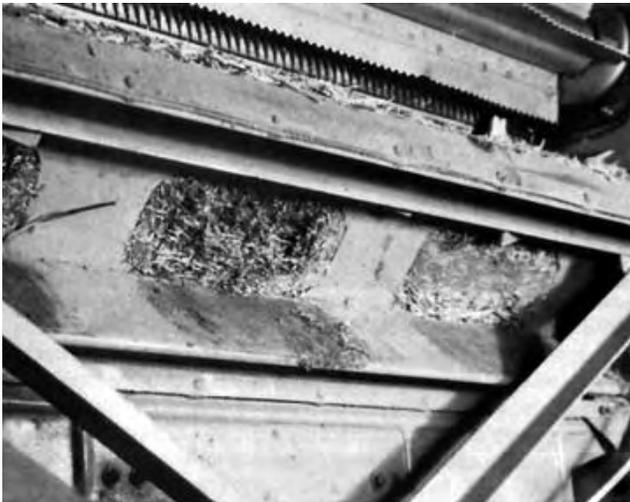
Cleaning the stone trap was inconvenient. The header had to be raised and an access door under the cylinder removed by hand. Stones could be removed through three 102 by 248 mm (4 by 9.8 in) openings (FIGURE 8). Larger stones, which could not pass through these openings, had to be maneuvered into the feeder housing and removed by turning the feeder backward.

FIGURE 8. Stone Trap Access on the Niva SK-5.

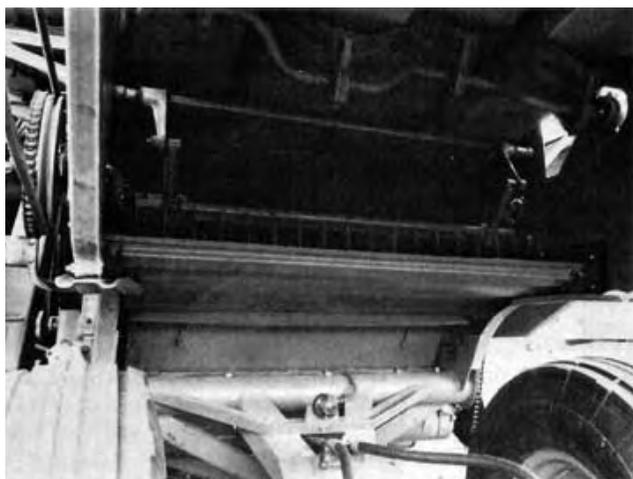
If recommended safety procedures were followed, all adjustments could be safely made. Since the Niva SK-5 was designed for a factory installed straw and chaff buncher, it was equipped with rotating straw buncher feed fingers and feed pan (FIGURE 20) directly behind the shoe. Extreme care had to be taken when hand sampling shoe losses while the combine was running to avoid contact with the feed fingers. The straw buncher feed fingers were not required in dry crops, however, they were required in damp barley and in green crops to prevent chaff build-up behind the shoe.

FIGURE 20. Straw Buncher Feed Finger Assembly.
