Evaluation Report

288

White 9700 Self-Propelled Combine

WHITE 9700 SELF-PROPELLED COMBINE

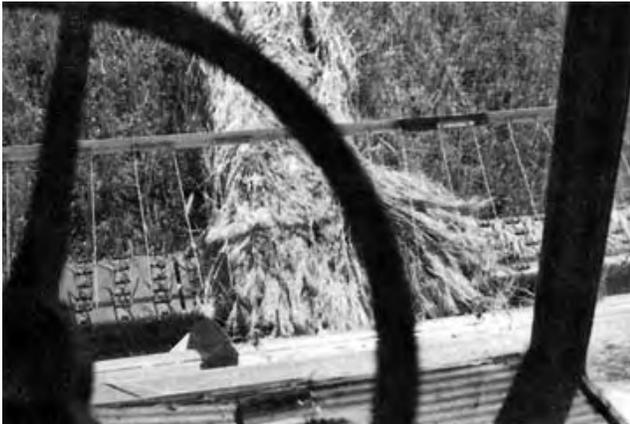
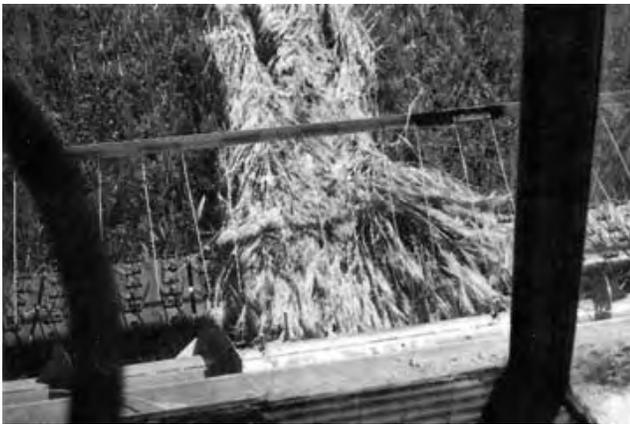
Operator Location: The White 9700 was equipped with an operator's cab as standard equipment. The cab was positioned ahead of the grain tank and slightly left-of-center. Forward and side visibility was very good while rear visibility was restricted. The rear view mirrors improved rear visibility to the left but only slightly improved rear visibility to the right. It is recommended that the manufacturer consider improving rear visibility to the right. Header visibility was very good for most operators when leaning slightly to the right (FIGURE 2). The grain level was visible through the rear window until the tank was nearly full.

FIGURE 2. View of Incoming Windrow (A) Normal Seated Position, (B) Leaning to the Right.

1. Improving the rear visibility to the right.
2. Modifications to provide positive separator switch response.
3. Modifications to the rotary screen to prevent radiator plugging.
4. Modifications to improve the ease of steering and to reduce the turning radius.
5. Modifications to improve the ease of operating the stone trap door lever.
6. Modifications to improve uniform straw spreading.
7. Modifications to increase table auger capacity and providing a wrench and hubs to facilitate table auger and feeder conveyor unplugging.
8. Supplying a safe, convenient apparatus to permit sampling the return tailings while harvesting.

1. The right hand side of new production combines are equipped with a West Coast mirror and convex spot mirror to provide better rear visibility. Additional means to improve rear visibility will be evaluated.

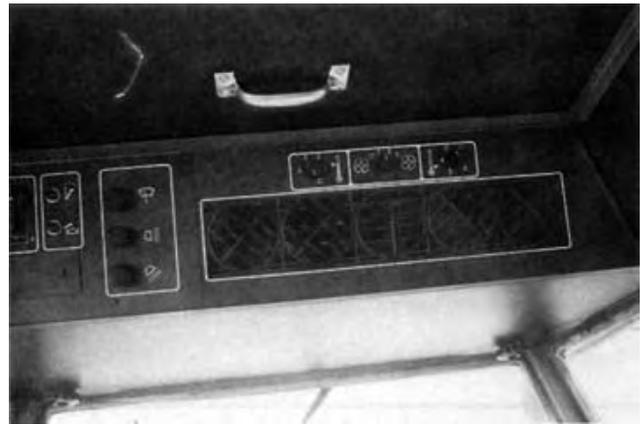
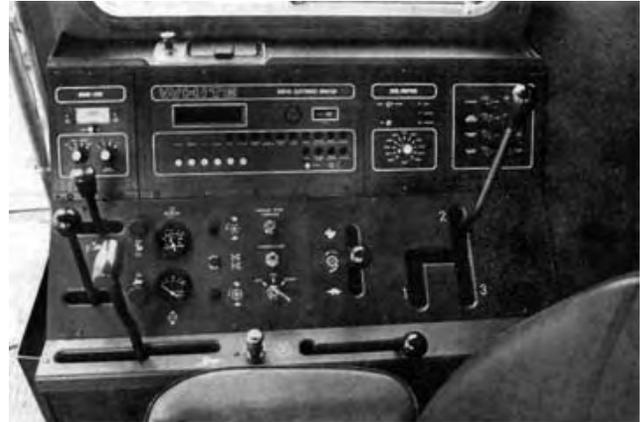
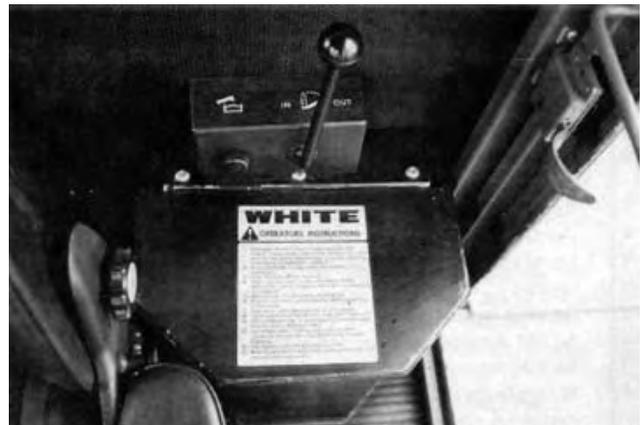
Controls: The control arrangement is shown in FIGURE 3. Most

controls were conveniently located and easy to use. However, the separator switch frequently failed to disengage the separator and it is recommended that the manufacturer consider modifications to provide positive separator switch response.

Instruments: The right instrument console (FIGURE 3B) contained gauges, warning lights, a digital readout and a grain loss monitor. The gauges indicated engine hour, oil pressure and coolant temperature. The warning lights and audio alarm indicated low fuel level, reduced battery voltage, excessive coolant temperature, low engine oil pressure, low coolant level, restricted air filter, parking brake engagement, full grain tank and a speed reduction of major combine drives. The digital readout selectively displayed engine, ground, cleaning fan and rotor speeds, fuel remaining and battery voltage.

FIGURE 3. Instruments and Controls (A) Upper Console (B) Right Console (C) Left Console.

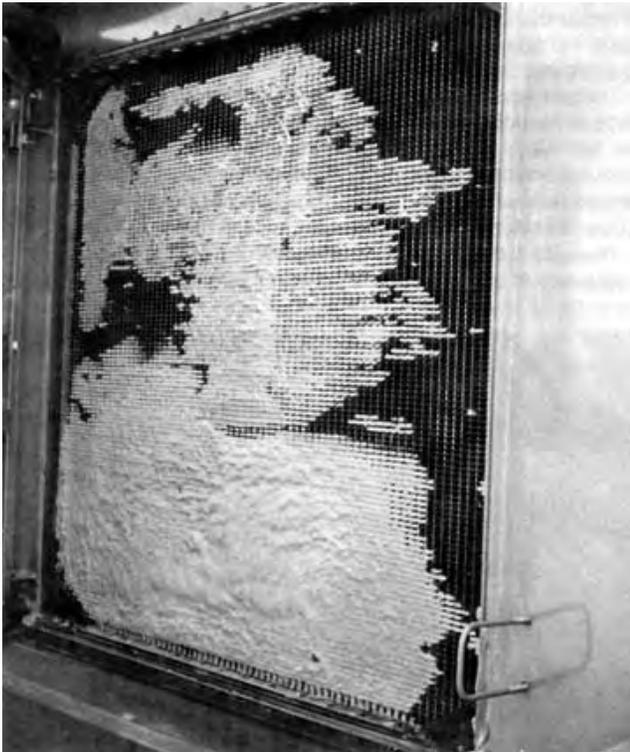
The radiator frequently plugged when operating in thistle infested crops (FIGURE 4) as thistle down readily passed through the end of the rotary screen. It is recommended that the manufacturer consider modifications to the rotary screen to prevent radiator plugging.

FIGURE 4. Radiator Plugged with Thistle Down.

2. Manufacturing techniques have been changed to improve separator switch operation.
3. The rotary radiator screen performance in adverse conditions is being evaluated.

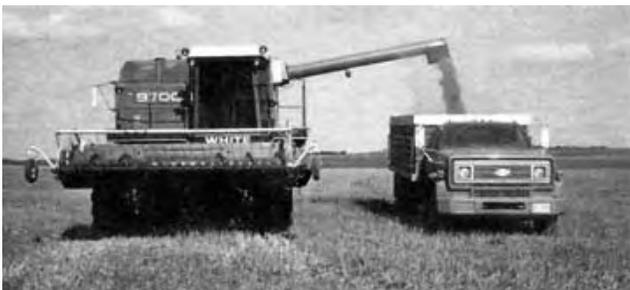
Unloading a full tank of dry wheat took about 155 seconds. The unloading auger had ample reach and clearance for unloading on-the-go (FIGURE 5).

FIGURE 5. Unloading.

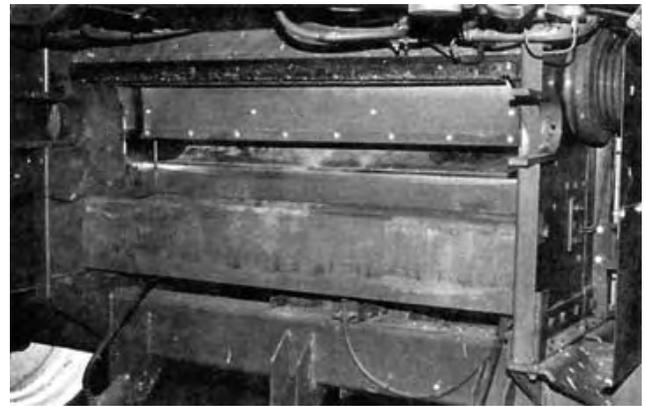
Stone Protection: The White 9700 was equipped with a stone trap (FIGURE 6), located below the feed impeller that prevented most stones and roots from entering the rotor chamber. One stone that entered the rotor chamber damaged the rotor intake flighting, turning vanes and threshing concaves (FIGURE 7). The stone trap lever was inconvenient to reach and difficult to latch. It is recommended

FIGURE 6. Stone Trap.

5. Means to make the stone trap door easier to operate will be investigated.
6. Spreading varies with straw moisture and crop properties. Several ways to provide more even spreading are being evaluated.

that the manufacturer consider modifications to improve the ease of operating the stone trap door lever.

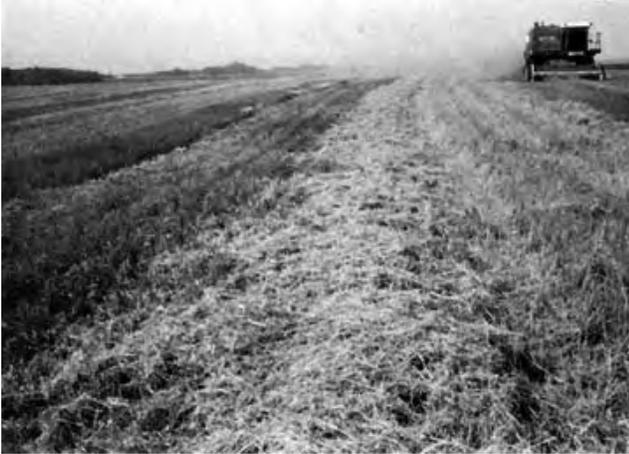
Straw Chopper: The optional straw chopper attachment performed well in most crops. The straw chopper spread crop up to 5.5 m (18 ft). The spread pattern was uneven with more material being distributed to the left (FIGURE 8). Removing the second deflector fin from the left end of the straw chopper tail plate improved the spread pattern. However, it is recommended that the manufacturer consider modifications to provide more uniform straw spreading.

FIGURE 8. Uneven Straw Distribution.

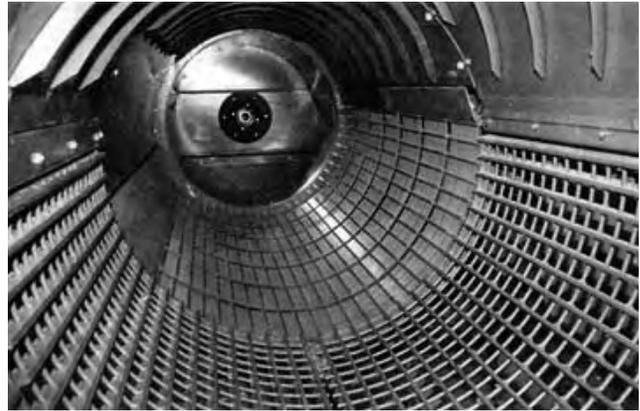
adjustable threshing concave and a stationary separating concave (FIGURE 9). The small grain threshing concaves used throughout the tests were accessible through one side door and two doors in the grain tank. The separating concaves were accessible through doors on each side.

FIGURE 9. Threshing and Separating Concaves.

Initial levelling and adjusting of the threshing concaves was easy, however, access for checking concave clearance was inconvenient. The concave could be levelled by adjusting the front or rear concave hanger bolts. The concave was initially set to obtain 1 to 2 mm (0.04 and 0.07 in) clearance between the highest rasp bar and the bottom of the third and rear concaves with the clearance indicator set at zero. The front hanger slot had to be extended to obtain adequate travel for initial concave setting (FIGURE 10). It is recommended that the manufacturer consider extending the slot for the front concave hanger to permit adequate travel for setting minimum clearance.

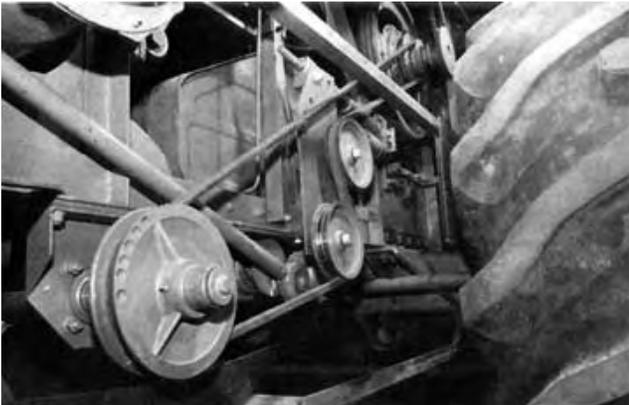
recommended that the manufacturer consider improving the access to the sieve adjusting lever. Fan speed could be varied from within the cab over a limited speed range. To extend the speed range the fan drive belt had to be moved to a different drive sheave and the idlers and actuator repositioned (FIGURE 12). This procedure was inconvenient and time consuming. It is recommended that the manufacturer consider modifications to permit full speed adjustment from the cab. The two wind boards were usually set to direct air to the front of the chaffer and sieve.

FIGURE 12. Fan Drive.
