Evaluation Report

Massey Ferguson 860 Self-Propelled Combine

MASSEY FERGUSON 860 SELF-PROPELLED COMBINE

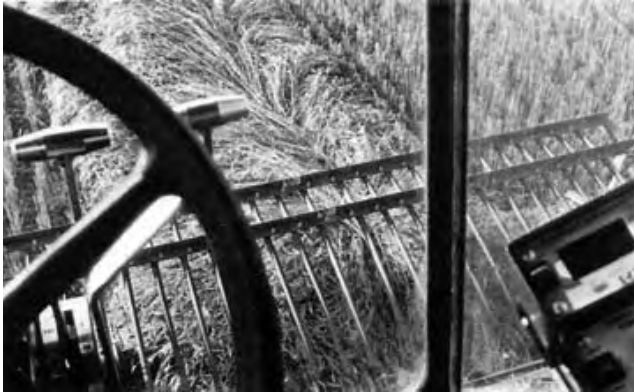
FIGURE 2. View of Incoming Windrow.

Operator Location: The Massey Ferguson 860 combine was equipped with an operator's cab positioned ahead of the grain tank and left of the center of the combine body. Forward and side visibility was very good. Rear visibility was good on the left but was restricted on the right. The rear view mirror on the right side was too small and too far away to be useful. It is recommended that the manufacturer consider improving rear visibility to the right. For most operators, view of the incoming windrow was very good (FIGURE 2). The grain level was very difficult to view from the operator's cab.

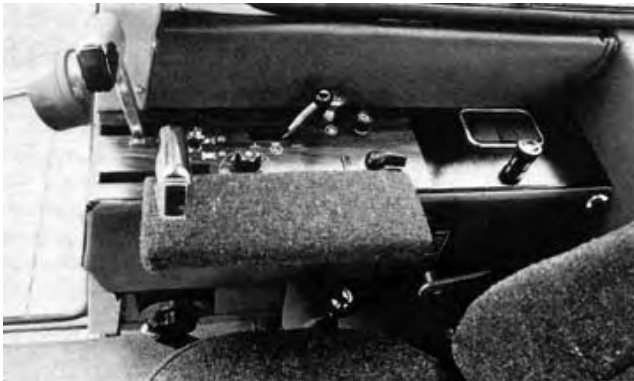
FIGURE 3. Control Console to the Right of the Operator.

knob was responsive, but difficult to reach if the concave adjusting lever was positioned from numbers 1 to 6. The parking brake lever interfered with the unloading auger lever if both were engaged. It is recommended that the manufacturer consider modifications to prevent interference between the pickup speed control knob and the concave adjusting lever, and also between the unloading auger engaging lever and the parking brake lever.

The gear selector lever was often difficult to shift. The hydrostatic speed control lever usually had to be momentarily activated to aid shifting. The cylinder speed adjusting crank was awkward to reach and stiff to turn. The unloading auger swing control was difficult to reach and operate when the unloading auger lever was engaged.

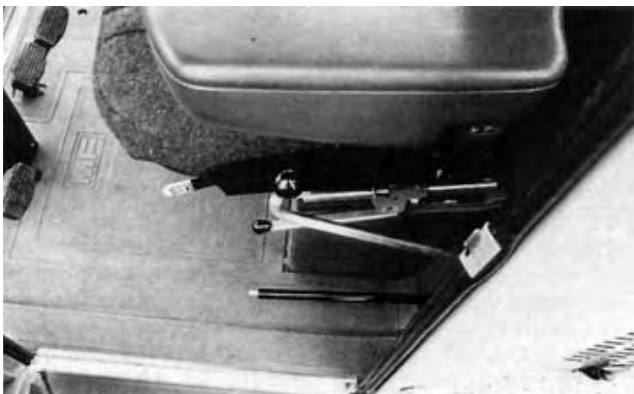
FIGURE 4. Controls to the Left of the Operator.

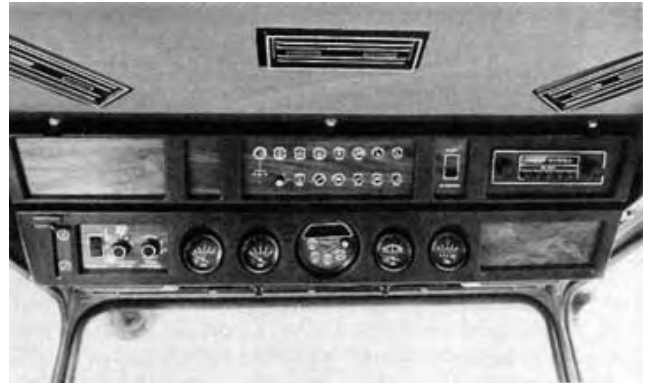
FIGURE 5. Instrument Panel Above Windshield.

Instruments: The instrument console for the Massey Ferguson 860 is shown in FIGURE 5. The console is located above the

windshield and houses gauges for fuel level, coolant temperature, battery voltage, and engine hours. A digital readout selectively displayed cylinder speed, main countershaft speed, engine speed, and combine ground speed.

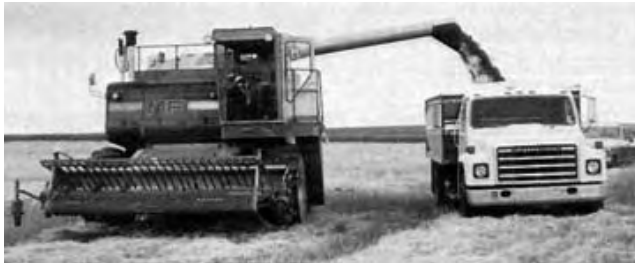
FIGURE 6. Unloading with Factory Installed Spout.

The unloading auger had ample reach and clearance for unloading into most trucks and grain trailers (FIGURE 6). However, the grain discharge was erratic and scattered, and the deflector spout was ineffective in concentrating the stream of grain. A modified deflector spout (FIGURE 7), installed by the Machinery Institute, greatly improved grain discharge. It is recommended that the manufacturer consider modifying the deflector shield to control the grain discharge. Unloading on-the-go and topping off loads was convenient as the auger could be easily repositioned from within the cab without significantly altering the discharge height. Unloading a full tank of dry wheat took about 120 seconds.

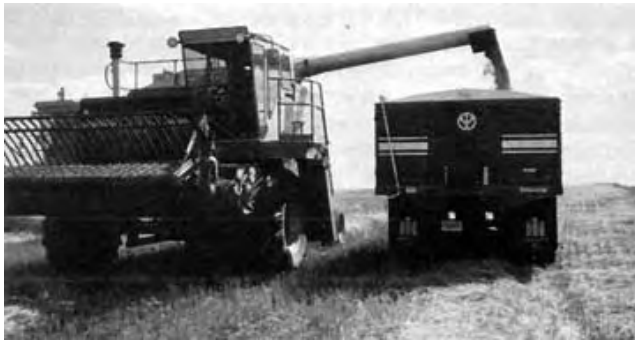
FIGURE 7. Unloading with Spout Modified by the Machinery Institute.

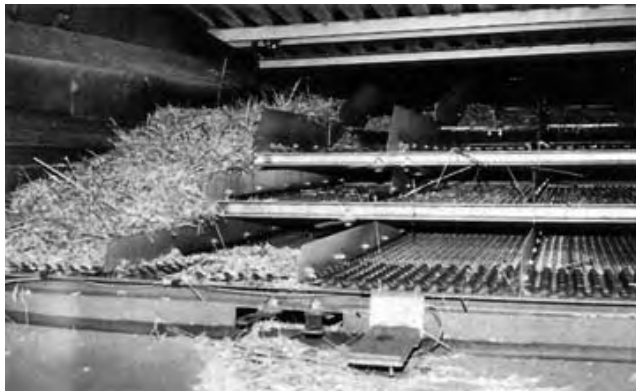
FIGURE 10. Overloading of the Left Section of the Shoe.

In some crop conditions it was not possible to adjust the shoe for satisfactory performance. The left side of the shoe often plugged with material (FIGURE 10). Increasing fan blast or directing the air blast farther to the rear reduced plugging slightly, but increased grain loss over the rest of the shoe. Changing the 0.31 in (8 mm) round hole sieve to a 0.44 in (11 mm) sieve helped but failed to eliminate the problem. It is recommended that the manufacturer consider modifications to improve air distribution to the cleaning shoe.

Shoe Loss: When properly adjusted for crop conditions, the shoe did not usually limit combine capacity. However, at higher feedrates, shoe losses increased rapidly when the left side of the shoe blanketed with material. An improvement in shoe performance would have reduced losses and increased capacity in some crops.

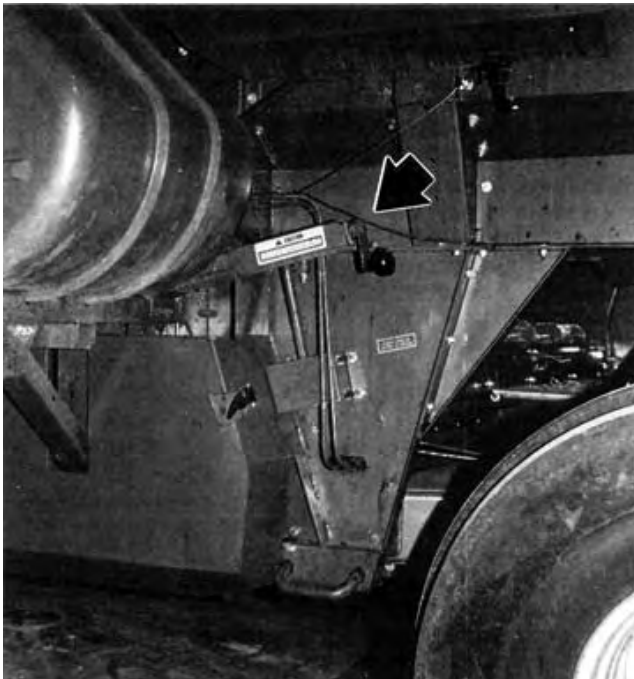
FIGURE 23. Fan Speed Control.

Machine adjustments could be made safely, if safety precautions were followed. However, the fan speed adjusting crank was located too close to the rear wheel to permit safe adjusting while harvesting (FIGURE 23). It is recommended that the manufacturer consider relocating the fan speed control crank to permit safe adjusting while harvesting.
