EVALUATION REPORT

SPERRY NEW HOLLAND TR85 SELF-PROPELLED COMBINE

A Co-operative Program Between

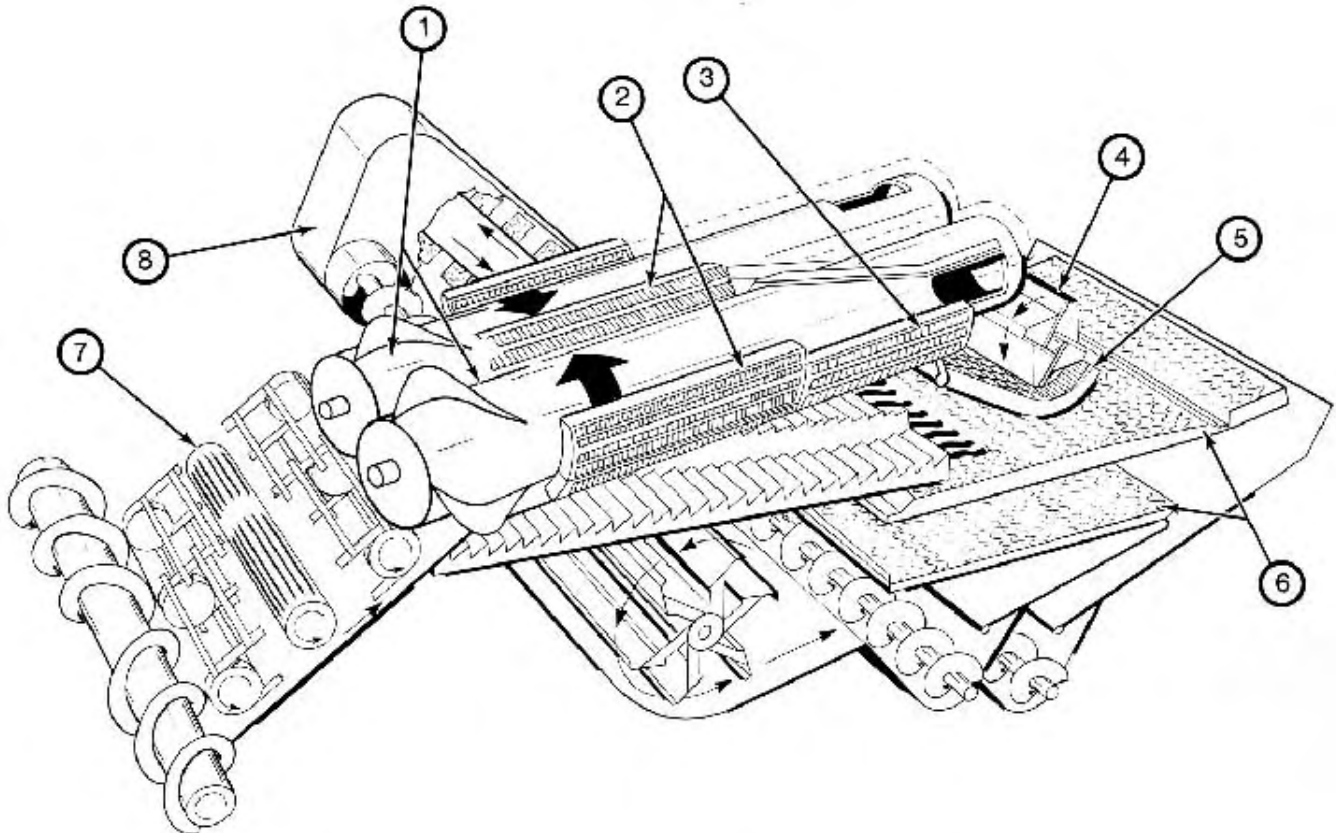
FIGURE 1. Sperry New Holland TR85: (1) Rotors, (2) Threshing Concave, (3) Separating Concave, (4) Discharge Beater, (5) Beater Grate, (6) Cleaning Shoe, (7) Stone Ejection Roller, (8) Tailings Return.

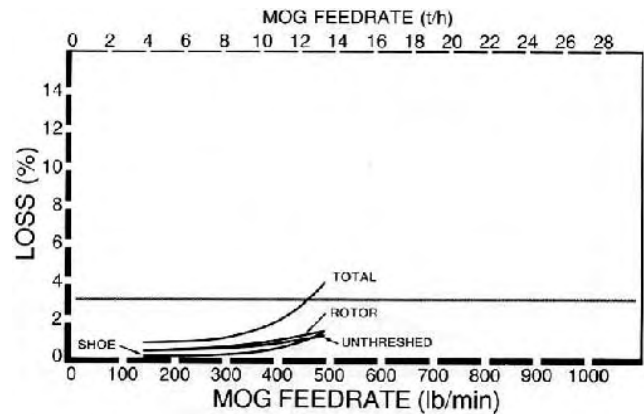
FIGURE 2. Grain Loss in Bonanza Barley (A).

Regression equations for the capacity results shown in FIGURES 2 to 5 are presented in TABLE 8. In the regressions, U = unthreshed loss in percent of yield, S = shoe loss in percent of yield, R = rotor loss in percent of yield, F = the MOG feedrate in lb/min, while \ln is the natural logarithm. Sample size refers to the number of loss collections. Limits of the regressions may be obtained from FIGURES 2 to 5 while crop conditions are presented in TABLE 3.

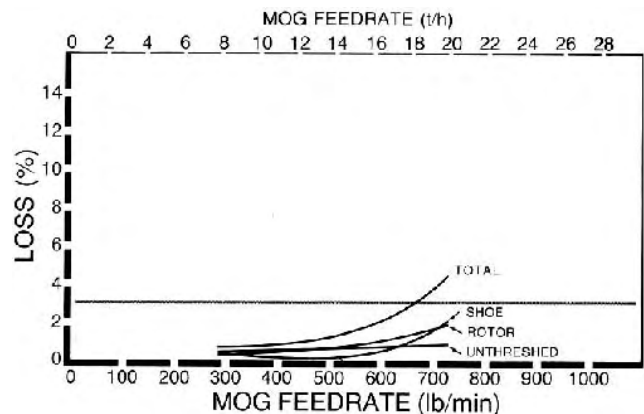
FIGURE 3. Grain Loss in Bonanza Barley (B).

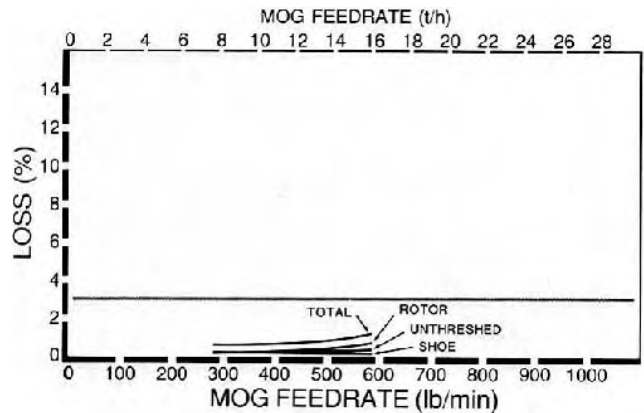
FIGURE 4. Grain Loss in Columbus Wheat (C).

For the two wheat crops (FIGURES 4 and 5), conditions were stable and all losses were fairly low. At maximum engine power, losses did not reach 3 percent. Capacity was slightly greater in Columbus wheat. This may have been due to the wider windrow and the easier-to-thresh nature of Columbus. It can be seen that for similar unthreshed loss, the Neepawa wheat had higher grain cracks.

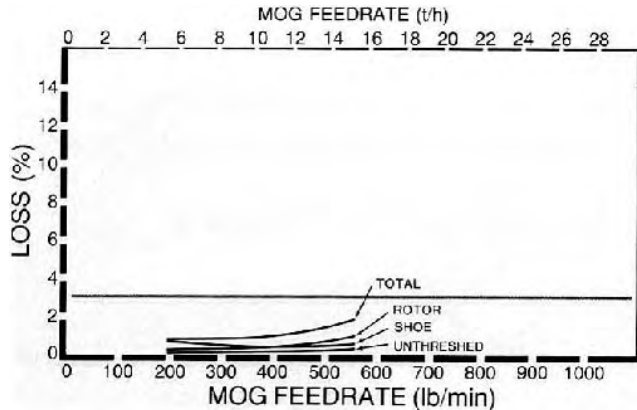
FIGURE 5. Grain Loss in Neepawa Wheat (D).

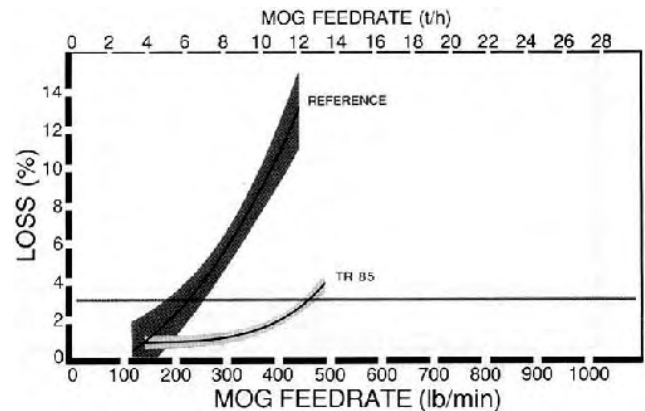
A test combine can also be compared to the reference combine at losses other than 3%. The total loss curves of both machines are shown on the same graph in FIGURES 6 to 9. Shaded bands around the curves represent 95% confidence belts. Where the bands overlap, very little difference in capacity could be noticed; where the bands do not overlap significant capacity differences existed.

FIGURE 6. Total Grain Loss in Bonanza Barley (A).

Capacity Compared to Reference Combine: The capacity of the Sperry New Holland TR85 was much greater than that of the reference combine in both wheat and barley. At 3% total loss the Sperry New Holland TR85 had about 2 times the capacity of the reference combine in barley. In wheat the Sperry New Holland TR85 losses did not reach 3%. Its maximum capacity in wheat was about 1.4 to 1.7 times the capacity of the reference combine at 3% total loss. FIGURES 6 to 9 compare the total loss curves of both combines.

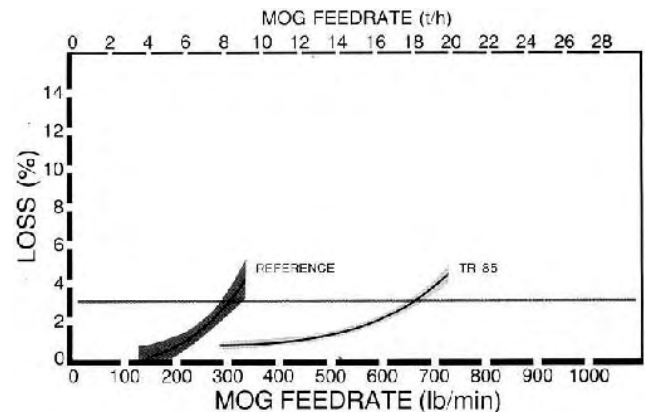
FIGURE 7. Total Grain Loss in Bonanza Barley (B).

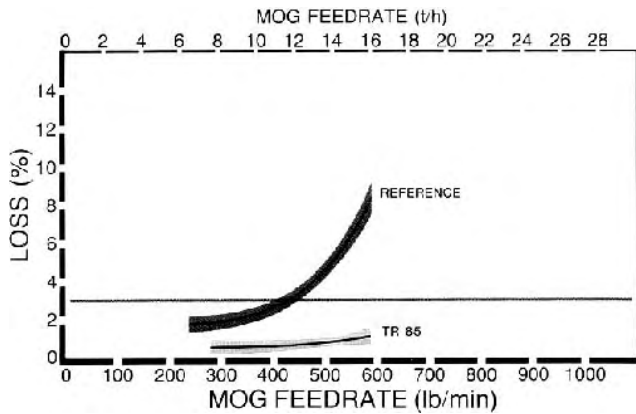
FIGURE 8. Total Grain Loss in Columbus Wheat (C).

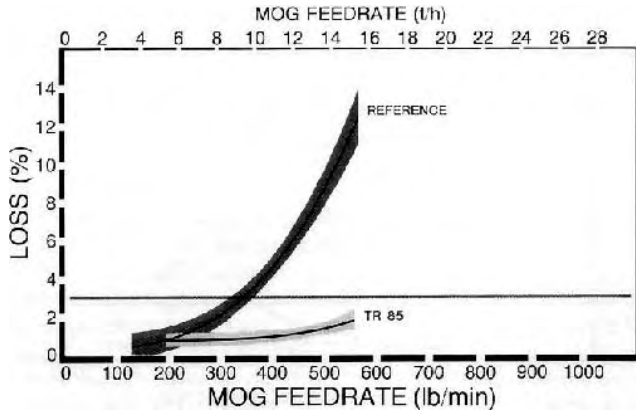
FIGURE 9. Total Grain Loss in Neepawa Wheat (D).

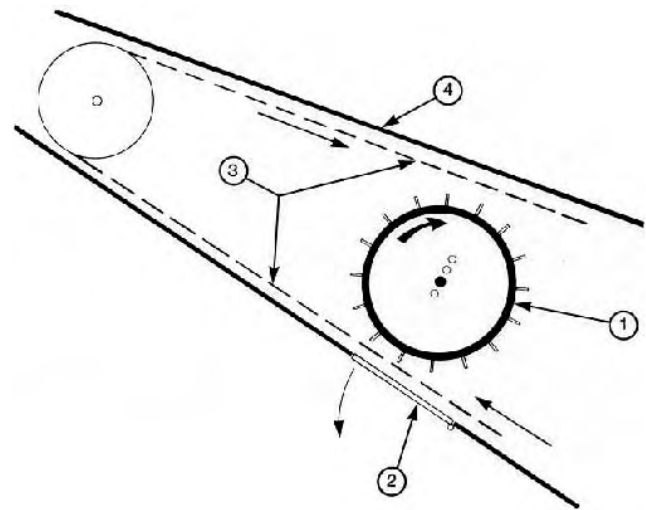
Stone Protection: Stones and other hard objects were removed as they travelled up the feeder house and passed between the powered stone ejection roller and trap door (FIGURE 10).

FIGURE 10. Stone Protection: (1) Stone Ejection Roller, (2) Trip Door, (3) Feeder Conveyor Chain, (4) Feeder House.

In stony conditions the powered stone roller was adjusted to provide maximum stone protection. In stone free conditions, it was raised to provide unrestricted feeding.

Most stones and hard objects were ejected. As a result there was negligible rotor and concave damage. When operating with the stone roller adjusted in the lowest position even a slight bunch in the crop often caused the door to be "kicked" open. The door had to be manually reset from outside the cab.

Auger timing, auger clearance, and auger stripper adjustment were easily made to suit crop conditions, and once set, seldom had to be readjusted. The stone ejection roller height was inconvenient and awkward to adjust. It is recommended that the manufacturer consider modifications to improve the ease of adjusting the stone ejection roller.

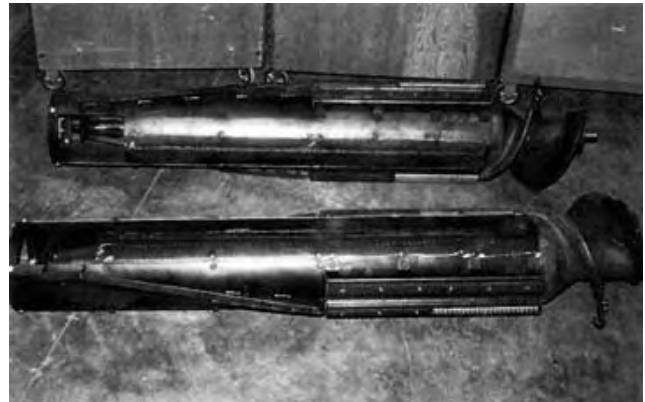
Threshing: Threshing was accomplished by the twin counter-rotating rotors, adjustable threshing concaves, extension modules and separating concaves (FIGURES 11 and 12).

FIGURE 11. Rotors. FIGURE 13. Material Build-up Behind Rasp Bars.

The rotors were powered through two gearboxes and a torque sensing variable speed belt drive. The drive was positive and provided a suitable speed range for all crops encountered. The concave had adequate adjustment. Suitable threshing in grain crops was obtained when using fast rotor speed and minimum concave clearance. In rapeseed much slower rotor speed and wider concave clearance were used to prevent over threshing. The rotor speeds and concave settings used for the various crops are given in TABLE 5.

The rotors were aggressive and plugging was not a problem. In all crops encountered the Sperry New Holland threshed completely. Even in hard-to-thresh crops such as Neepawa wheat, unthreshed losses were low and grain cracks minimal. This aggressive threshing caused severe straw break-up in dry conditions. In tough conditions, unthreshed loss was still acceptable although the maximum feedrate

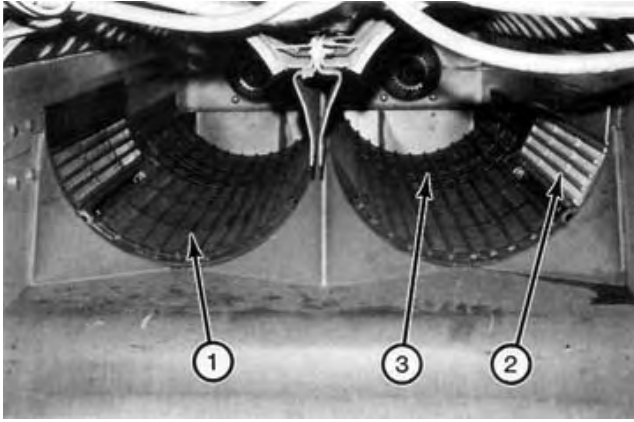
FIGURE 12. Concaves: (1) Threshing, (2) Extension Module. (3) Separating.

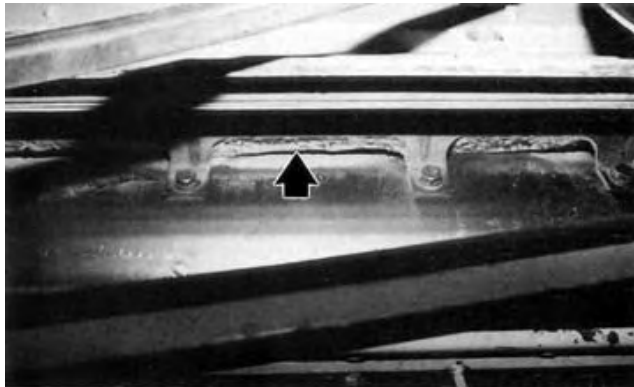
Threshing at medium to high feedrates in most crops, especially wheat, caused severe rotor and concave vibration. The noise was so irritating to the operator that often the full capacity of the combine was not utilized. The vibrations increased as dust and dirt settled behind the rasp bars (FIGURE 13), causing rotor imbalance. It is recommended that the manufacturer consider modifications to reduce threshing vibration and to prevent material build-up behind the rasp bars.

FIGURE 13. Material Build-up Behind Rasp Bars.

Material regularly collected behind the threshing rasp bars (FIGURE 13) throwing the rotors out of balance. The material often had to be cleaned out daily, which required removing the concave extension modules and prying the material loose with a tool.

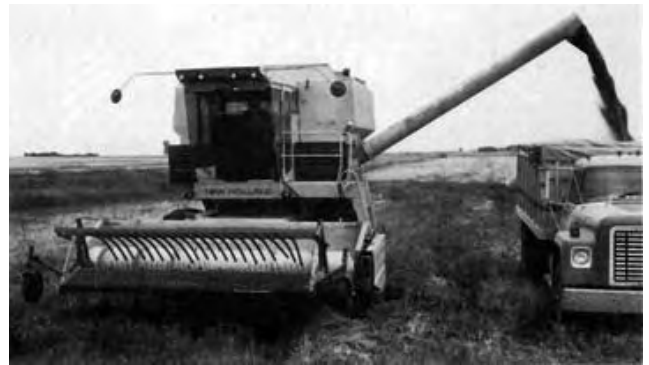
Although the auger delivered a compact stream of grain, the discharge height made unloading on-the-go inconvenient and caused grain loss in windy conditions (FIGURE 14). The optional downspout was effective in reducing loss in windy conditions (FIGURE 15) but was poorly constructed and lasted only 61 hours. Swinging the unloading auger back reduced the discharge height but also reduced clearance and reach.

FIGURE 14. Unloading With Standard Spout.

The unloading auger had ample reach and clearance for unloading into trucks and grain trailers. The unloading auger discharged grain in a compact stream and could empty a tank of dry wheat in about 198 seconds. This was slow. Opening the control gates to increase the unloading rate often caused the unloading auger belt to slip. Increasing belt tension beyond recommended settings helped. It is recommended that the manufacturer consider modifications to provide faster grain unloading.

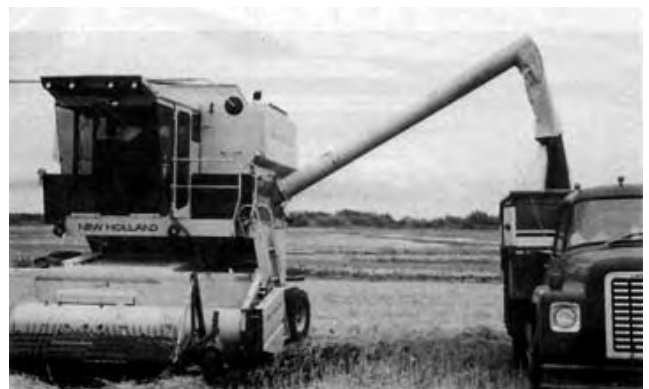
FIGURE 15. Unloading With Optional Spout.

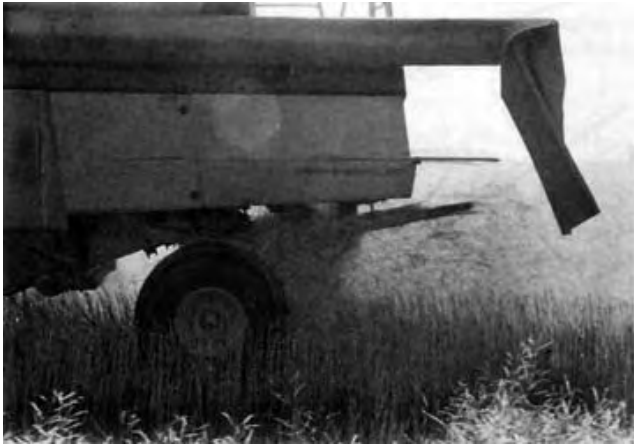
Straw Spreading: The Sperry New Holland TR85 was tested with straw spreaders. The rotors usually broke the straw into small lengths making further chopping unnecessary, the spreaders spread the straw and some of the chaff from the shoe, evenly over about 16 ft (4.9 m). The spread pattern was affected considerably by wind. Some straw and chaff thrown forward onto the rear axle (FIGURE 16) by the spreaders may have been drawn into the cleaning fan. Flexible shielding was added by the Machinery Institute to prevent this.

FIGURE 16. Straw Spreader Throwing Material Forward.

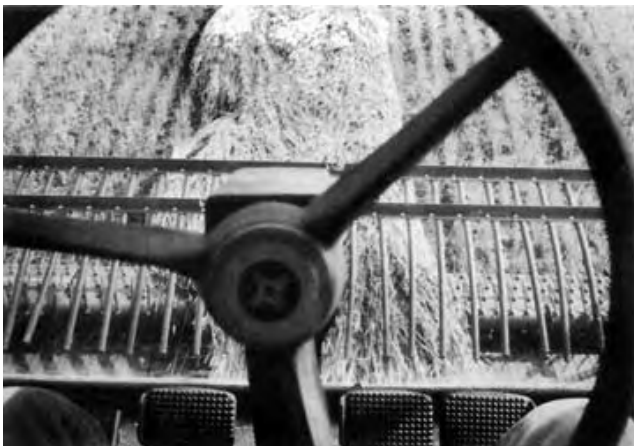
View of the incoming windrow was partially blocked by the steering column (FIGURE 17). The view was improved by leaning ahead and slightly to the right (FIGURE 18). This, however, became uncomfortable after several hours of operating. The grain level was visible through the rear window until the tank was about two-thirds full. As the tank became full, the grain level could be seen in the rear view mirrors.

FIGURE 17. Normal View of Incoming Windrow.

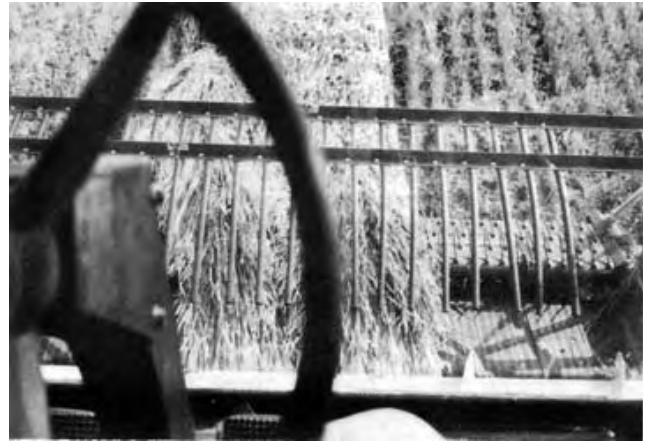
FIGURE 18. View of Incoming Windrow When Leaning Forward and Right.

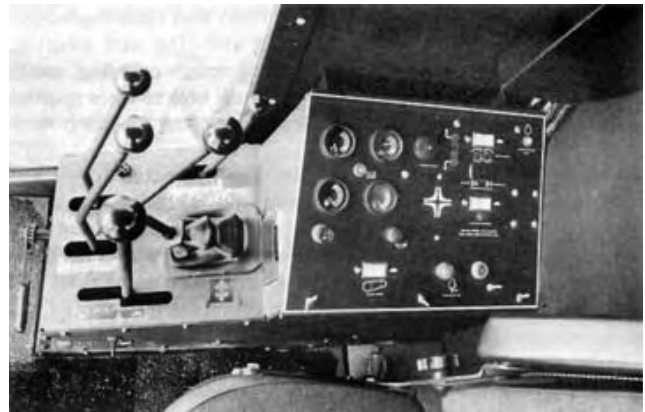
Instruments: The instruments were located to the right of the operator, and above the windshield (FIGURES 19 and 20). The lower console contained gauges for engine oil pressure, coolant temperature, battery charging and fuel level. There was also a battery charge indicator light and an engine circuit breaker. Feeder speed was indicated by a pointer on the feeder housing. The upper console contained an engine hour meter, a selective digital display for ground, engine, fan, and rotor speeds and an optional grain loss monitor. Warning lights and an audio alarm warned of air

Controls: The controls for the Sperry New Holland TR85 (FIGURES 19 to 22) were conveniently located and easy to operate.

FIGURE 19. Lower Right Console.

restriction, low coolant level, excessive coolant temperature, low engine oil pressure, full grain tank, open stone trap, parking brake engagement, and a speed reduction of the major combine drives. The digital readout and warning systems were very useful, but the digital display and combine loss monitor were inconvenient to observe while harvesting. It is recommended that the manufacturer consider relocating the digital display for more convenient observation while harvesting.

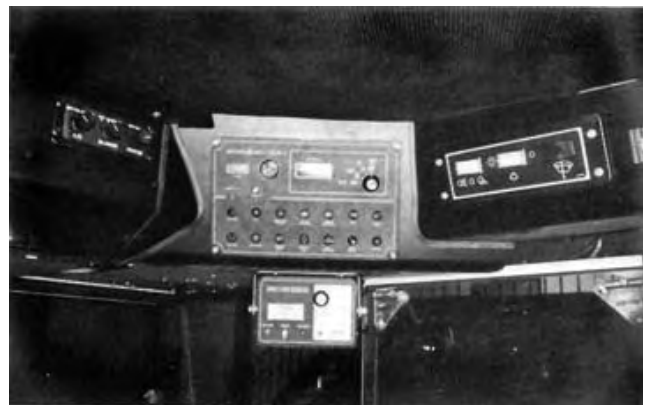
FIGURE 20. Upper Right Console.

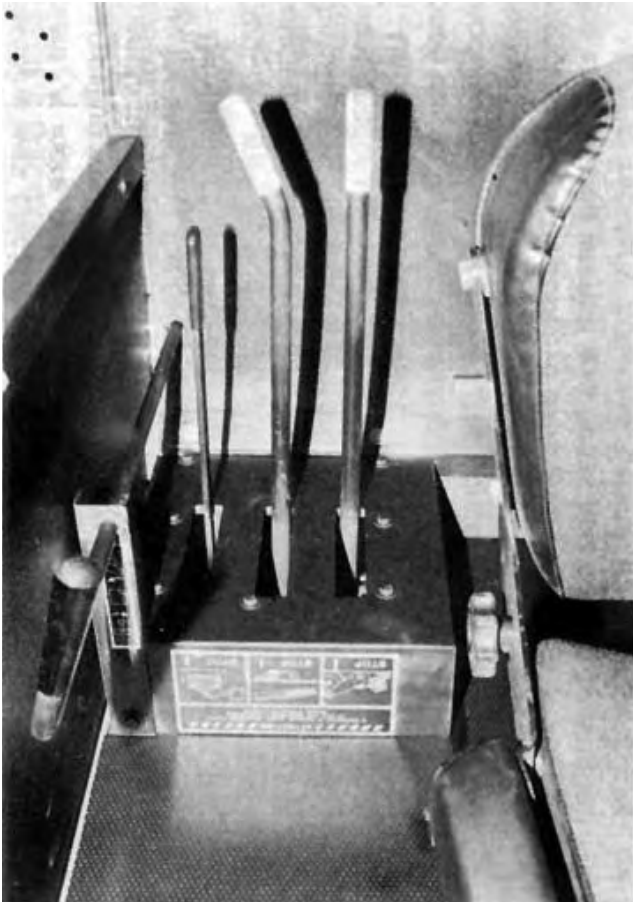
The foot-operated pickup speed control was easy to adjust but responded slowly. The fan and rotor speed adjustment also responded slowly. The unloading auger swing control was stiff to turn and the auger swung slowly. The hydrostatic ground speed and header height control levers were inconveniently located. The levers were too far from each other to be operated simultaneously and they were positioned too far ahead of the armrest for comfortable

FIGURE 21. Lower Left Console.

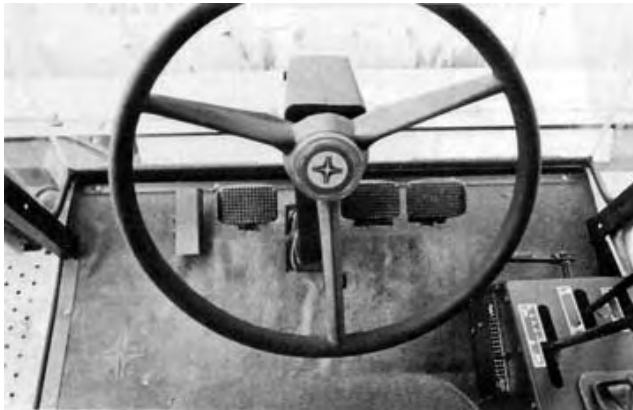
FIGURE 22. Foot Operated Controls.

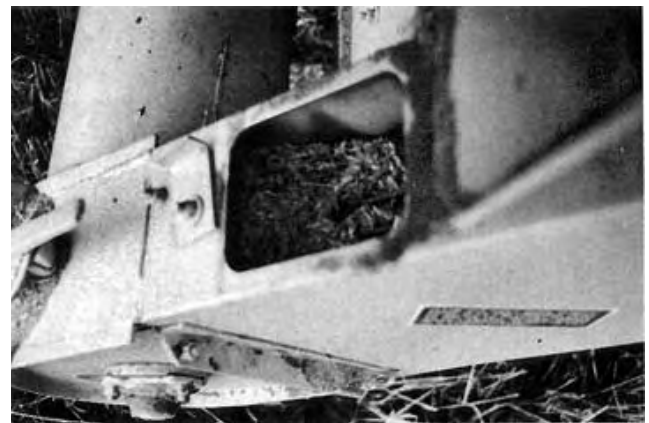
FIGURE 23. Return Sampler.

Field Setting: The Sperry New Holland TR85 was very easy to set for all crops and conditions encountered. Usually, very little "fine tuning" was required after initial adjustments were made. It was essential to remove the straw spreaders to check grain loss. The return tailings (FIGURE 23) could be examined only if the machine was quickly shut down under load. This was inconvenient. A more convenient method of sampling the return while harvesting would have been beneficial. It is recommended that the manufacturer consider supplying a safe, more convenient apparatus for sampling the return tailings while harvesting.

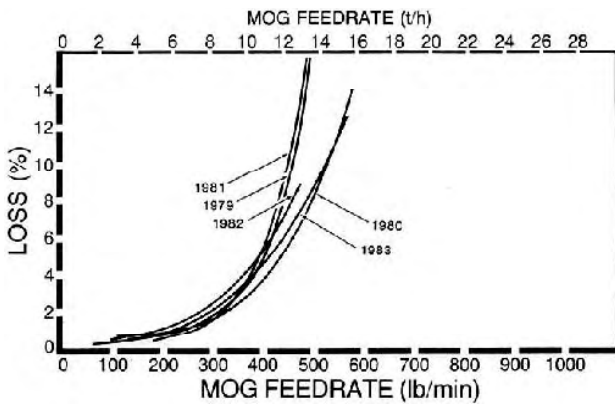
TABLE 7 and FIGURES 24 and 25 present the capacity results for the Machinery Institute reference combine in wheat and barley crops harvested from 1979 to 1983. FIGURE 24 shows capacity differences in Neepawa wheat for the five years. The 1983 Neepawa wheat crop shown in TABLE 7 had about average straw yield, below average grain yield, and below average grain and straw moisture content.

FIGURE 24. Total Grain Loss for the Reference Combine in Neepawa Wheat.

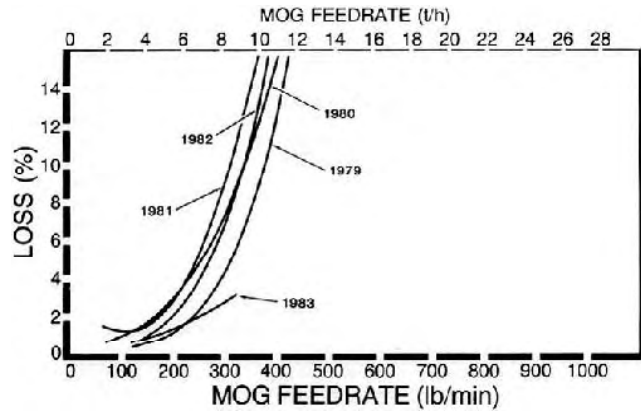
FIGURE 25. Total Grain Loss for the Reference Combine in Bonanza Barley.
