EVALUATION REPORT

365

ALLIS-CHALMERS GLEANER N7 SERIES THREE SELF-PROPELLED COMBINE

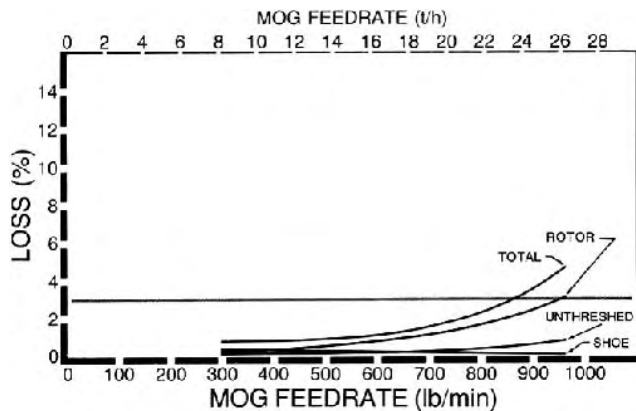
FIGURE 4. Grain Loss in Columbus Wheat (C).

The performance curves for the capacity tests are presented in FIGURES 2 to 5. The curves in each figure indicate the effect of increased feedrate on rotor loss, shoe loss, unthreshed loss, and total loss. From the graphs, combine capacity can also be determined for loss levels other than 3%. These results were obtained with the combine set for optimum performance at a reasonable feedrate. Unthreshed losses may be slightly greater than indicated since some grain left in the heads was probably threshed out by the straw chopper. The straw chopper was mounted behind the rotor and could not be removed for the tests.

For the two wheat crops (FIGURES 4 and 5), conditions were stable and at maximum feedrate losses were fairly low. Capacity in the Columbus wheat was considerably greater than in the Neepawa wheat. This may have been due to the easier-to-thresh nature of Columbus.

Regression equations for the capacity results shown in FIGURES 2 to 5 are presented in TABLE 8. In the regressions, U = unthreshed loss in percent of yield, S = shoe loss in percent of yield, R = rotor loss in percent of yield, F = the MOG feedrate in lb/min, while ln is the natural logarithm. Sample size refers to the number of loss collections. Limits of the regressions may be obtained from FIGURES 2 to 5 while crop conditions are presented in TABLE 3.

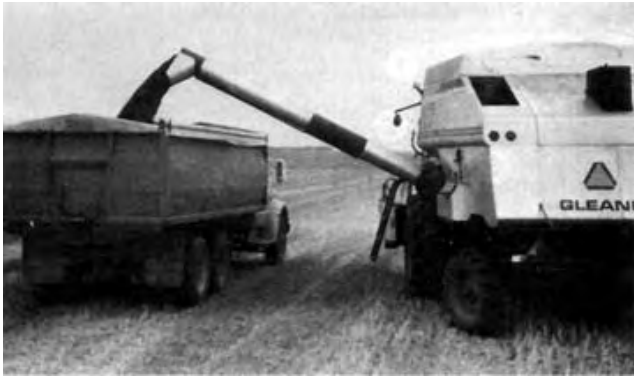
FIGURE 14. Unloading.

Clean Grain Handling: The clean grain elevator had adequate capacity for all crops encountered. The open grain tank filled evenly and completely in all crops, the tank held about 300 bushels (10.9 m³) of dry wheat. The unloading auger had adequate reach and clearance for unloading into trucks and grain trailers (FIGURE 14). The auger discharged grain in a compact even stream and could empty a tank of dry wheat in about 190 seconds. The tank did not empty completely, leaving about 1 bu (36 L) of grain trapped on various ledges.

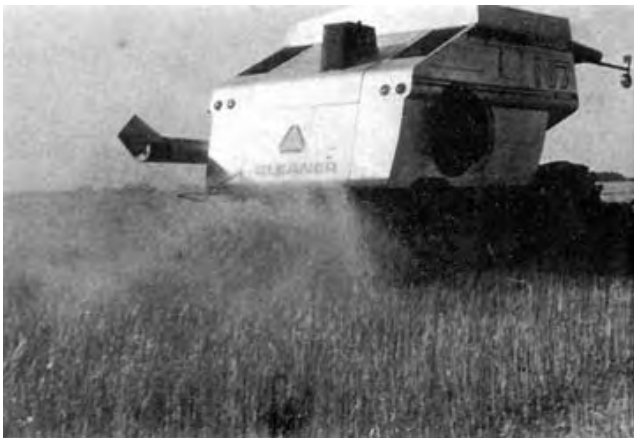
FIGURE 15. Straw Spreader Operation.

Straw Spreading: The test machine was equipped with the optional straw chopper and straw spreader. The straw chopper replaced the discharge beater and could not be disengaged. The straw from the chopper was broken into very small lengths. The bat-type spreader spread straw up to 12 ft (3.6 m). This was narrow for this size of machine. Most of the straw was spread directly behind the combine (FIGURE 15). The straw spread was greatly affected by wind. The straw spreader was easily removed for checking losses or to permit windrowing, although the windrows were not suitable for baling.

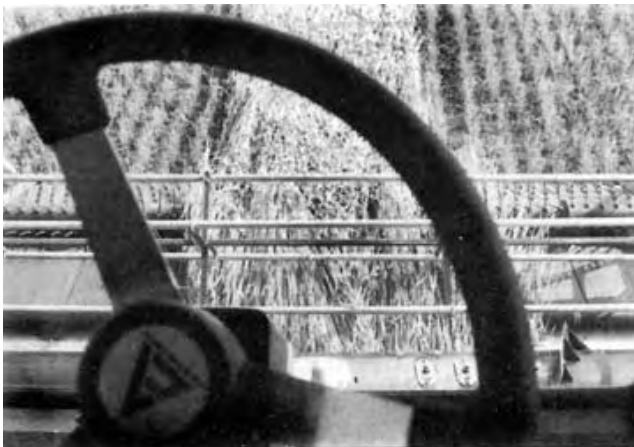
FIGURE 16. View of Incoming Window.

Visibility forward and to both sides was very good; rear visibility was restricted to the use of rear view mirrors. Four rear view mirrors were provided, which gave very good visibility to the rear. Caution was still needed when maneuvering in confined areas. View of the incoming window was very good (FIGURE 16). Grain level was visible through the rear window until the tank was nearly full.

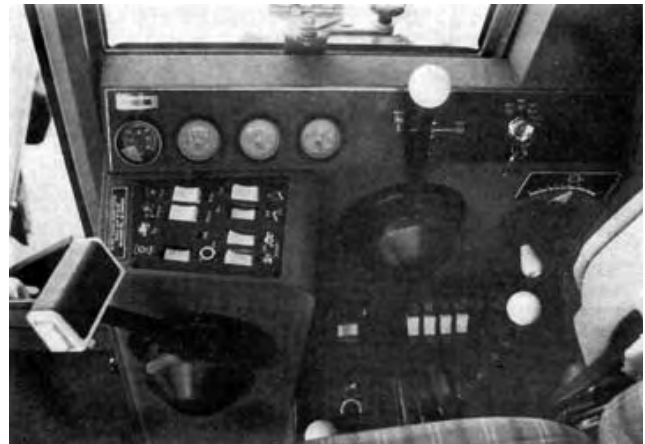
FIGURE 17. Controls and Lower Instrument Console.

Instruments: The instruments were located on two consoles, one to the right of the operator, the other above the windshield (FIGURES 17 and 18). The lower console had gauges for turbocharger boost pressure, battery voltage, coolant temperatures, engine oil pressure, and a grain loss monitor meter. The upper console had the grain loss monitor adjustments, engine and separator hour meters, an acre estimator, air conditioning and heater controls, and a digital readout that selectively displayed fuel level, cylinder speed, engine speed, and combine ground speed. As standard equipment, warning lights signalled an open stone trap door, engaged parking brake, excessive hydraulic oil temperature, engine air filter restrictions, low coolant level, fuel filter restriction, transmission lubrication pressure, and reduced speeds of the major combine drives. No shaft speed monitor was supplied to warn of rotor speed reduction.

Controls: The controls for the Allis-Chalmers Gleaner N7 (FIGURE 17) were conveniently located and easy to operate. Most functions were activated electrically with rocker switches. They were easily operated but sometimes difficult to identify quickly in an emergency. The light switches and header reverse switch were in conveniently located. The throttle lever was often difficult to release from its locked high idle position. The hydrostatic lever and header height control switch were very conveniently located. Header height adjustment was very abrupt without the optional header hydraulic accumulator. With the hydraulic accumulator properly adjusted, control was smooth and responsive. The fan adjustment was stiff to
