Evaluation Report

425

John Deere 8820 Titan II Self-Propelled Combine

JOHN DEERE 8820 TITAN II SELF-PROPELLED COMBINE

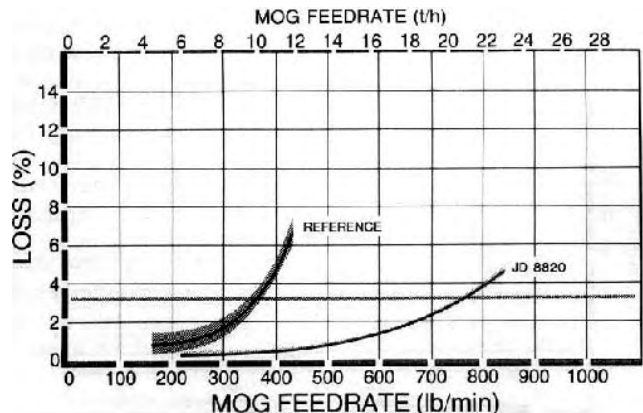
FIGURE 10. Total Grain Loss in Neepawa Wheat (Field D - Double Windrows).

Capacity Compared to Reference Combine: The capacity of the John Deere 8820 Titan II was much greater than that of the reference combine. At 3% loss the John Deere 8820 Titan II had about 2 times the capacity of the reference combine in both wheat and barley. FIGURES 7 to 11 compare the total loss curves of both combines.

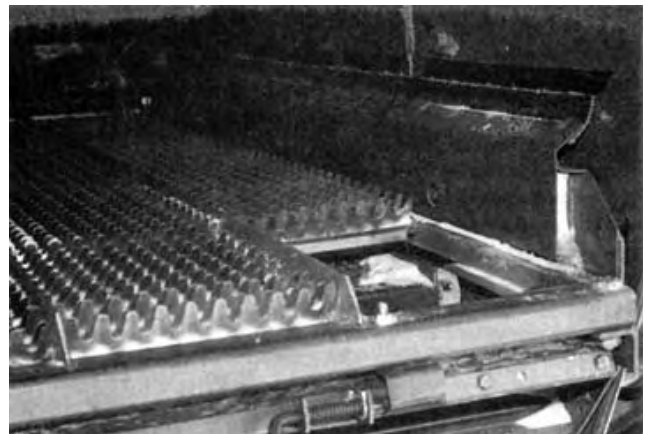
The chaffer sieve and cleaning sieve on the John Deere 8820 Titan II were each 6 in (152 mm) longer than the 8820 Titan tested in 1980. The chaffer also had removable corner sections (FIGURE 12), which could be removed to retain grain, which might be lost when combining on side slopes.

FIGURE 12. Chaffer Insert Removed.

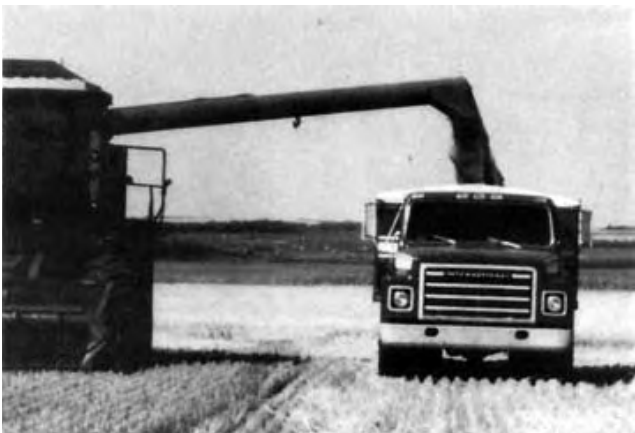
The open grain tank on the John Deere 8820 Titan II filled evenly and completely and held approximately 215 Imp bu (7.8m³) of dry wheat. The unloading auger had ample reach and clearance for unloading into trucks and grain trailers (FIGURE 14). The grain discharged in a compact stream and a full tank of dry wheat was unloaded in about 115 seconds. Unloading rates could be increased by opening the adjustable control gates.

FIGURE 14. Unloading.

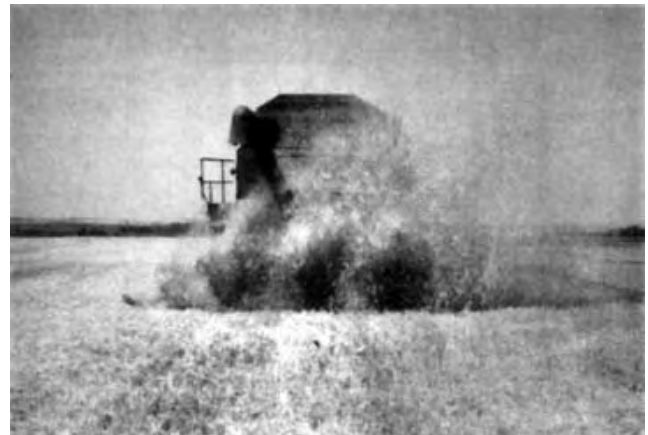
Straw Spreading: The John Deere 8820 Titan II was equipped with a straw chopper with the extended tail plate and large deflectors. The straw chopper generally spread the straw evenly over about 30 ft (9 m) in optimum conditions, in double windrows. Spreads of up to 35 ft (10.7 m) were attained (FIGURE 15). Tail plate angle was critical with the optimum angle being 10 to 15 degrees up from the horizontal. Wind reduced spreading effectiveness.

FIGURE 15. Straw Spreading.

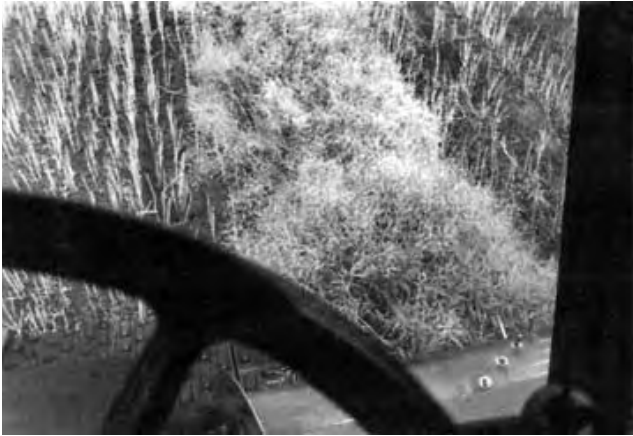
FIGURE 16. View of Incoming Windrow.

Visibility forward and to the left was very good. Visibility to the right was fair. Rear visibility was fair to the left but restricted directly behind. Rear view mirrors were provided. The convex mirror on the right was too far away and too small to be effective. The rear view mirror on the left provided a good view of traffic approaching from the rear but did not permit full view of the left side. An extra convex mirror on the left side and a larger one on the right would improve rear visibility. View of the incoming windrow was only partially blocked by the steering column (FIGURE 16). The grain in the tank could be viewed until the tank was 3/4 full. The operator had to leave the cab to determine when the tank was full. It is recommended that the manufacturer consider installing a full grain tank warning device.

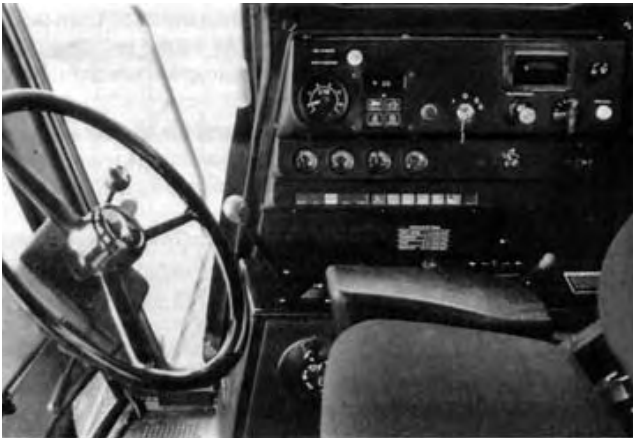
Instruments: The instruments were located on a console to the right of the operator (FIGURE 17), while the loss monitor display was located on the pillar in the front left corner of the cab. Cylinder speed was indicated by a dial tachometer, while a digital readout selectively displayed engine speed, fan speed, ground speed, and front feeder shaft speed. Gauges indicated engine water temperature, engine oil

pressure, battery voltage, and fuel level. In addition, warning lights indicated air filter restriction, park brake engagement, hydraulic and hydrostatic high oil temperatures, decrease in transmission oil pressure, plugged straw walkers, and reduced speed of major combine drives. Also located on the console was an engine hour meter. The cylinder tachometer, independent of the digital display, was very convenient. The digital readouts were very easy to read and were not affected by direct sunlight.

FIGURE 17. Instruments and Controls.

Controls: All the controls in the cab were color coded, distinctively shaped, and clearly marked for easy identification (FIGURE 17). Most were conveniently located and easy to operate. However, the park brake lever and header reverser control were located close together which created a pinch point for the operator's hand (FIGURE 18).

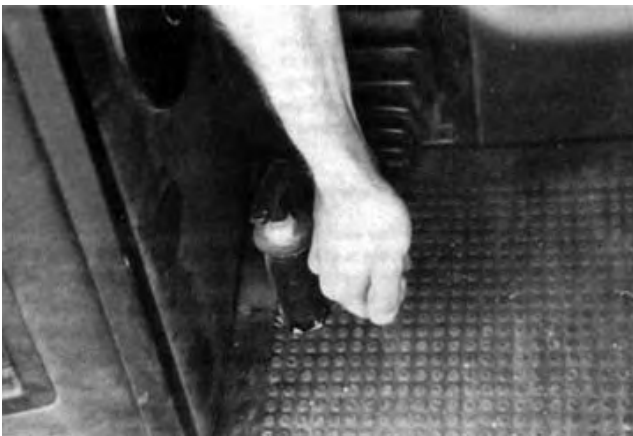
FIGURE 18. Pinch Point Between Park Brake Lever and Header Reverser.
