# Evaluation Report

# 438

## Hurricane Chaff Spreading Attachment

# HURRICANE CHAFF SPREADING ATTACHMENT

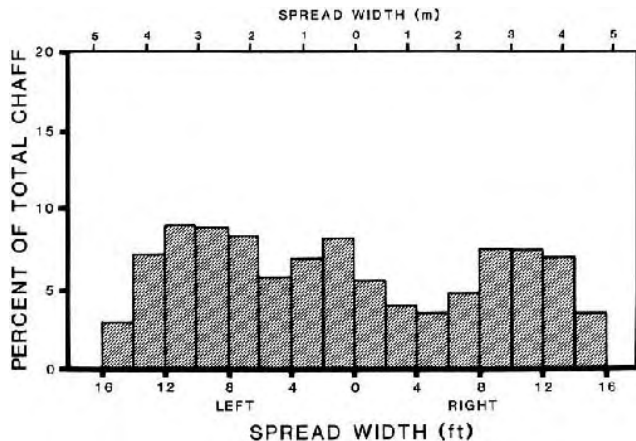
FIGURE 2. Typical Chaff Spread Pattern Uniformity After Modifications.

A typical spread pattern obtained with the shaker pan and deflector shield is shown in FIGURE 2. The coefficient of variation (CV)\* was 25 percent and was well within the acceptable limit. The uniformity of the spread pattern may differ considerably with field conditions and machine adjustments.

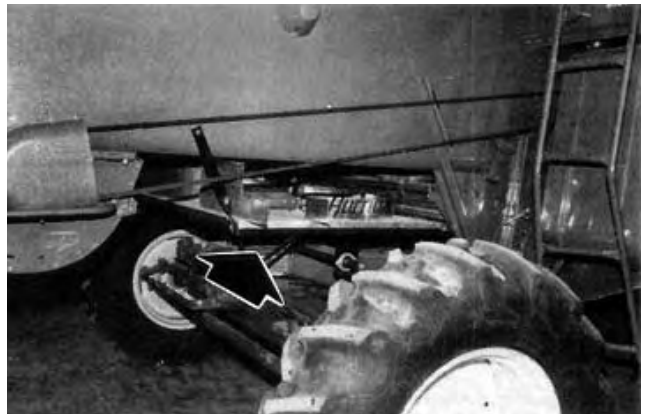
FIGURE 4. Access to Shoe Adjustments.

the combine's cleaning shoe was unsatisfactory with the Hurricane installed (FIGURE 4). The spreader body blocked access to the combine's shoe for viewing. The chaffer and sieve were difficult and inconvenient to adjust with the Hurricane in place. It is recommended that the manufacturer modify the Hurricane to allow access to the combine shoe.
