Evaluation Report

New Holland TR96 Self-Propelled Combine

NEW HOLLAND TR96 SELF-PROPELLED COMBINE

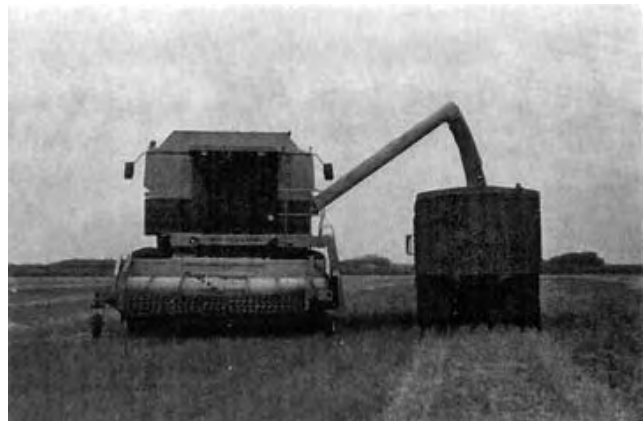
FIGURE 14. Unloading With Optional Spout.

The unloading auger had ample reach and clearance for unloading into trucks and grain trailers. The unloading auger discharged grain in a compact stream and could empty a tank of dry wheat in about 170 seconds. This was slow. Opening the control gates and removing cover plates over the grain tank discharge increased the unloading rate only slightly. It is recommended that the manufacturer consider modifications to increase the grain unloading rate. The optional downspout was effective in reducing grain loss in moderately windy conditions (FIGURE 14). Swinging the unloading auger back to reduce the discharge height reduced clearance and reach and also made it more difficult for the operator to see the spout.

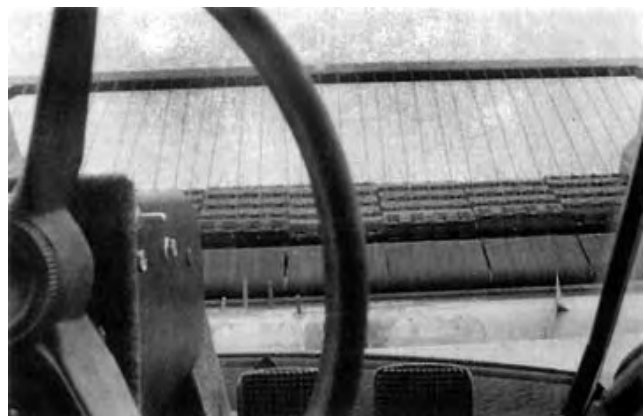
FIGURE 15. View of Feed Intake Area.

View of the feed intake area was partially blocked by the steering column (FIGURE 15). The view was improved by leaning ahead and slightly to the right. This became uncomfortable after several hours of operating. Grain level was visible through the rear window until the tank was about 2/3 full.

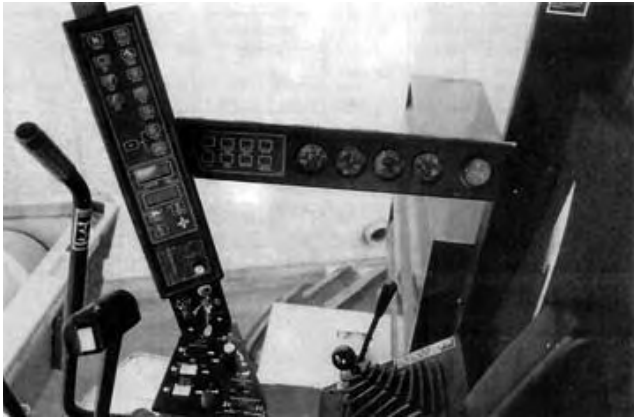
FIGURE 16. Instrument Bars and Lower Right Controls.

Instruments: Instrumentation on the New Holland TR96 was very good. The instruments were located at eye level to the right of the operator on two separate panels (FIGURE 16). The horizontal panel contained gauges for coolant temperature, engine oil pressure, fuel level, and battery voltage. It also contained an engine hour meter, and audio visual warning lights for park brake engagement, hydraulic oil temperature, air filter restriction, coolant temperature, engine oil pressure, battery voltage, and drives engaged. The vertical instrument bar contained warning lights and an audio alarm for full grain bin, unloading auger position, open stone trap, and speed reductions of clean grain elevator, return elevator, discharge beater, straw chopper, cleaning fan, and rotors. A digital readout

Controls: The controls on the New Holland TR96 were very good (FIGURES 16 and 17). They were conveniently located and easy to operate. The foot pedal control for the unloading auger position was very convenient to use. The header engaging lever could also be used to engage the header reverser. With the lever in the reverse position, a rocker switch would slowly rotate the feeder in either direction. This was very convenient. The header height switch located on the hydrostatic control lever was very convenient to use. Header lift and drop rate were adjustable.

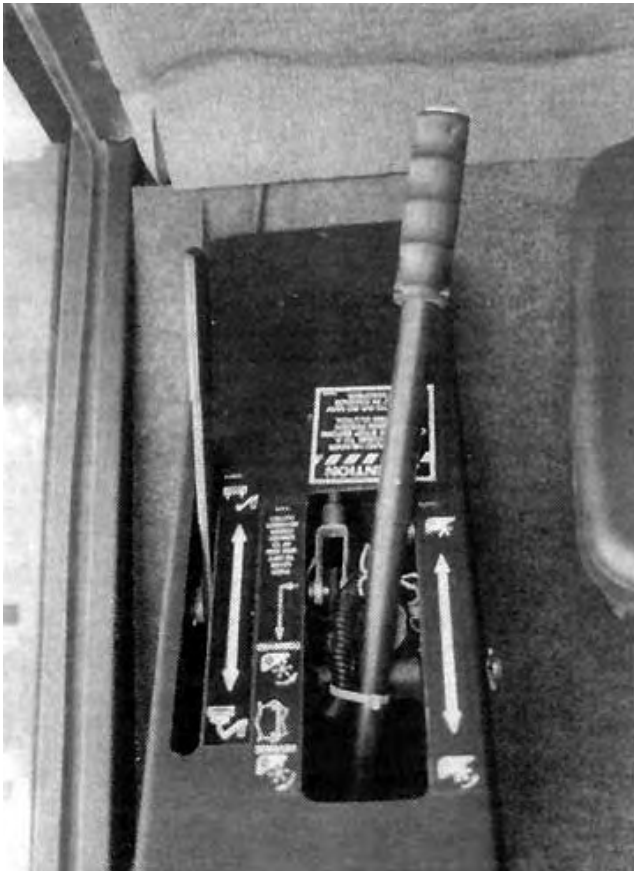
FIGURE 17. Lower Left Controls.

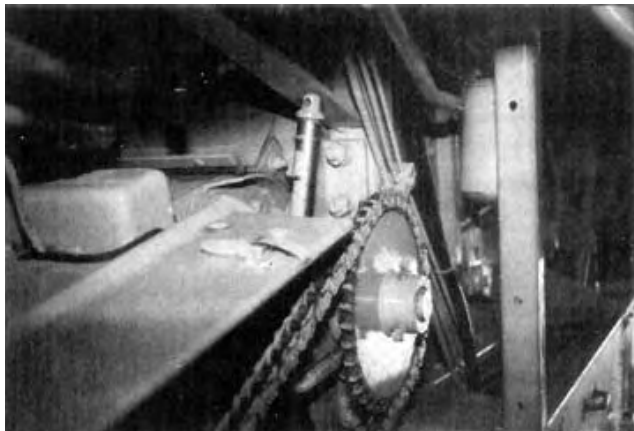
FIGURE 18. Feeder House Locking Pins Contacting Frame.

The complete header and feeder house assembly was easily removed and installed. However, the locking pins, which hold the feeder house pivot blocks in place had to be shortened so they could be removed (FIGURE 18). It is recommended that the manufacturer consider modifying these locking pins to allow for easier removal. Removing the rotors was fairly difficult. The intake section of the rotor with the flighting had to be screwed off before the rotor could be pulled out. The rotors were heavy and caution had to be taken when handling them. When installing the rotors, it was necessary to "time" them.
