Evaluation Report

Sperry New Holland TR70 Self-Propelled Combine

SPERRY NEW HOLLAND TR70 SELF-PROPELLED COMBINE

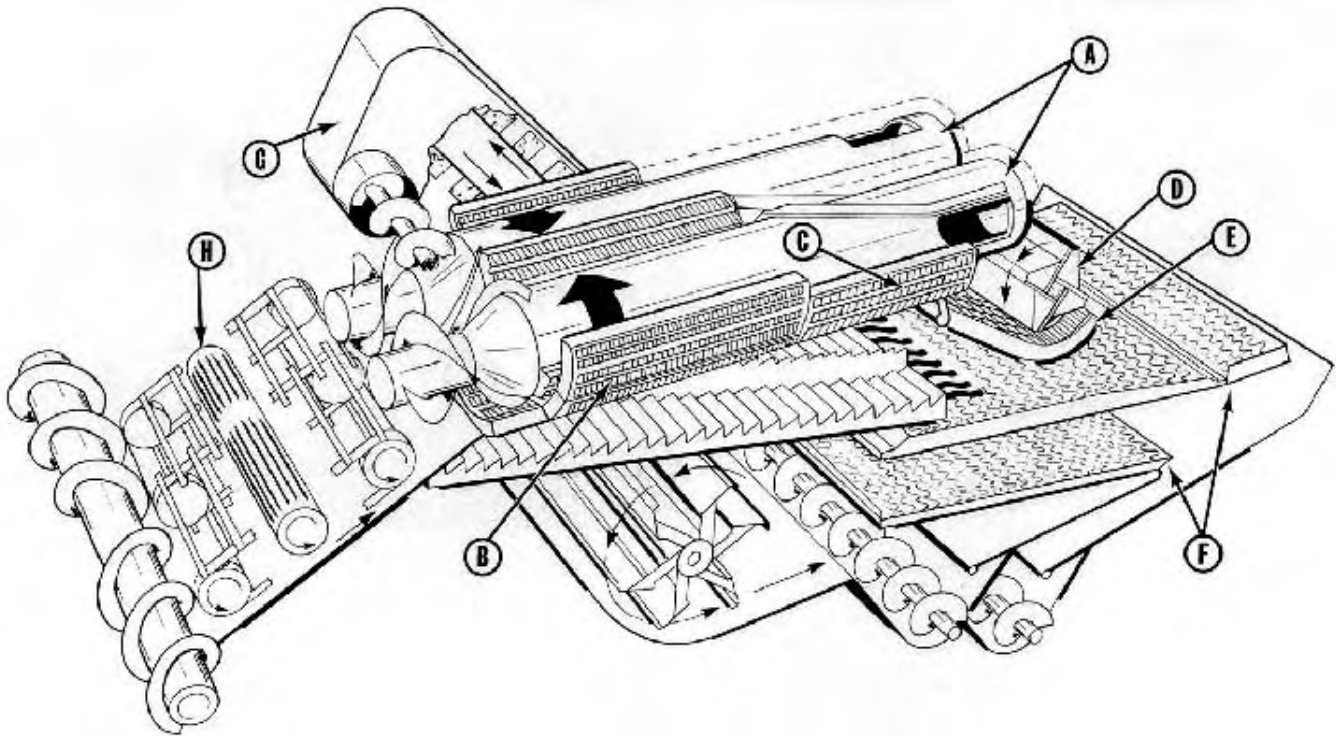
FIGURE 1. Sperry New Holland TR70: (A) rotors, (B) threshing concave, (C) separating concave, (D) back beater, (E) beater grate, (F) shoe, (G) tailings return, (H) stone ejection roller.

The Sperry New Holland TR70 is a self-propelled combine with two longitudinally mounted, axial, threshing and separating rotors. Threshing occurs at the front section of the rotors while separation of grain from straw is accomplished with full length threshing and separation concaves in conjunction with a rear beater and grate. A cleaning shoe is used, with return tailings delivered to the front of the rotors. A stone ejection roller is mounted within the feeder housing.

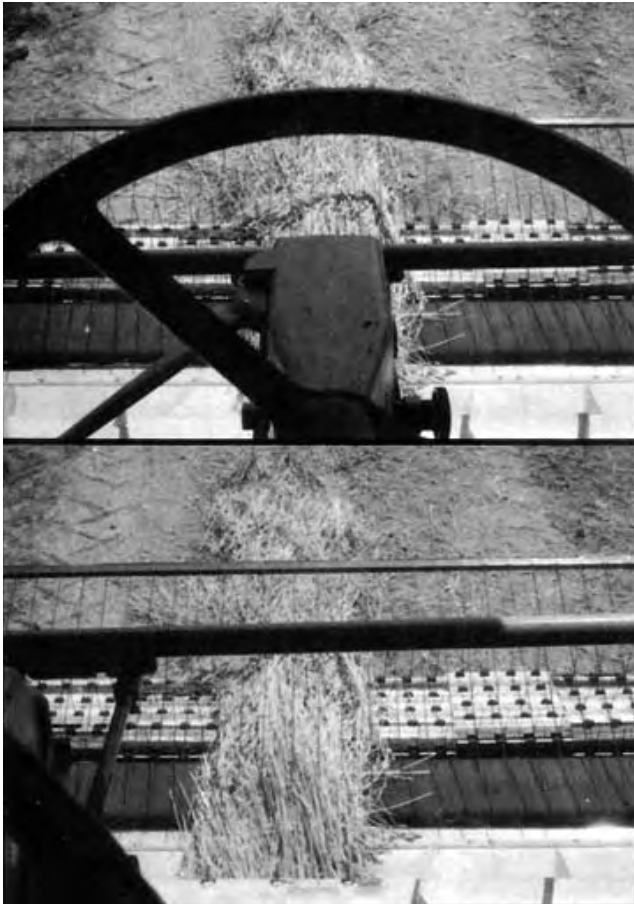
FIGURE 2. Operator's View of the Windrow, Over the Steering Column and to the Right of the Steering Column.

The steering column obstructed the operator's view of the incoming windrow, resulting in a tendency to feed the windrow to the right of centre (FIGURE 2). Since centering the windrow on the feeder housing is important in obtaining equal flow to both rotors, it is recommended that the manufacturer consider modifications to improve visibility over the steering column.

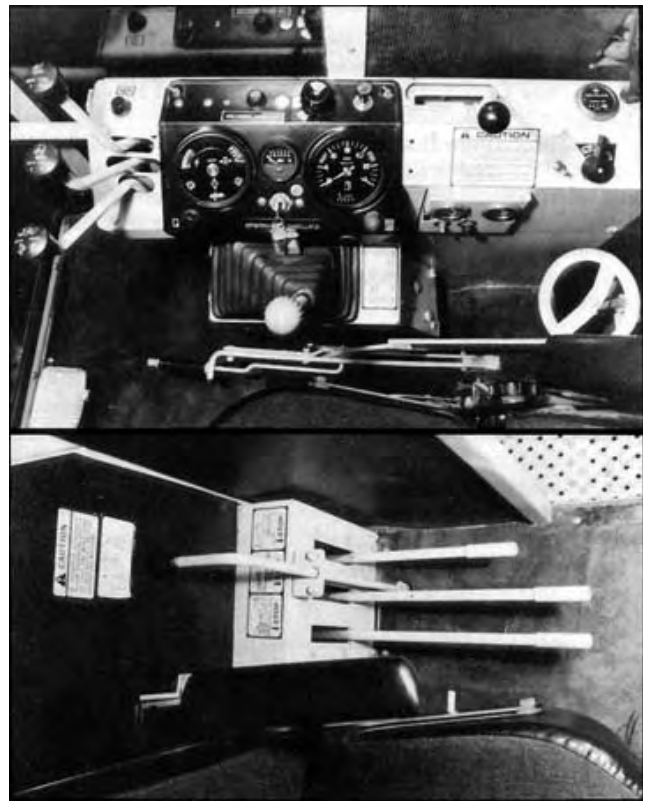
FIGURE 3. Control Layout.

Controls: The control arrangement is shown in FIGURE 3. Most controls were conveniently placed, easy to use and responsive. The gear shift lever interfered with the variable speed lever when

shifting between third and fourth gear, and with the right armrest when shifting to reverse. Rotor speed adjustment was slow due to the large reduction ratio of the system. The hydraulically controlled pickup drive and the responsive header lift gave the operator good control. Header lift was quick enough to suit all conditions; header drop rate was adjustable.

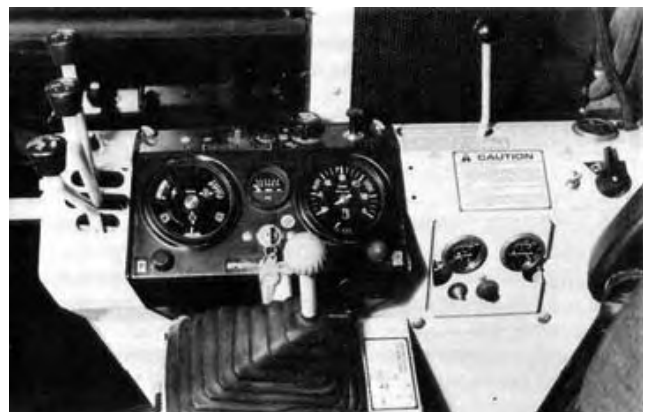
FIGURE 4. Instrument Console.

Instruments: The instrument console (FIGURE 4) included gauges for engine oil pressure, coolant temperature, battery charging, fuel level, engine hours, variable speed position and rotor speed. Indicator lights were provided for engine oil pressure, battery charging, transmission oil pressure, parking brake and the unloading auger position. The optional engine shutoff panel contained engine oil pressure and coolant temperature gauges with automatic shutoff, stop and reset buttons.

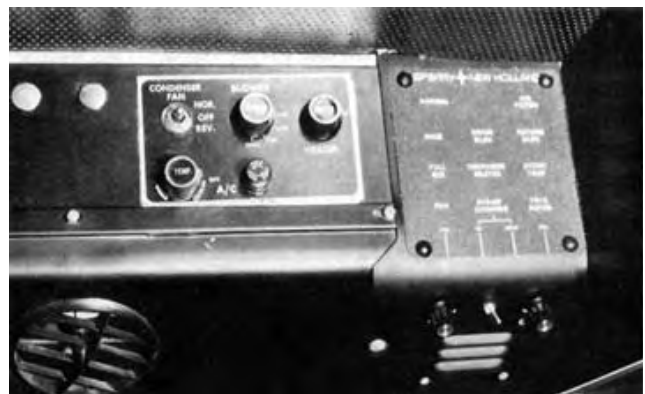
FIGURE 5. Shaft Speed Monitors.

The optional shaft speed monitors (FIGURE 5) were useful in detecting component stoppage. They monitored the tailings elevator, clean grain elevator, shoe, fan, rotors and straw chopper, signalling the operator if any shafts fell below 80% of normal speed. Also monitored were the air filter, stone trap door and grain bin level.

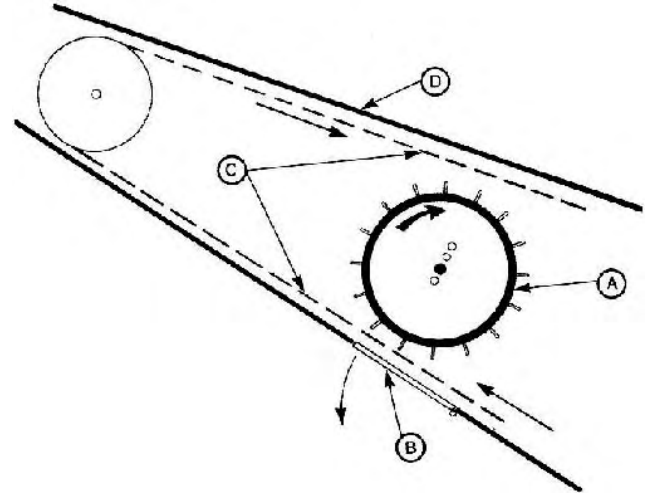
FIGURE 6. Stone Protection. (A) stone ejection roller (B) door, (C) feeder chain, (D) feeder housing.

equipped with a stone ejection roller in the middle of the feeder housing (FIGURE 6). The stone trap door, retained by an adjustable spring loaded latch is located beneath the adjustable ejection roller. When a large straw wad or a foreign object is forced under the roller, the door opens ejecting the object. When the door opens, a monitor is triggered to inform the operator. The operator then has to stop the combine, leave the cab, secure the header and close the door. The ejection roller was very effective, ejecting most roots, stones or wads before they entered the rotors. Examination of the rotor housings after testing showed negligible damage, although there were many small scars, which were probably caused by small stones.

In bunched rapeseed windrows, the stone roller had to be raised to its highest position to increase feeder capacity. In this position, only limited stone protection was provided. It was important to operate the stone roller at minimum possible clearance to provide optimum stone protection.

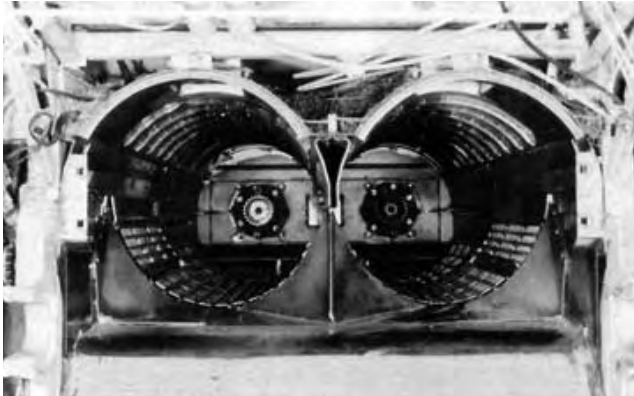
FIGURE 7. Threshing and Separating Concaves.

Concave Adjustment: Each rotor was equipped with a set of concaves (FIGURE 7), consisting of an adjustable threshing portion and a stationary separating portion. Access to the threshing concaves was through doors on both sides of the combine.

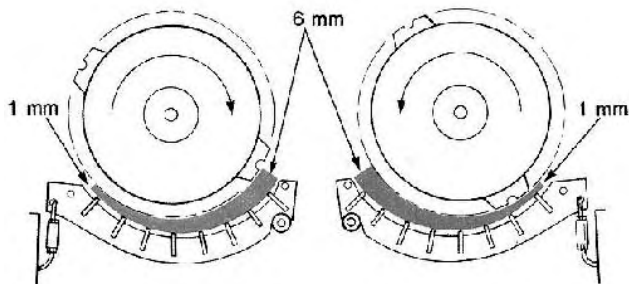
FIGURE 8. Initial Concave Settings used in Grain and Oilseeds.

Levelling and adjustment of initial concave clearance was very difficult, and was possible only after fabricating a suitable clearance gauge for use on the leading concave bars. It is recommended that the manufacturer supply suitable gauges and a more explicit concave levelling and initial adjustment procedure in the operator's manual. Suitable initial concave settings (FIGURE 8), with the operator station control lever in its first notch, were 6 mm (0.22 in) at the leading bars and 1 mm (0.04 in) at the trailing bars.

Once the concaves had been initially set, clearance was easily adjusted with a lever in the operator's cab. The control linkage held the leading and trailing concave bars parallel to the rotor axis, however the leading bars opened faster than the trailing bars. Leading bar clearances could be varied from 6 to 36 mm (0.24 to 1.42 in), while trailing bar clearances could be varied from 1 to 20 mm (0.04 to 0.79 in).

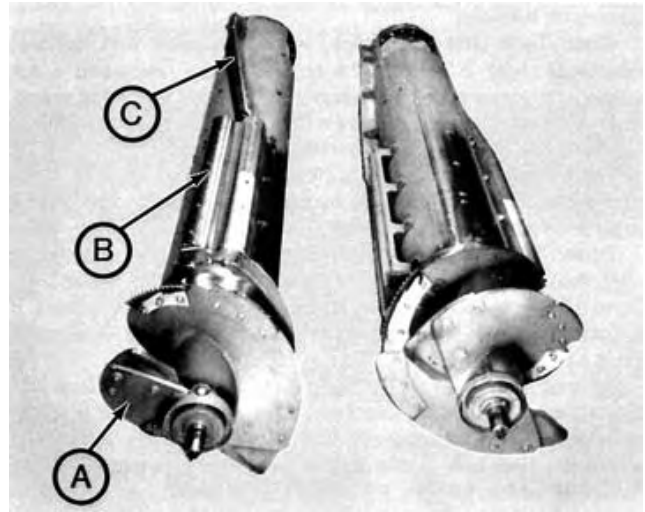
FIGURE 9. Rotors (A) Feed Augers (B) Rasp Bars (C) Separation Fins.

The rotor rasp bars were in good condition at the end of the test. Wear was greater than on conventional combines with tangential threshing cylinders.

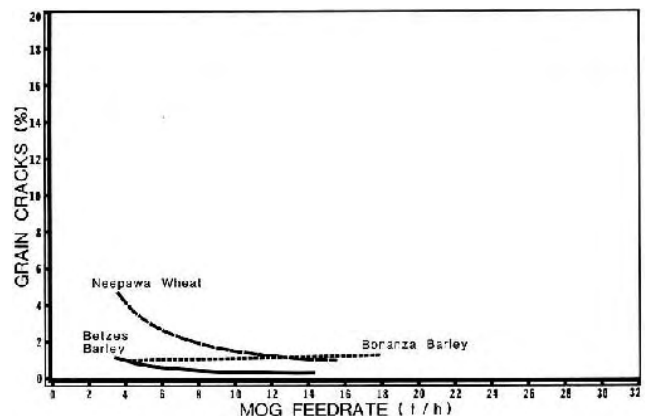
FIGURE 10. Grain Damage in Barley and Wheat.

Higher rotor speeds than indicated in the operator's manual could be used. Suitable rotor speeds were 1100 rpm in dry wheat, from 1200 to 1300 rpm in tough wheat, 1200 rpm in both tough and dry barley, 1000 rpm in dry rapeseed and 1100 rpm in tough rapeseed. Grain crackage varied from 0.3 to 1.5% in Betzes and Bonanza barley and from 0.8 to 4.7% in Neepawa wheat (FIGURE 10). In Tower rapeseed crackage was about 0.3%.

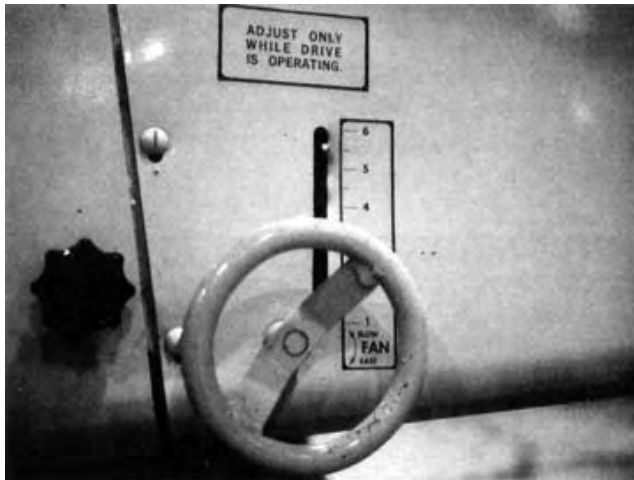
FIGURE 11. Fan Adjustments.

Shoe Adjustments: The shoe was convenient to adjust. Fan speed was varied with a hand wheel (FIGURE 11) while the chaffer, chaffer extension and clean grain sieves were adjusted with levers at the rear of the shoe. Access to the adjusting levers was through a door at the rear of the shoe. There was no provision to safely and conveniently sample tailings to aid in machine adjustment. Fan blast could also be directed with wind boards. Windboard position was

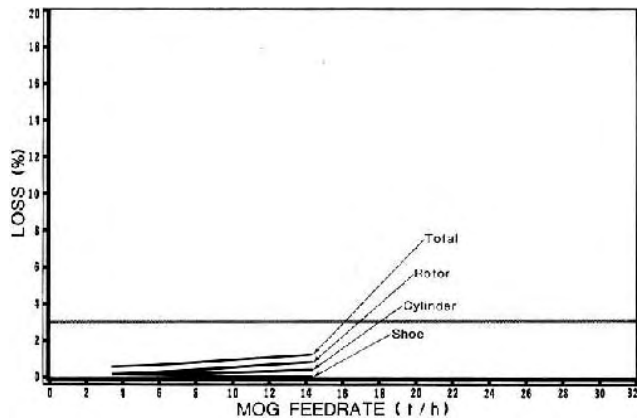
FIGURE 12. Grain Loss in Betzes Barley.

APPENDIX II REGRESSION EQUATIONS FOR CAPACITY RESULTS				
Regression equations, for the capacity results shown in FIGURES 12 to 15 are presented in TABLE 6. In the regressions, C = cylinder loss in percent of yield, S = shoe loss in percent of yield, R = rotor loss in percent of yield, F = the MOG feedrate in t/h, while \ln is the natural logarithm. Sample size refers to the number of loss collections. Limits of the regressions may be obtained from FIGURES 12 to 15 while crop conditions are presented in TABLE 4.				
TABLE 6. Regression Equations				
CROP — VARIETY	FIG. NO.	REGRESSION EQUATIONS	SIMPLE CORRELATION COEFFICIENT	SAMPLE SIZE
BARLEY — Betzes	12	$C = 0.12 + 0.02F$ $\ln S = 0.24 - 1.27 \ln F$ $R = -0.03 + 0.06F$	0.89 0.91 0.82	8
WHEAT — Neepawa	13	$C = 0.24 + 0.09F$ $\ln S = 1.43 - 1.48 \ln F$ $R = -0.22 + 0.09F$	0.87 0.84 0.82	9
BARLEY — Bonanza	14	$C = -0.20 + 0.05F$ $\ln S = -6.98 + 2.65 \ln F$ $\ln R = -5.02 + 1.79 \ln F$	0.95 0.91 0.97	7

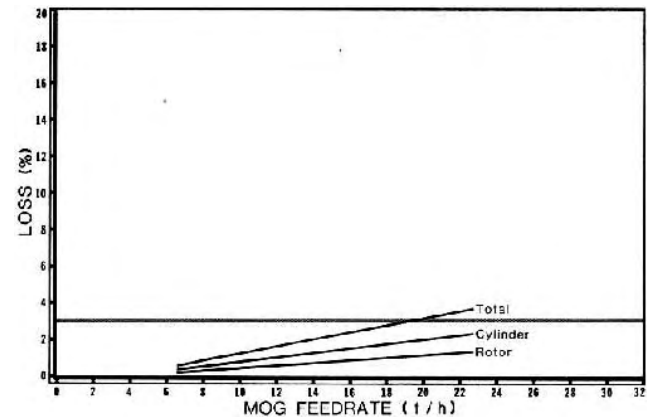
FIGURE 15. Grain Loss in Neepawa Wheat (Laboratory Run).

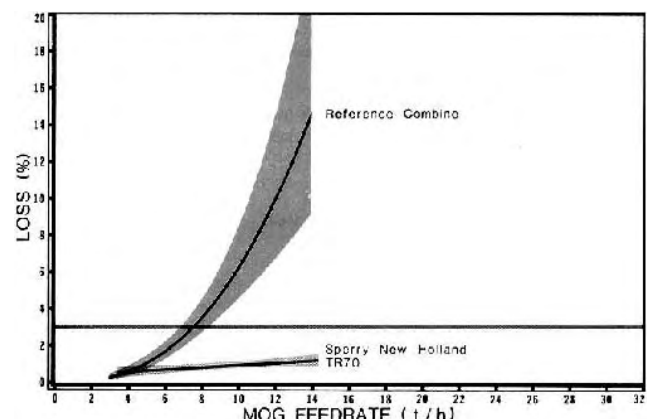
FIGURE 16. Total Grain Losses in Betzes Barley.

FIGURES 16 to 18 compare the total grain losses of the Sperry New Holland TR70 and the PAMI reference combine in three of the crops described in TABLE 4. The shaded areas on the figures are the 95% confidence belts. If the shaded areas overlap, the loss characteristics of the two combines are not significantly different whereas if the shaded areas do not overlap, the losses are significantly different. The capacity of the Sperry New Holland TR70 was much greater than the capacity of the reference combine and the Sperry New Holland TR70 had much lower grain losses than the reference combine when operating at the same feedrate.

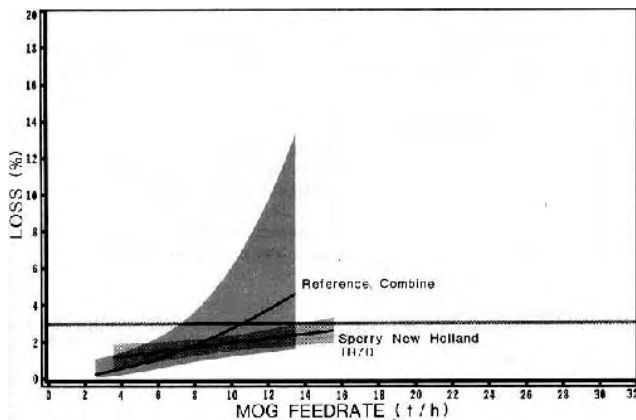
FIGURE 17. Total Grain Losses in Neepawa Wheat.

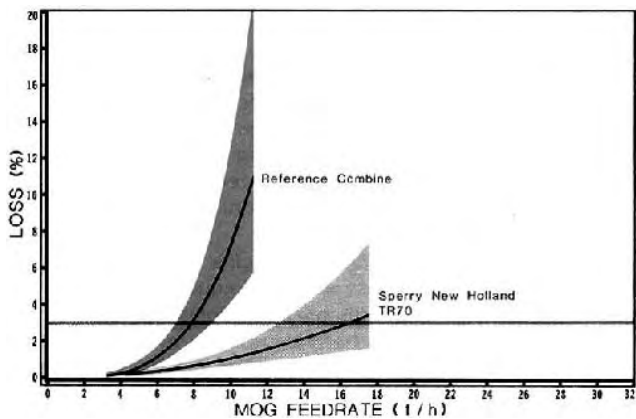
FIGURE 18. Total Grain Losses in Bonanza Barley.

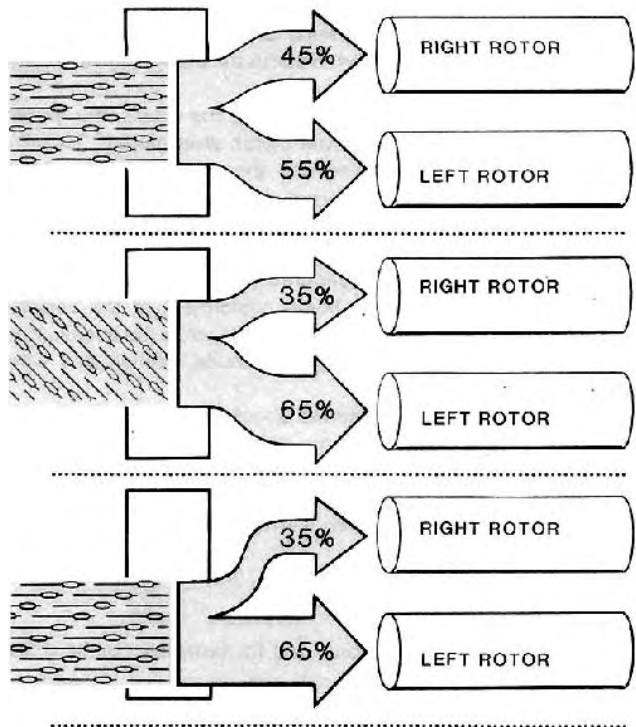
FIGURE 19. Crop Division to the Rotors with a Parallel Windrow Fed into the Centre of the Feeder (top), with an Angled Windrow Fed into the Centre of the Feeder (centre), and with a Parallel Windrow Fed 230 mm (9 in) to Left of Centre (bottom).

Laboratory studies were conducted to determine if equal crop division was occurring. Results are summarized in FIGURE 19. When parallel windrows were fed, centred on the feeder housing, nearly equal amounts of crop were fed to each rotor. When angled

windrows were fed, centred on the feeder housing, or when parallel windrows were fed to one side of the feeder housing, one rotor had to process considerably more crop than the other. As can be seen, driving only 230 mm (9 in) off the centre of the windrow forced one rotor to process two-thirds of the incoming crop.
