Evaluation Report

Case IH Self-Propelled Combine

CASE IH 1660 SELF-PROPELLED COMBINE

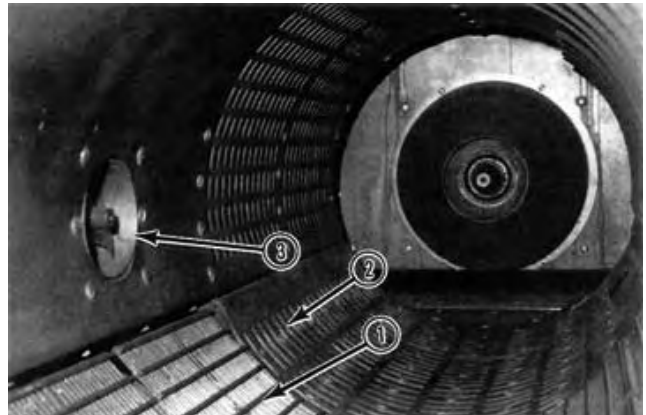
FIGURE 2. Rotor: (1) Intake Section, (2) Threshing Section, (3) Separating Section.
FIGURE 3. (1) Threshing Concaves, (2) Separating Concaves, (3) Tailings Return.

The Case IH 1660 is a self-propelled combine. It has a single longitudinally mounted rotor, threshing and separating concaves, discharge beater, and cleaning shoe. The rotor is a closed tube design with infeed fins, a combination of parallel and spiral rasp bars, and separating fins (FIGURE 2). The threshing concaves are bar and wire design. The separating grate is slotted, formed metal (FIGURE 3). The discharge beater is a wing type beater. The

Crop is fed to the rotor intake fins, which spiral the material into the rotor. Threshing begins upon first contact with the rotor and continues throughout the length of the threshing concaves. The angled rasp bar ribs and adjustable fins on the top of the rotor housing move the crop rearward. Separation starts at the threshing concaves and continues as the crop spirals over the separating grates. The winged discharge beater strips the processed crop away from the rotor and discharges it out the back of the combine. The material separated from the threshing and separating concaves is fed to the cleaning shoe by augers. Tailings are returned to the rotor above the third threshing concave (FIGURE 3).

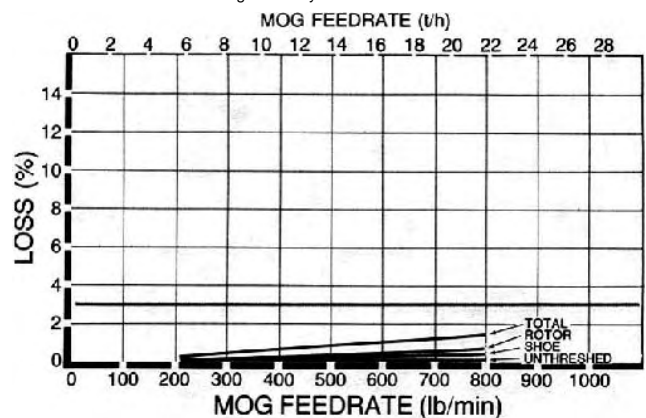
FIGURE 5. Grain Loss in Columbus Wheat.

The performance curves for the capacity tests are presented in FIGURES 4 to 6. The curves in each figure indicate the effect of increased feedrate on rotor loss, shoe loss, unthreshed loss, and total loss. From the graphs, combine capacity can also be determined for loss levels other than 3%.

Regression equations for the capacity results shown in FIGURES 4 to 6 are presented in TABLE 8. In the regressions, U = unthreshed loss in percent of yield, S = shoe loss in percent of yield, R = rotor loss in percent of yield, F = the MOG feedrate in lb/min, while \ln is the natural logarithm. Sample size refers to the number of loss collections. Limits of the regressions may be obtained from FIGURES 4 to 6 while crop conditions are presented in TABLE 3.

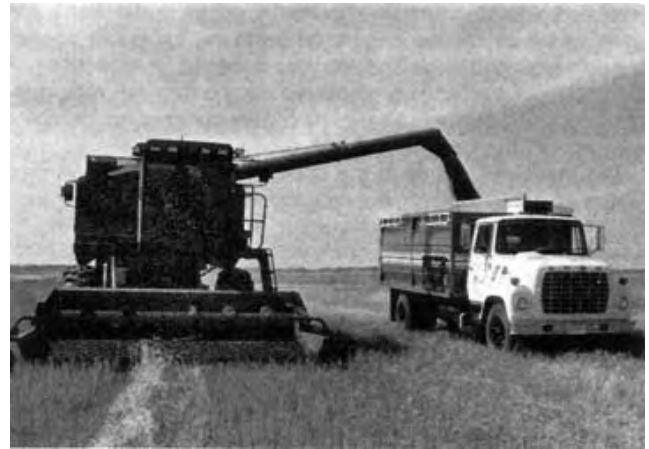
FIGURE 13. Unloading.

The open grain tank filled evenly in all crops, although the top corners usually did not fill completely. A full tank of dry wheat held about 175 bu (6.4 m³). No full bin sensors were provided and if overfilled, grain spilled over the front of the tank. It is recommended that the manufacturer consider supplying "full bin" warning sensors. The unloading auger was hydraulically positioned for unloading to the left. The hydraulic swing was useful for topping loads and unloading on-the-go. The unloading auger had ample reach and clearance for unloading into all trucks and trailers encountered (FIGURE 13). The auger discharged the grain in a compact stream and unloaded a full tank of dry wheat in about 110 seconds.

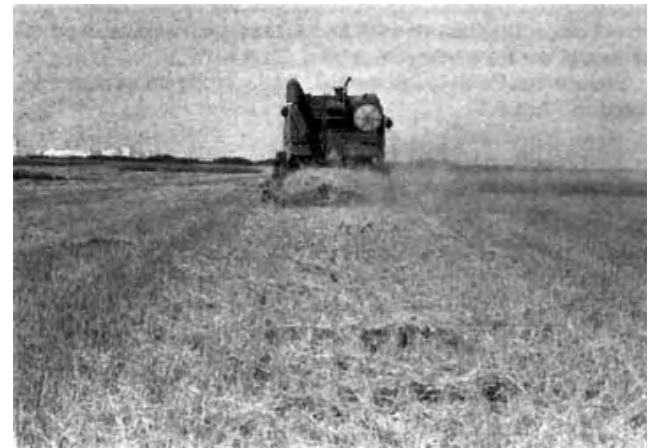
FIGURE 14. Straw Spreading.

In most conditions the straw from the rotor of the Case IH 1660 was severely broken and additional chopping was not required. The bat-type spreaders spread most of the straw evenly over about 12 to

15 ft (3.7 to 4.6 m) directly behind the combine (FIGURE 14). This was a narrow spread for the windrow width needed for this combine. It is recommended that the manufacturer consider modifications to improve straw spreading.

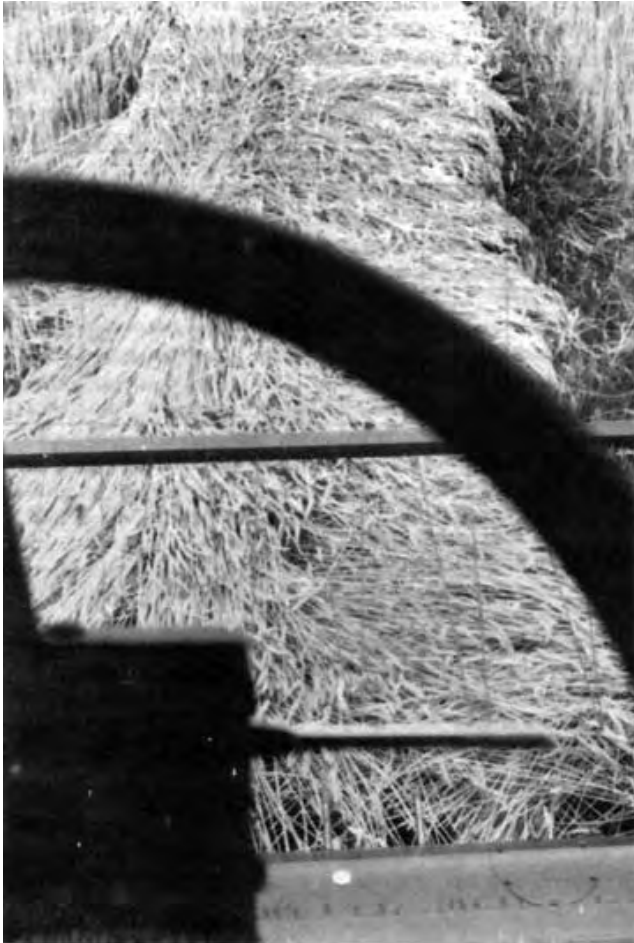
FIGURE 15. Operator's View of Incoming Windrow.

Ease of Operation and Adjustment: Operator comfort in the Case IH 1660 was very good. The cab was very quiet and relatively dust free. The heater and air conditioner provided comfortable cab temperatures. The seat and steering column could be adjusted to suit most operators. Visibility forward and to the sides was very good. Rear view mirrors provided good visibility to the rear. View of the incoming swath was partially blocked by the steering column.

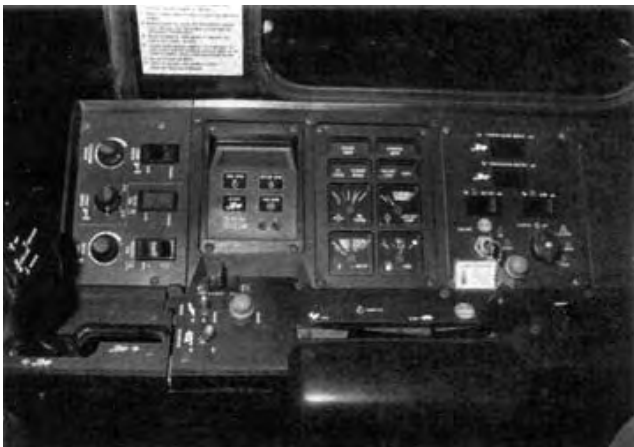
FIGURE 16. Instrument Panel to Right of Operator.

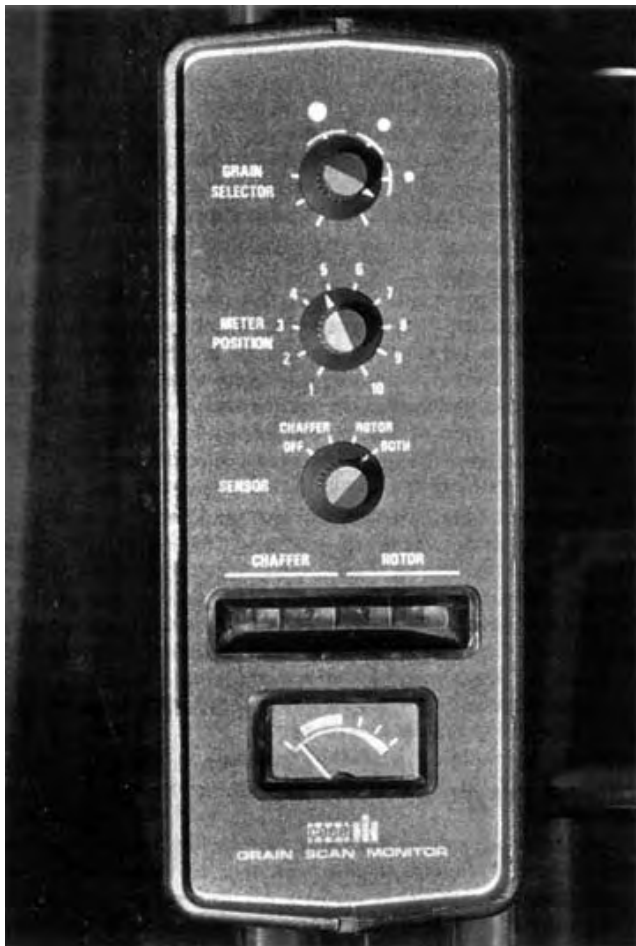
FIGURE 18. Grain Loss Monitor.

Two grain loss sensor pads were located at the rear of the rotor and two at the rear of the chaffer sieve. The meter display was located to the right of the operator on the cab corner post and was convenient to observe (FIGURE 18). The grain loss monitor contained four sensor lights above the meter that signalled which sensor(s) were being activated. These lights did not indicate the amount of loss. However, a meter was also provided to indicate a relative loss from the shoe, rotor or both. Grain loss readings were meaningful only if compared to actual losses observed behind the combine.

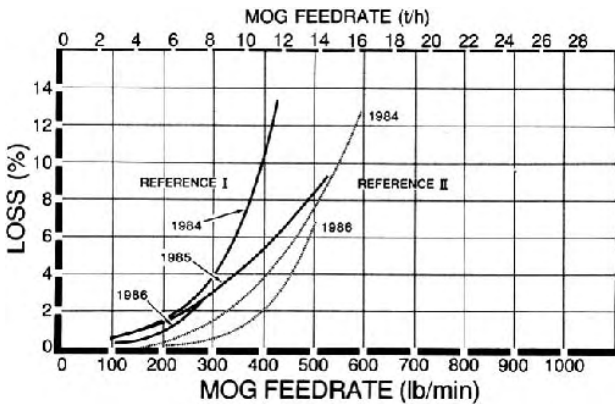
FIGURE 19. Total Grain Loss for the PAMI Reference Combines in Barley.

FIGURE 19 shows capacity differences in barley crops for 1984 and 1986. The 1986 Harrington barley crop shown in TABLE 7 had lower than average straw yield and slightly lower than average grain yield. It also had slightly below average straw and grain moisture.
