Evaluation Report

532

Versatile Trans-Axial 2000 Pull-Type Combine

VERSATILE TRANS-AXIAL 2000 PULL-TYPE COMBINE

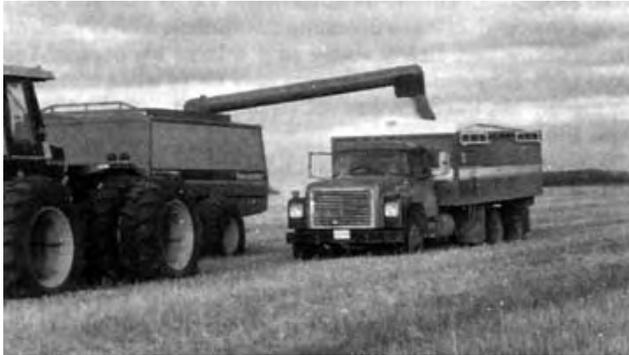
The unloading auger was hydraulically positioned to the left, rear or right. It had ample reach and clearance for all trucks and trailers encountered (FIGURE 9). The grain discharged in a compact stream, unloading a full tank of dry wheat in about 190 seconds. This was slow. When the unloading auger was shut off before it was empty, grain leaked from the end. In most crops the grain tank did not empty completely as grain bridged in the corners. It is recommended that the manufacturer consider modifications to ensure complete emptying of the grain tank.

FIGURE 9. Unloading.

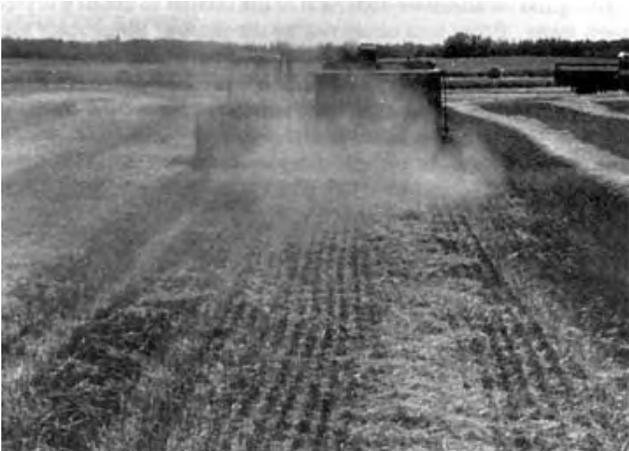
The straw spreaders spread the straw over about 20 ft (6.1 m) directly behind the combine. The spread was uneven with a ridge of straw formed in the centre (FIGURE 10). PAMI installed solid disks, just slightly smaller than the bat diameter, on the bottom of each spreader. This improved the spread and uniformity slightly, and also spread some of the chaff.

FIGURE 10. Typical Straw Spread Pattern.

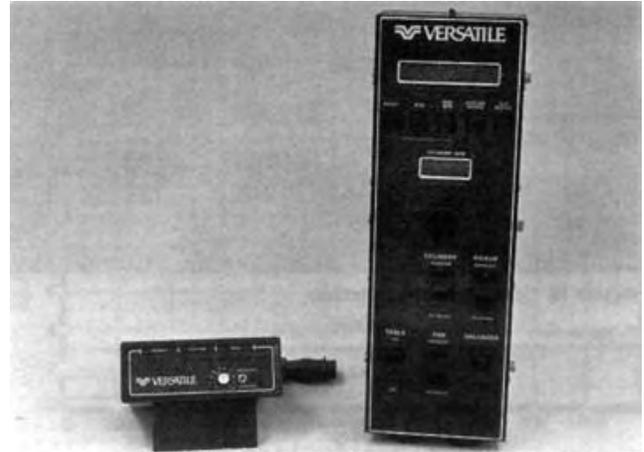
The instruments were located on a control box mounted in the cab (FIGURE 11). All important shaft speeds were monitored, as well as acres harvested, acres/hours harvested, and ground speed. These were displayed in metric or imperial units. The ability to display cylinder speed as well as ground speed or PTO speed was very convenient.

FIGURE 11. Combine Control Box and Grain Loss Monitor.

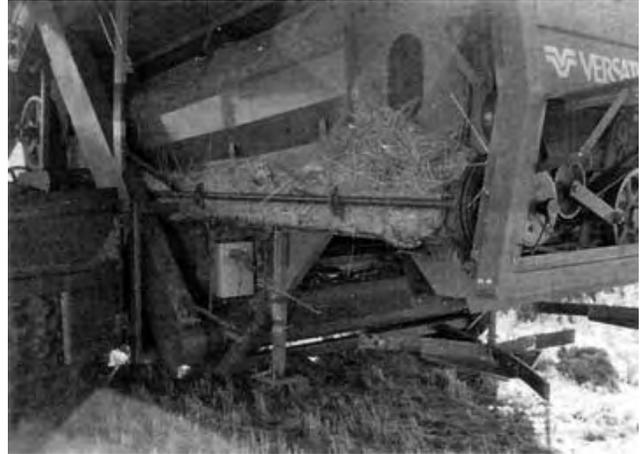
Even though many internal components were easily accessible, cleaning was time consuming. Crop material packed behind the cylinder strippers, above the cylinder housing and in a few other hard-to-clean places inside the combine. Not only was the material hard to clean but also it was a fire hazard. On one occasion material, which had packed around the right separator rotor intake caught on fire. The exterior of the combine had many ledges, which collected large amounts of crop material (FIGURE 13). These ledges were hard to clean. It is recommended that the manufacturer consider modifications to prevent chaff and debris from collecting in and on the combine.

FIGURE 13. Chaff and Straw Build-up on the Combine.
