# Evaluation Report

**White 8650 Pull - Type Combine**

# WHITE 8650 PULL-TYPE COMBINE

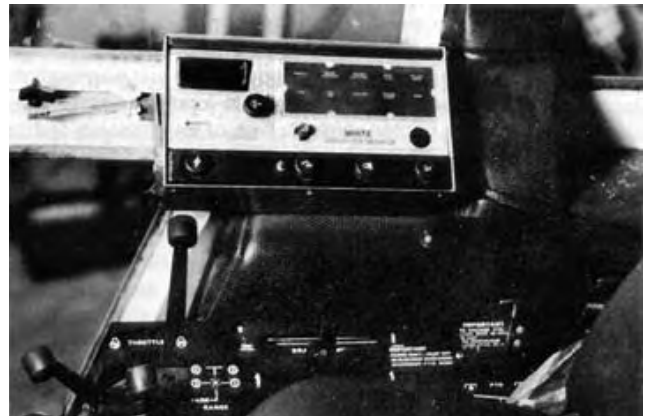
FIGURE 2. Harvester Monitor Installed in Tractor.

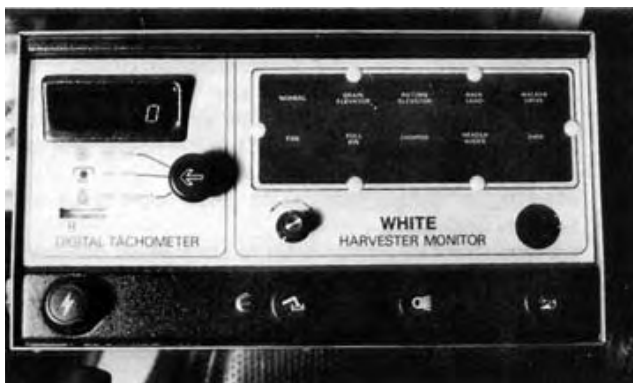
**Harvester Monitor:** The harvester monitor (FIGURE 4) contained nine channels for monitoring the header auger, cleaning shoe, cleaning fan, clean grain elevator, return elevator, straw walkers, straw chopper, rack load and grain bin level. In addition, the cylinder, cleaning fan or the power take-off speeds could alternately be read on a digital tachometer.

The harvester monitor was very useful in detecting component malfunction or imminent plugging. The digital tachometer allowed the operator to set the power take-off speed at 1000 rpm under load.

FIGURE 4. Harvester Monitor and Control Switches.

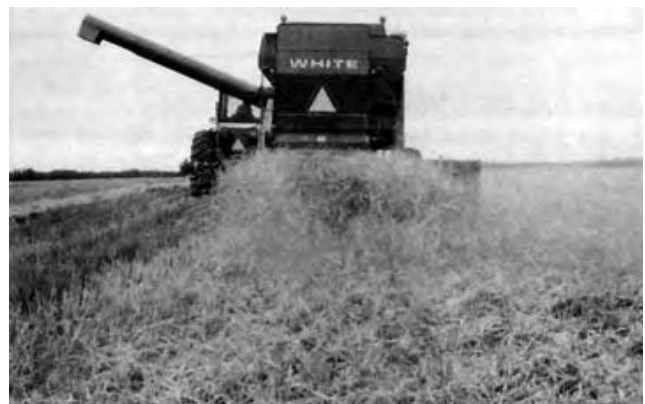
**Straw Chopper:** The optional straw chopper attachment performed well in all crops. Length of cut could be adjusted by varying the clearance between the rotor hammers and concave. Although the straw detectors were adjustable to control spreading width, maximum width was about 5 m (16 ft) and varied depending on the straw and wind conditions (FIGURE 5).

FIGURE 5. Spreading of Chopped Straw.

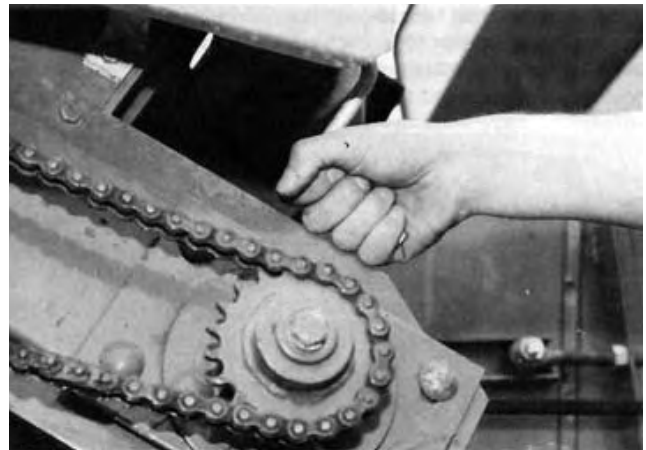
Pickup speed was controlled by a crank operated variable speed drive on the combine. Adjusting pickup speed was somewhat hazardous as the speed control crank had to be turned while the combine was running. The proximity of the crank to the pickup frame often caused skinned knuckles (FIGURE 7).

FIGURE 7. Pickup Drive Variable Speed Control.

It is recommended that the manufacturer modify the pickup variable speed control to widen the speed range and to permit safer adjustment. Consideration should also be given to providing an optional variable speed pickup drive, which is adjustable from the tractor seat.

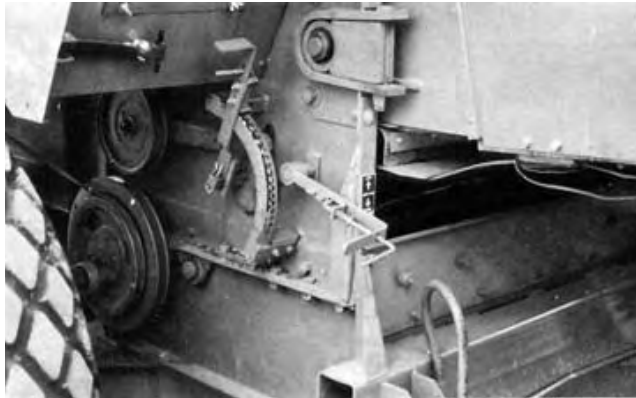
**Concave Adjustment:** The White 8650 had a single segment concave. The concave has to be initially levelled and adjusted with shims at the front and eyebolts at the rear. Front concave clearance may be gauged through the front cylinder access door while the rear may be gauged through inspection holes on both sides of the combine. It is recommended that the manufacturer consider providing front inspection holes to simplify initial concave adjustment.

FIGURE 8. Concave Adjustment.

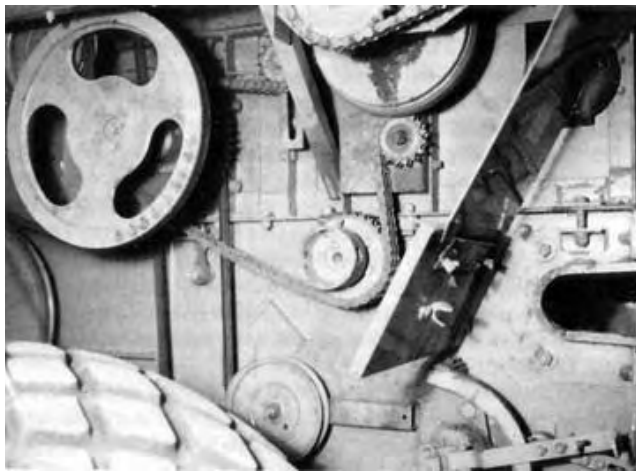
FIGURE 9. Cylinder Speed Adjustments.

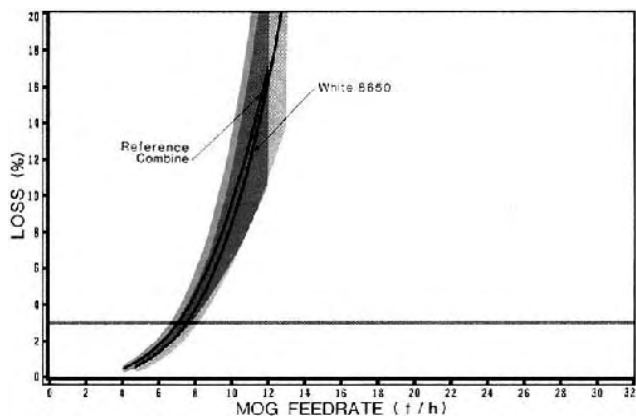
FIGURES 16 to 18 compare the total grain losses of the White 8650 and the PAMI reference combine in three of the crops described in TABLE 4. The shaded areas on the figures are 95% confidence belts. If the shaded areas overlap, the loss characteristics of the two combines are not significantly different whereas if the shaded areas do not overlap, the losses are significantly different. The capacity of the White 8650 was similar to the capacity of the reference combine and usually had similar grain losses when operating at the same feedrate.

FIGURE 16. Total Grain Losses in Betzes Barley.
