Evaluation Report

Don 1500 Self-Propelled Combine

DON 1500 SELF-PROPELLED COMBINE

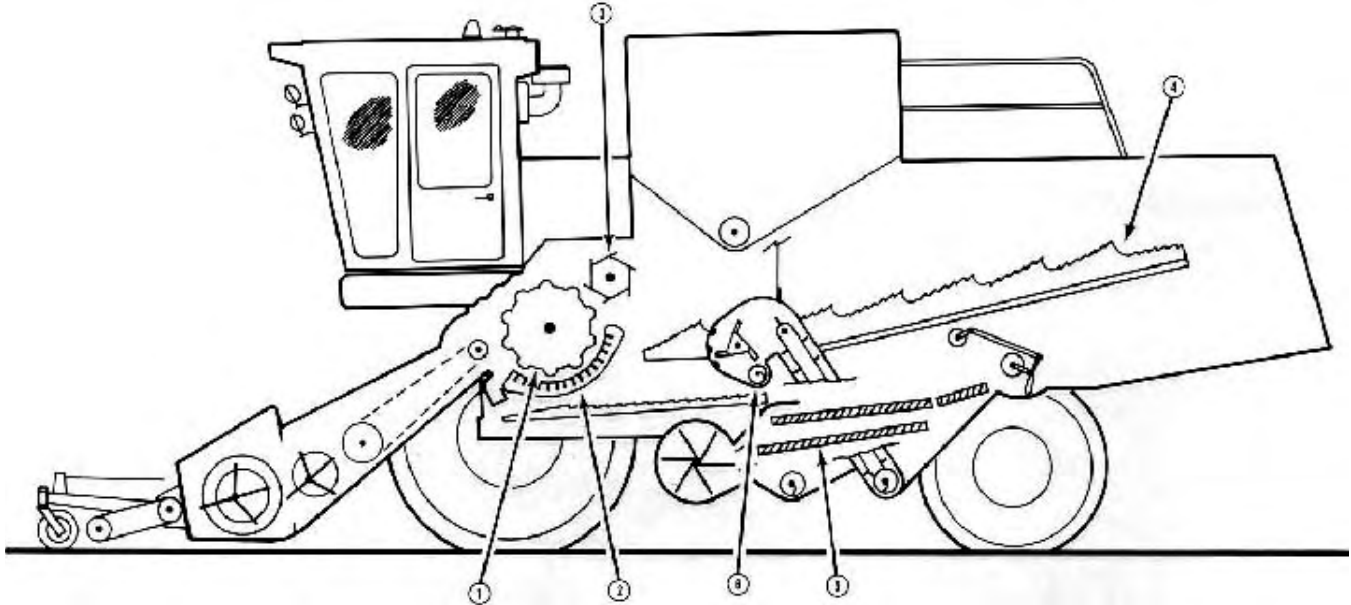
FIGURE 1. Don 1500: (1) Cylinder, (2) Concave, (3) Rear Beater, (4) Straw Walkers, (5) Cleaning Shoe, (6) Tailings Return.

The Don 1500 is a self-propelled combine. It has a single transverse mounted cylinder, concave, rear beater, straw walkers and a cleaning shoe. The open design cylinder has 10 rasp bars with the ribs on alternate bars having the opposite angle. A bar and wire concave is matched to the cylinder. There are four, stepped, closed bottom, straw walkers. The cleaning fan is a six blade paddle fan. The chaffer sieve and cleaning sieve are both adjustable lip sieves which move in opposed motion. The tailings sieve has adjustable slats and adjustable "saw tooth" louvers (FIGURE 2). The combine is equipped with an independent rethresher (FIGURE 3).

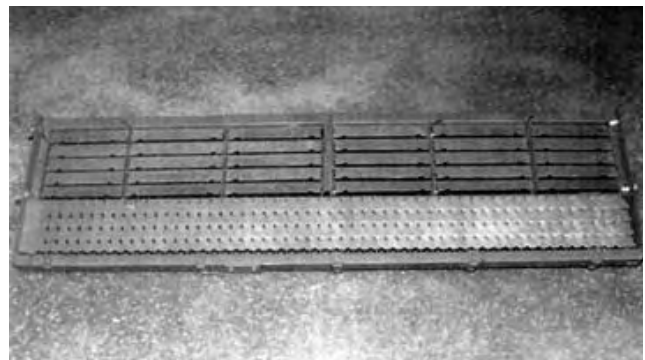
FIGURE 2. Tailings Sieves.

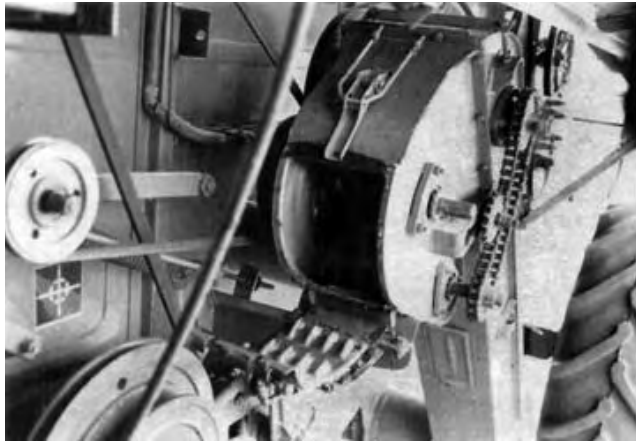
FIGURE 3. Rethresher.

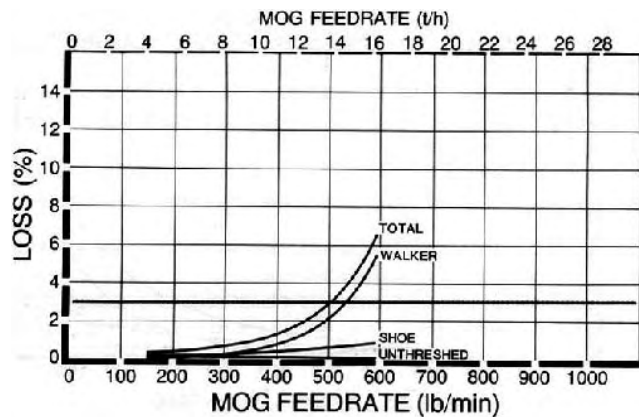
FIGURE 4. Grain Loss in Harrington Barley.

The performance curves for the capacity tests are presented in FIGURES 4 to 6. The curves in each figure indicate the effect of increased feedrate on walker loss, shoe loss, unthreshed loss and total loss. From the graphs, combine capacity can be determined for loss levels other than 3%. The rate at which loss changes with respect to feedrate shows where the combine can be operated effectively. Portions of loss curves, which are "flat" or slope gradually indicate stable performance. Where the curves hook upward sharply, small increases in feedrate cause loss to increase greatly. It would be difficult to operate in this range of feedrates without having widely varying loss.

The Harrington barley crop used for the test was from a uniform stand laid in a single well formed windrow. The windrow was nearly as wide as the feeder on the Don 1500. The crop was mature and both the straw and grain were very dry. The grain threshed easily and the awns broke off readily. The straw was long and break-up was average. The yield was a good average, but the long straw resulted in a high MOG/G ratio. The high MOG/G ratio meant that for a given MOG feedrate the accompanying grain feedrate was relatively low. Settings used were typical of those recommended by the manufacturer. In this barley crop at 3% total loss, the MOG feedrate was about 500 lb/min (13.6 t/h). The curves in FIGURE 4 show that loss was very Low up to MOG feedrates of about 350 to 400 lb/min (9.6 to 10.9 t/h). Loss increased rapidly above those feedrates. The main source of grain loss was over the straw walkers.

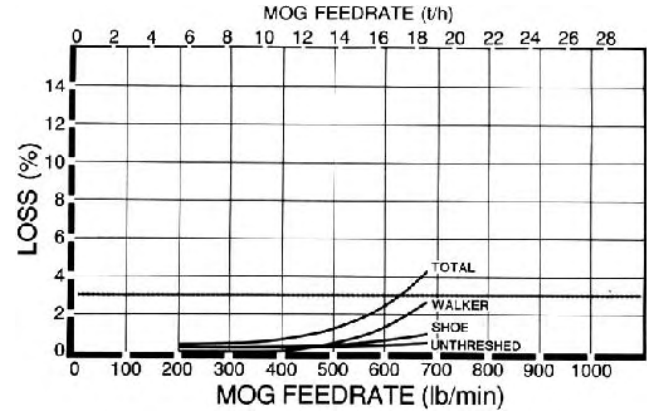
FIGURE 5. Grain Loss in Columbus Wheat.

At 3% total loss, the MOG feedrate in the Columbus wheat was about 625 Lb/min (17.1 t/h). The loss curves in FIGURE 5 show that total loss remained low up to MOG feedrates of about 500 to 550 Lb/min (13.6 to 15.0 t/h). Loss increased rapidly above those

feedrates. Capacity was limited by straw walker loss.

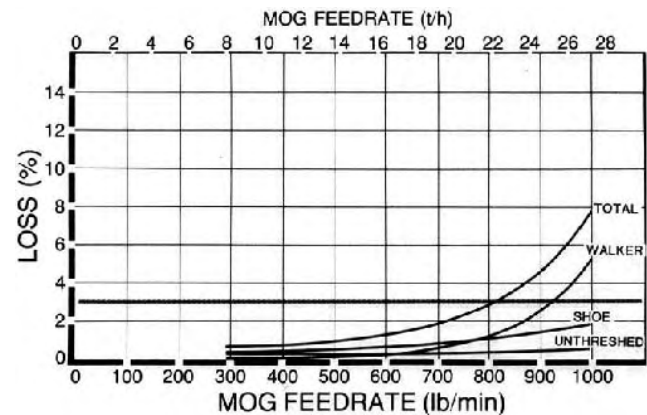
FIGURE 6. Grain Loss in Katepwa Wheat.

The MOG feedrate at 3% total loss reached 800 lb/min (21.8 t/h). FIGURE 6 shows that grain loss increased gradually over most of the feedrate range. At capacity, shoe and straw walker loss were equal.

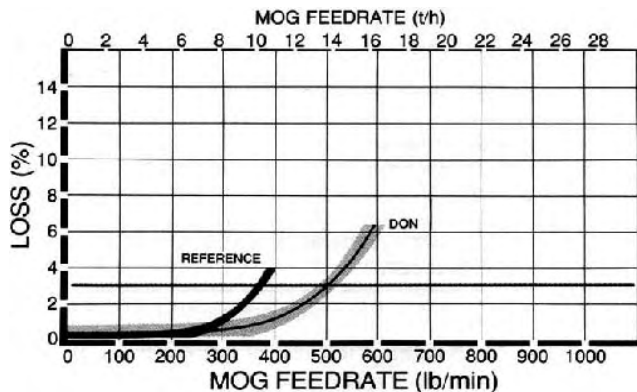
FIGURE 7. Total Grain Loss in Harrington Barley.

FIGURES 7 to 9 compare the total losses of the Don 1500 and the Reference II combine. The curves show that there was a significant difference between the combines at the 3% loss level. However, at Low loss the difference was much smaller.

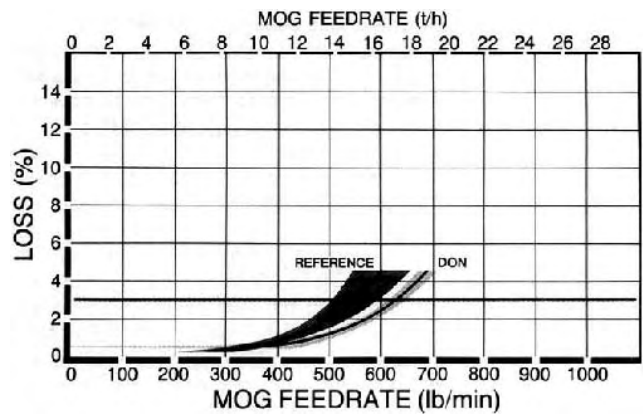
FIGURE 8. Total Grain Loss in Columbus Wheat.

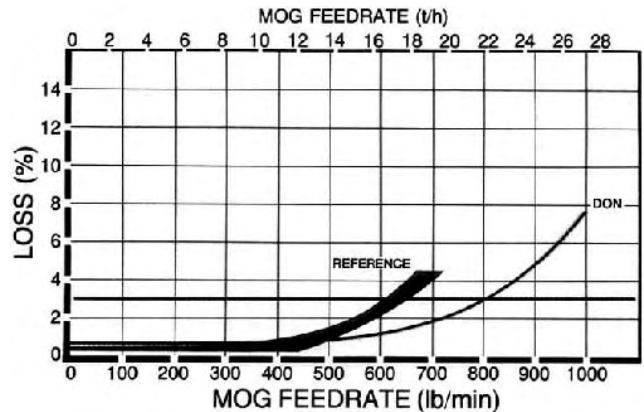
FIGURE 9. Total Grain Loss in Katepwa Wheat.

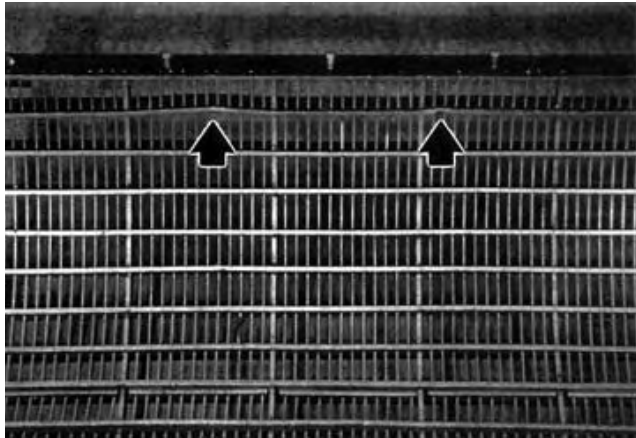
FIGURE 10. Concave Damage.

The stone trap, located in front of the concave, was effective in collecting most stones and roots, which were driven into the pocket upon contact with the cylinder. Objects up to 6 in (152 mm)

in diameter were emptied from the trap. Larger roots and stones stopped the feeder when they jammed under the secondary feeder drum. These objects broke one retractable finger and bent the feed assist plate on the secondary feeder drum. Both were minor damages and did not affect feeding. The feeder chain slats were not damaged. The stone trap was most effective if emptied regularly to prevent grain and dirt from hardening in the "trap". Some small stones did go through the combine. The cylinder was not seriously damaged. However, several concave wires were broken, bars scored and some of the bars were bent (FIGURE 10).

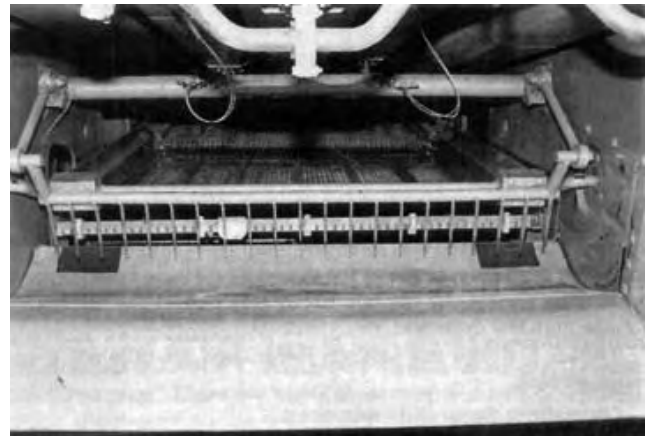
FIGURE 11. "Chaff Kicker".

Shoe loading uniformity was hard to determine because of the effects of the "chaff kicker" (FIGURE 11) located behind the chaffer. Material off the shoe built up on the trough until the rotating sweep "kicked" the chaff off in a bunch. Shoe loading could not be checked using the "kill stall" method since the separator could not be stopped quickly nor disengaged after the combine had been stopped.

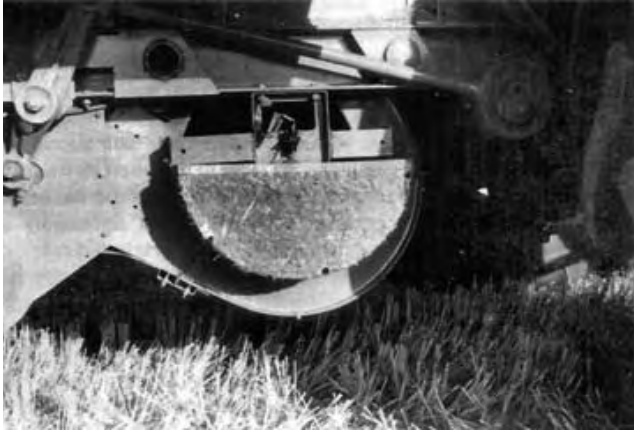
FIGURE 12. Chaff Blocking the Cleaning Fan Intake Screen.

to ensure cleaning sieve openings are uniform. In barley, foreign material was usually not a problem. However, when foreign material did become a problem, it was found that chaff had accumulated on the cleaning fan intake screen (FIGURE 12). Cleaning off the chaff improved the sample. Very dry straw, leaves in the stubble and thistles promoted the plugging.

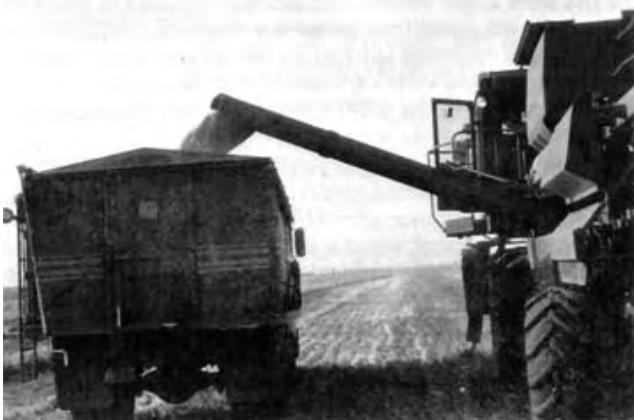
FIGURE 13. Marginal Unloading Auger Clearance.

The unloading auger clearance was marginal. The auger cleared most truck boxes (FIGURE 13), but did not have enough clearance to unload grain into the center of grain trailers. It is recommended that the manufacturer consider modifications to increase unloading auger clearance.

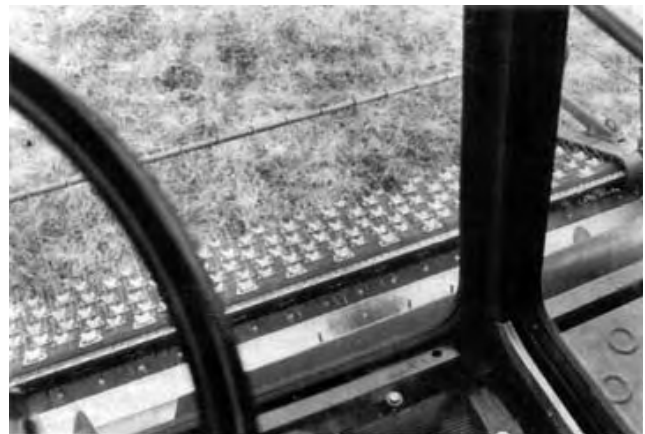
FIGURE 14. View of Header.

View of the incoming windrow was partially blocked by the steering wheel. To see the table auger, it was necessary to slide the seat forward and lean forward slightly (FIGURE 14). This was comfortable, but made access to some controls, especially the header height control lever, less convenient.

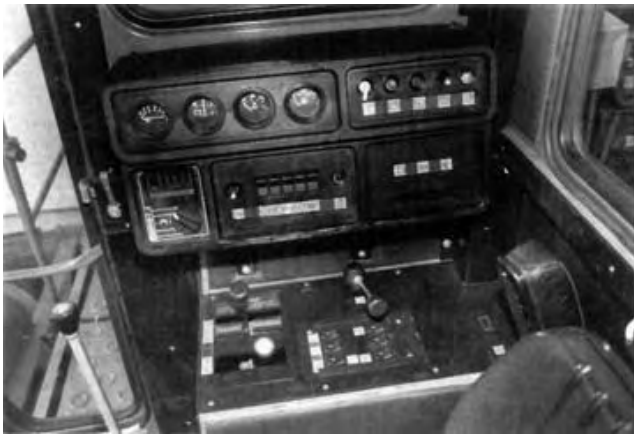
FIGURE 15. Instruments to Right of Operator.

The instruments were located to the right of the operator and on a ceiling console (FIGURES 15 and 16). The console to the right had gauges for engine oil pressure, battery charge, coolant temperature, hydrostatic oil temperature and fuel level. The coolant and hydrostatic oil temperature shared a common gauge with a switch to select the desired function. The console also contained a digital display. This display provided a selective readout for an electronics system check, ground speed, cylinder speed, fan speed and engine speed.

Most of these instruments worked well. However, the fuel gauge was inaccurate and the digital display could not be read in direct sunlight. As well, the oil pressure, engine coolant and hydrostatic oil temperature gauges did not have normal and/or dangerous operating ranges identified. It is recommended that the manufacturer consider modifications to improve fuel gauge accuracy, digital display visibility and identifying the normal operating ranges of the pressure and temperature gauges.

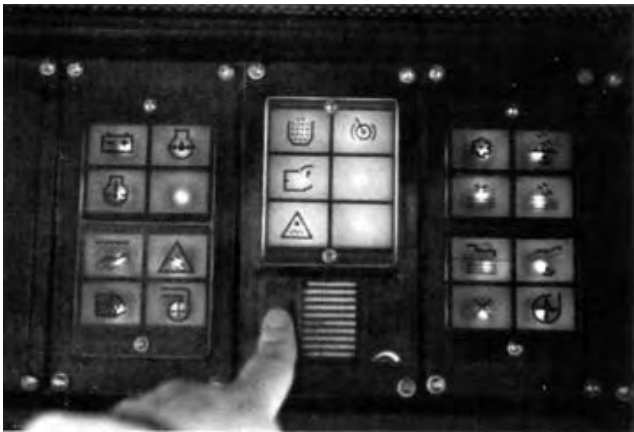
FIGURE 16. Warning Monitors in Ceiling Console.

The upper console had three sets of lighted warning symbols

(FIGURE 16) and an audible alarm. One set of warnings indicated power on, low engine oil pressure, excessive coolant temperature, straw walkers plugged and full scale grain loss monitor reading. The second set of indicators signalled a full grain bin, park brake engaged, and restricted flow in the hydraulic system. The third set of warning indicators were for speed reduction of the cylinder, grain pan, tailings auger, clean grain auger, straw walkers, and straw chopper.

The symbols were clearly visible and provided adequate warning for malfunction. The audible alarm was loud and annoying. The electrical system used a combination of 12 and 24 volt power supply. The starter and lights were powered by 24 volts, while the instrumentation operated on 12 volts.

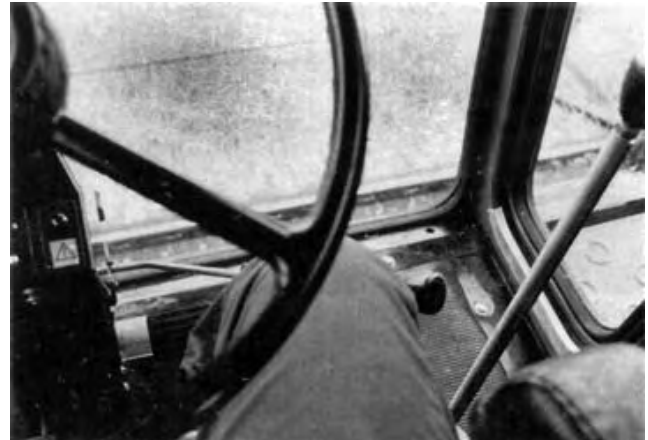
FIGURE 17. Interference Between the Hydrostatic Lever and the Operator's Knee.

The hydrostatic lever was inconveniently placed. When the seat was set back, the lever was difficult to reach. With the seat forward, when the hydrostatic lever was moved into reverse, it hit the operator's knee (FIGURE 17). The lever also flexed which caused poor control. As well, neutral was very hard to locate. It is recommended that the manufacturer consider modifications to improve the convenience and ease of operating the hydrostatic ground speed control lever.

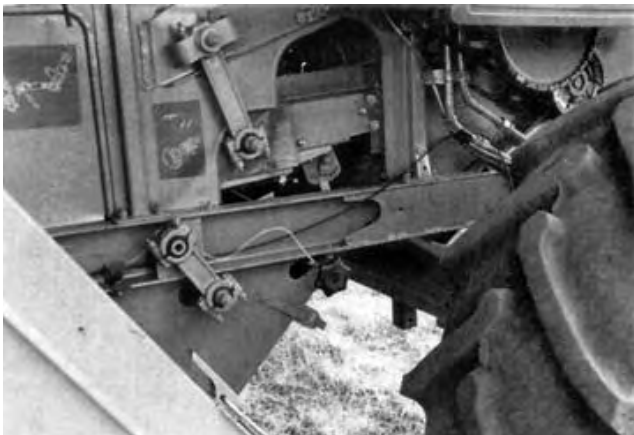
FIGURE 18. Sieve Adjustment.

The fan adjustment was located on the side of the combine behind the left front wheel. Fan adjustment was inconvenient since the fan speed display was in the cab. The sieves were adjusted from the side of the combine (FIGURE 18).

Removable panels along the side provided access for adjustment and viewing sieve opening. Caution was required so

as not to lose the wing nuts, which secured the access panels. A special wrench was provided for adjusting the cleaning sieve and chaffer sieve. The first section of the tailings chaffer was adjusted by an attached lever, which made adjustment quick and easy. The final section of the tailings chaffer required loosening a locking mechanism with a wrench and tapping the adjustment open or closed with a hammer. This adjustment procedure was time consuming and inconvenient.

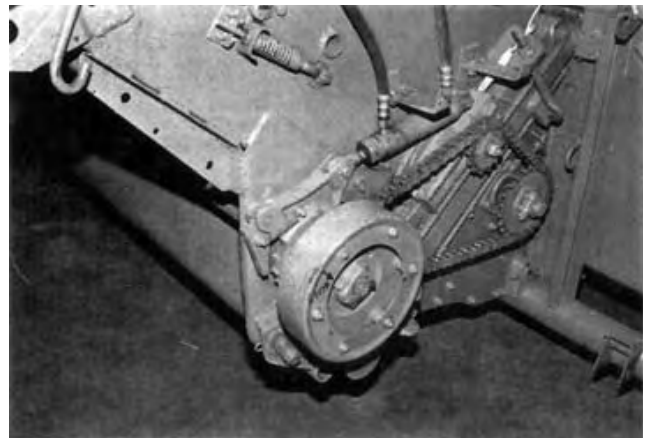
FIGURE 19. Header Reverser.

The feeder had a unique reverser. A hydraulic cylinder rotated a ratcheting drive (FIGURE 19). This mechanism could be activated either from the cab or the ground. The pickup drive had a clutch to prevent it from being reversed. The reverser backed out most obstructions. Twice, in very wet flax, the table auger plugged and would not reverse as the table auger clutch slipped.

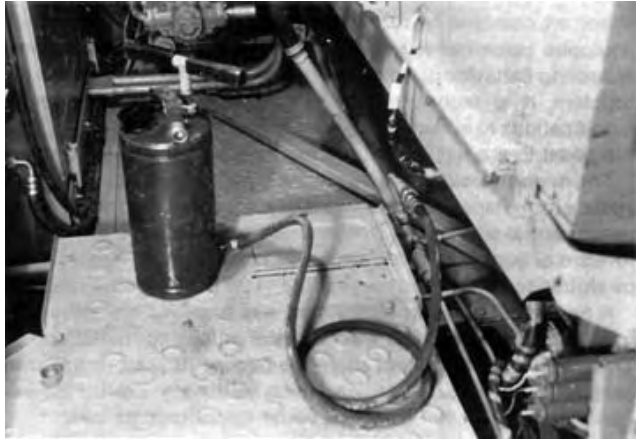
FIGURE 20. Pump for Adding Hydraulic and Hydrostatic Oil.

Engine, hydraulic and hydrostatic oil levels were accessible for easy checking. Adding hydraulic and hydrostatic oil required the use of a special pump which adapted to "tap in" fittings on the lines (FIGURE 20). Oil specifications were not available at the time of testing.

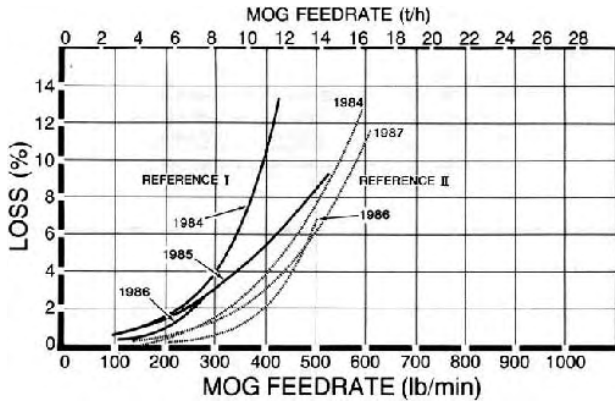
FIGURE 21. Total Grain Loss for the PAMI Reference Combines in Barley.

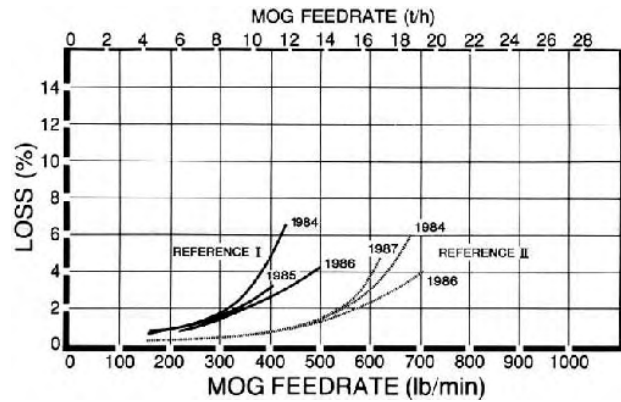
FIGURE 22. Total Grain Loss for the PAMI Reference Combines in Wheat.
