Evaluation Report

596

Cereal Implements 9850 Pull Type Combine- Series 64005

CEREAL IMPLEMENTS 9850 PULL-TYPE COMBINE - SERIES 64005

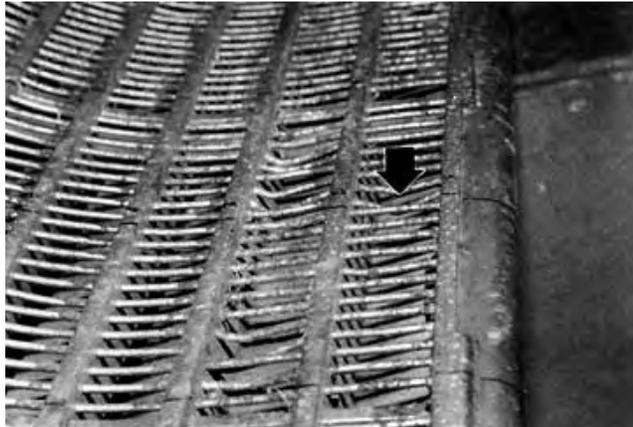
The stone trap, located directly in front of the concave, was effective, stopping most stones. Hard objects were driven into the pocket when contacted by the rasp bars. Objects up to 3 in (75 mm) in diameter were emptied from the trap. The stone trap was most effective if emptied regularly to prevent grain and dirt from hardening in the trap. Some small stones did go through the combine, and caused minor damage to some concave wires (FIGURE 10).

FIGURE 10. Concave Damage.

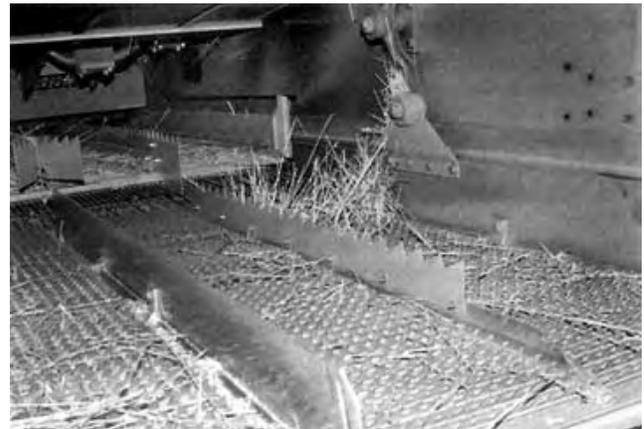
Straw tended to “spear” through the chaffer and cleaning sieves (FIGURE 11). A moderate amount of spearing had little effect on shoe loss but could eventually cause increased shoe loss. Although the unison movement of the chaffer and cleaning sieves may not

have been responsible for the “spearing”, it did not “work” the straws through. Slight reductions in chaffer sieve openings decreased “spearing” but also increased shoe loss.

FIGURE 11. Straw “Spearing” on Chaffer.

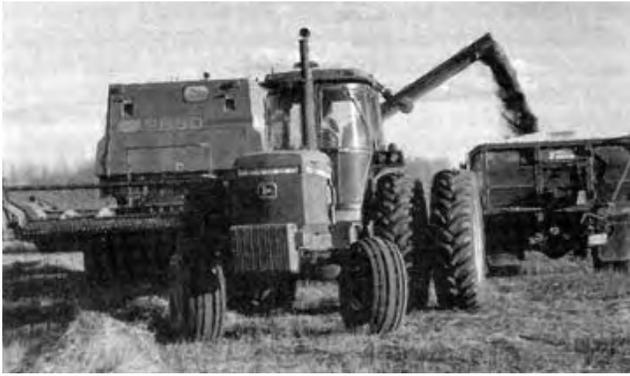
The auger discharged grain in a compact stream and unloaded a full tank of dry wheat in about 130 seconds. In windy conditions the unloading auger had to be swung back to reduce the discharge height to minimize grain loss.

FIGURE 12. Unloading.

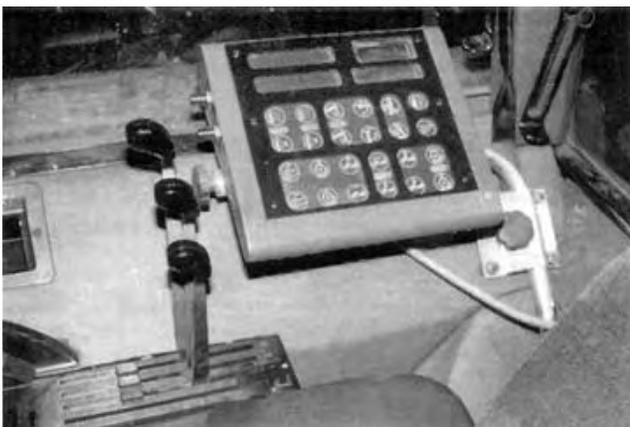
The most practical location for the control console was in the right rear corner of the tractor cab (FIGURE 13). Arm room was restricted for operating the controls and the operator had to sit in a turned position. This was awkward and made prolonged operation uncomfortable.

FIGURE 13. Control Console in Tractor Cab.

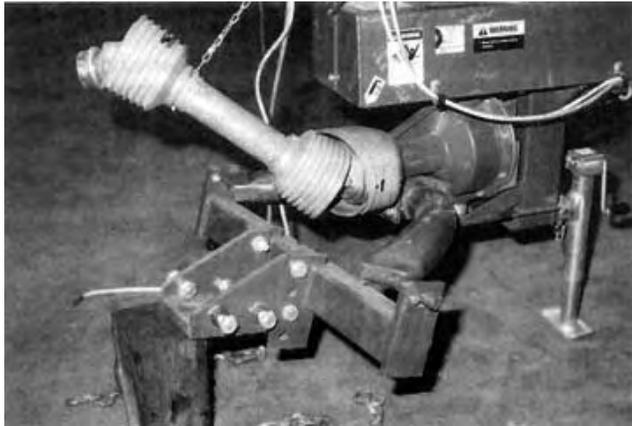
The unique hitch of the Cereal Implements 9850 (FIGURE 15) enabled very sharp cornering without PTO vibration.

FIGURE 15. Hitch and Drive.

This was possible since the PTO shaft remained in-line with the front gearbox even while turning. During the turn, the hitch pivoted about the vertical output shaft of the gearbox. Since the output of the gearbox was a belt drive the rotation had an insignificant effect.

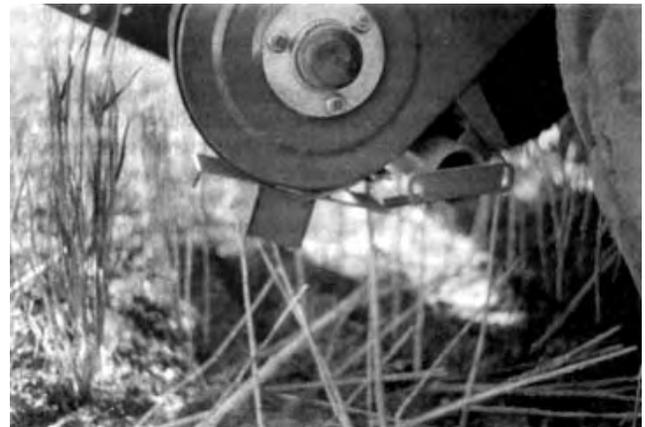
Returned tailings were easily and safely sampled (FIGURE 16) using the spring loaded chute at the bottom of the tailings elevator.

FIGURE 16. Tailings Sampling Chute.

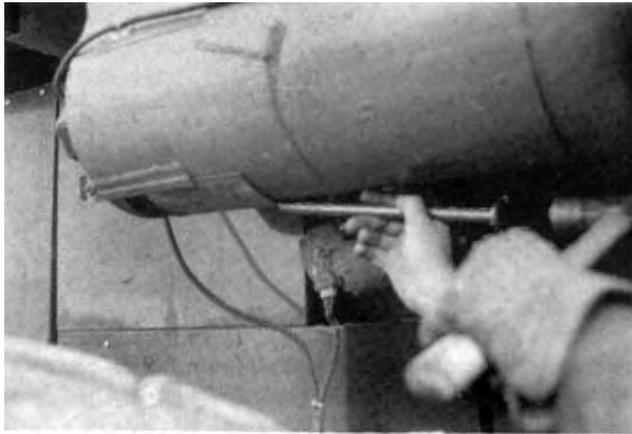
Machine Cleaning: Ease of complete cleaning was good. Cleaning the grain tank was easy, as there were few ledges to hold grain. The sump retained only about 2 quarts (2 L) of grain; however, removing the sliding sump cleanout door was difficult and required a hammer and drift (FIGURE 17). It is recommended that the manufacturer consider modifications to the grain tank sump door to enable easier more convenient opening.

FIGURE 17. Sliding Sump Door.
