Evaluation Report

600

Case IH 1682 Pull-Type Combine

CASE IH 1682 PULL-TYPE COMBINE

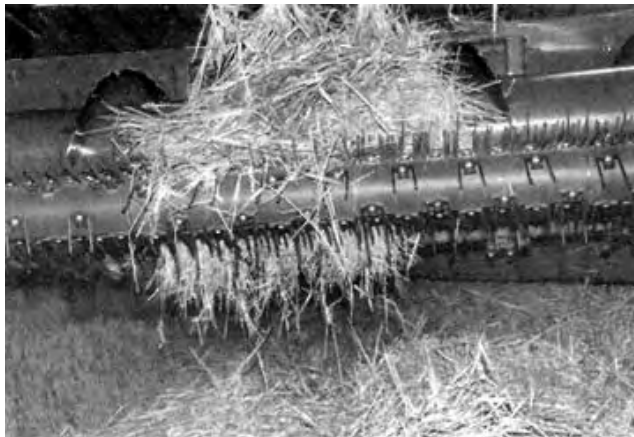
In short barley crops, plugging frequently occurred between the drapers and the pickup stripper (FIGURE 11). Increasing the pickup angle, which usually minimizes this problem on other pickups, had no effect on the Case IH pickup.

FIGURE 11. Plugging at the Pickup Stripper.

The problem may have been aggravated by improper positioning of the stripper during assembly. Later in the test, the assembly error was discovered and corrected. However, the problem conditions were no longer available, thus the extent of the assembly error for causing plugging was not determined.

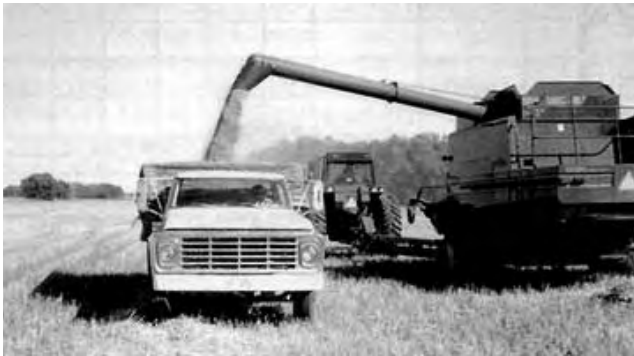
The unloading auger had ample reach and clearance for all trucks encountered (FIGURE 13). The unloading auger was hydraulically positioned for unloading to the left. The optional longer unloading auger enabled the tractor to drive past a stationary truck or trailer while still having adequate reach for convenient unloading. The longer auger and hydraulic auger swing also aided topping loads and unloading on-the-go. The auger discharged the grain in a compact stream, unloading a full tank of dry wheat in about 135 seconds. The high discharge with the optional long unloading auger fully extended, resulted in some grain scattering and loss in moderate winds.

FIGURE 13. Unloading.

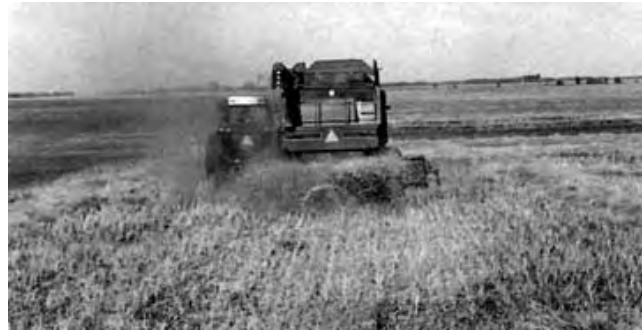
In most conditions, most of the straw from the rotor entered the right side of the discharge chopper and in turn was fed to the right spreader. This resulted in a heavier concentration of straw to the right. The bat-type spreaders typically spread the straw about 15 to 20 ft (4.6 to 6.1 m) (FIGURE 14). The spread was narrow compared to the width of cut, which was suitable for this combine. It is recommended that the manufacturer consider modifications to improve straw spreading.

FIGURE 14. Straw Spreading.

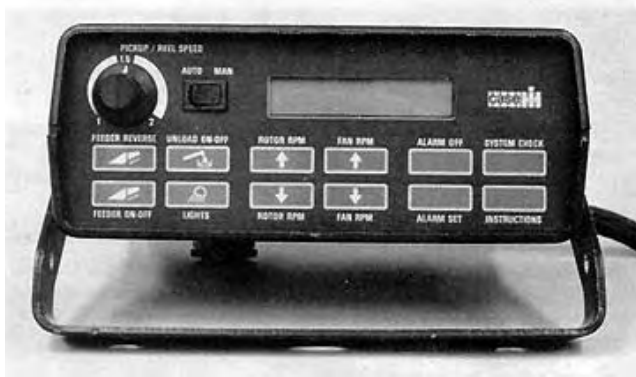
The instruments were located in the control console (FIGURE 15). A single digital display was used to selectively show rotor speed or fan speed. It also showed speed slowdown of selected shafts, and the status of certain harvesting functions. The display also presented operating instructions when the operator selected the "instructions" mode. Although only one item could be displayed at one time, the display would switch automatically to the appropriate component function if a failure occurred. An audible alarm also signalled a shaft speed slowdown and the rotor and fan speed alarm set points were adjustable. The instruments also had a self-diagnostic function that signalled a failure in the combine sensing or control circuits.

The switches in the console controlled the header and unloading auger clutches, rotor speed, fan speed, and feeder reverser. A rocker switch selected either automatic or manual pickup speed control, while a dial regulated the pickup speed in the manual mode and pickup speed to ground speed ratio in the automatic mode. Most of the switches were incorporated into the touch sensitive membrane keypad. Although these type of switches are often difficult to use

while harvesting since they require precise finger placement and provide no indication that contact has been made, this was not the case on this unit. The switches on the console were large and easy to use, and “beeped” each time they were activated, to signal contact. This made console control convenient, while the tractor hydraulics provided familiar control of the other functions.

FIGURE 15. Control Console.

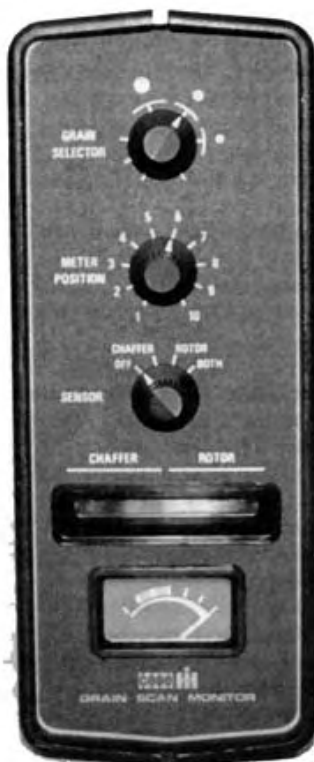
Two grain loss sensor pads were located at the rear of the rotor and two at the rear of the chaffer sieve. The monitor console was mounted separately from the control console for convenient viewing (FIGURE 16). A meter display on the monitor console indicated loss from the cleaning shoe, the rotor, or both, relative to acceptable loss observed behind the combine. The monitor console also contained four indicator lights that respectively signalled which sensor pads were being activated, but these lights did not indicate the amount of loss.

FIGURE 16. Loss Monitor Console.

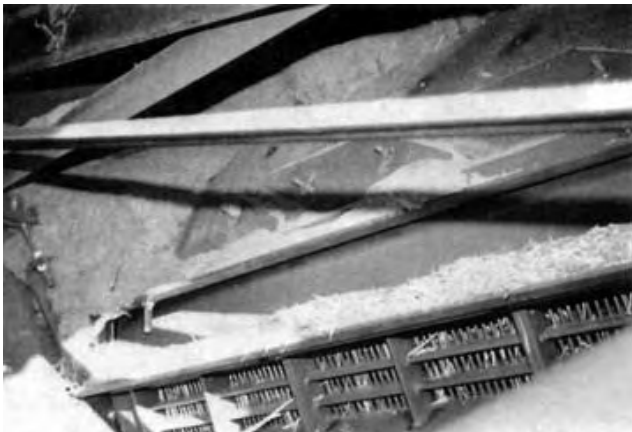
The sieves were easy to remove and provided access to the lower tailings and clean grain auger troughs. The shoe supply auger troughs were accessible from the sides and could be cleaned with a vacuum cleaner. Chaff and dust that built up on top of the rotor cage was difficult to remove (FIGURE 18). The outside of the combine collected large amounts of chaff, particularly on the rear deck, and although the chaff was easily removed, the task was usually very dirty.

FIGURE 18. Chaff Accumulation Above Rotor Cage.

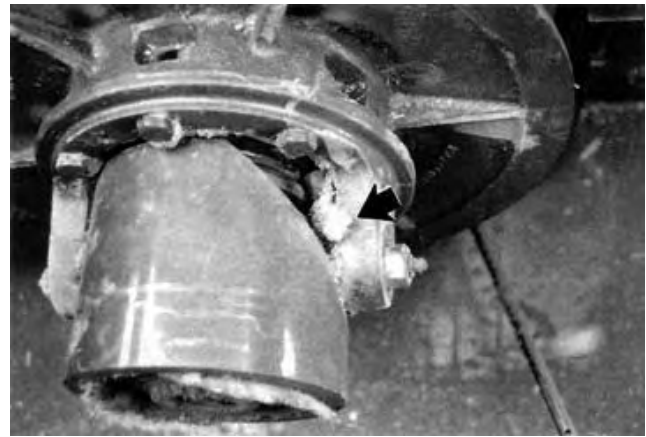
Rotor Drive: On numerous occasions during the test, the rotor drive belt slipped under moderate load. The driven sheave assembly incorporated a torque sensing mechanism that was intended to respond to increased load by increasing the sheave pitch diameter, thus tightening the drive belt. During normal combine operation, however, this torque sensing mechanism was exposed to chaff, dirt, and debris (FIGURE 20). This may have caused binding of the mechanical components in the sheave assembly, and prevented proper drive belt tensioning under increased load.

When rotor drive slippage occurred, cycling the rotor speed through its full adjustment range displaced the dirt in the cam assembly and freed the components. The drive then worked well for a short time but the problem soon recurred. Similarly, the drive

worked well for a short time after it had been disassembled and cleaned.

FIGURE 20. Debris in Torque-Sensing Hub.

Lubrication of the torque sensing hub was to manufacturer's specifications. Several parts of the assembly were inspected and replaced under the manufacturer's direction, but the problem was not rectified.
