Evaluation Report

622

Massey Ferguson 8560 Self-Propelled Combine

MASSEY FERGUSON 8560 SELF-PROPELLED COMBINE

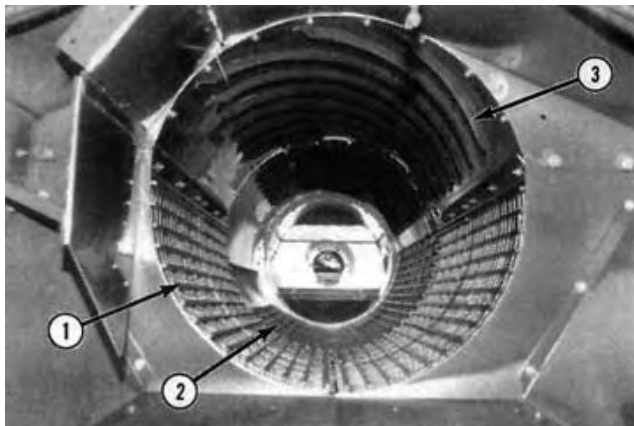
FIGURE 3. Rotor Housing: (1) Threshing Concaves, (2) Separating Concaves, (3) Vanes.

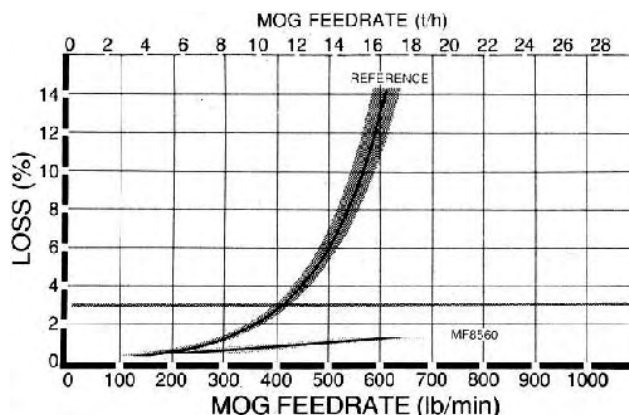
Capacity Compared to Reference Combine: The capacity of the Massey 8560 was greater than that of the PAMI Reference II combine in both wheat and barley. In all crops, the capacity of the test combine was limited by engine power and did not reach 3% loss. When compared to the Reference II at 3% loss, the capacity of the Massey 8560 was 1.6 and 2.4 times the Reference II's capacity in Argyle and Harrington barley respectively, and 1.0 to 1.4 times its capacity in Katepwa wheat. FIGURES 9 to 13 compare the total losses of both combines.

FIGURE 9. Total Grain Loss in Argyle Barley.

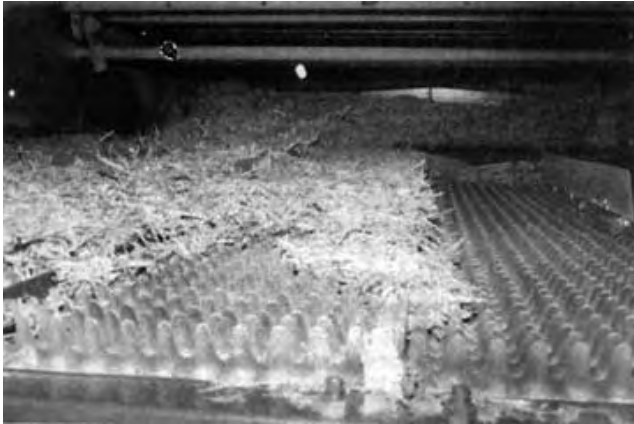
Material from the rotor often loaded the shoe unevenly. Chaff loads were usually heavier along the left side (FIGURE 14). Under most conditions this uneven loading had no apparent detrimental effect on shoe performance. Only in very dry conditions with high straw break-up did shoe load become heavy enough to occasionally overload part of the chaffer and cause grain to slough over. The concave deflector adjustment helped distribute the chaff load more evenly. However, in the severe conditions, reducing threshing aggressiveness, increasing fan speed or reducing feedrate was also required to compensate for the heavy, uneven loading.

FIGURE 14. Uneven Shoe Loading.

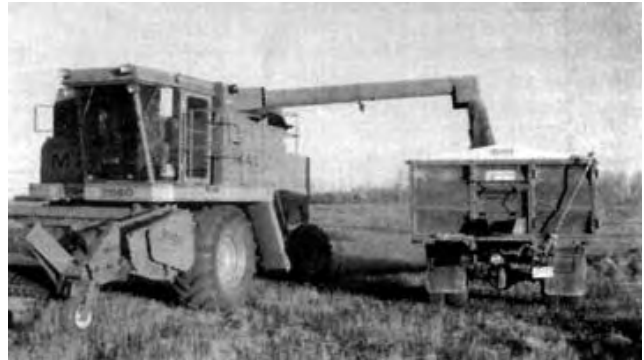
The unloading auger was electro-hydraulically positioned for unloading to the left. This enabled easy topping of loads and unloading on-the-go. The unloading auger had ample reach and clearance for unloading into all trucks and trailers encountered (FIGURE 16). The auger discharged grain in a compact stream and unloaded a full tank of dry wheat in 116 seconds. Grain spillage out of the auger when swung back was stopped by an optional "spill saver" mounted at the outlet.

FIGURE 16. Unloading.

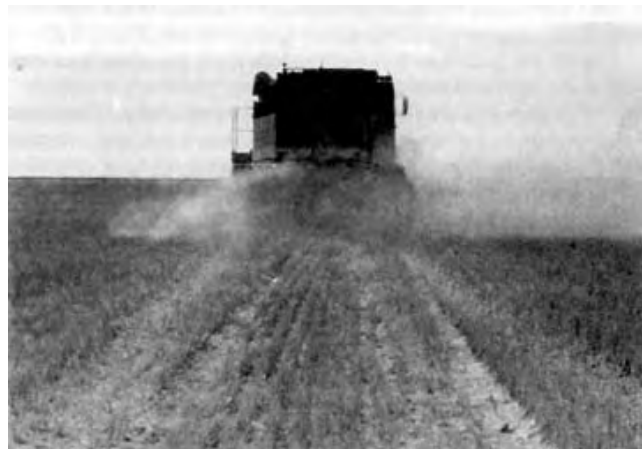
In most conditions, most of the straw from the rotor entered the left side of the straw chopper, resulting in a heavier discharge of straw to the left (FIGURE 17). Adjusting the rotor discharge deflector did not change the distribution appreciably. The straw chopper spread most of the straw over 15 to 20 ft (4.6 to 6.1 m), which was narrow for the width of cut most suitable for this combine. The chaff was not spread with the straw.

FIGURE 17. Uneven Straw Chopper Discharge.

A provision was made for conversion of the straw chopper to drop straw, but it was not very convenient. Several bolts had to be removed and the chopper tailplate had to be pivoted 90° to provide clearance for swing-away of the chopper. The opening for straw discharge was small and impeded free material flow. It is recommended that the manufacturer consider modifications to the straw chopper mounting system to allow simpler conversion for windrowing straw and to provide a larger opening for straw discharge.

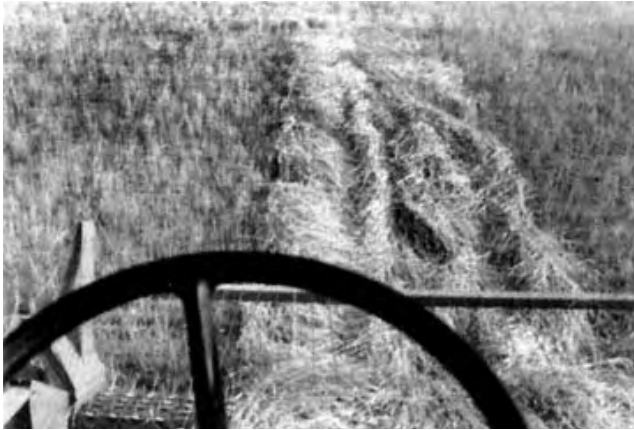
The operator had a clear view forward and to the sides. The rear view mirrors provided rear visibility. View of the incoming swath was slightly obstructed by the steering wheel (FIGURE 18). Visibility of the grain coming into the tank was restricted by the grain tank screen and completely blocked as the tank became nearly full. The unloading auger was visible when swung fully forward but the operator had to lean forward to see the auger if it was swung back slightly.

FIGURE 18. View of incoming Windrow.

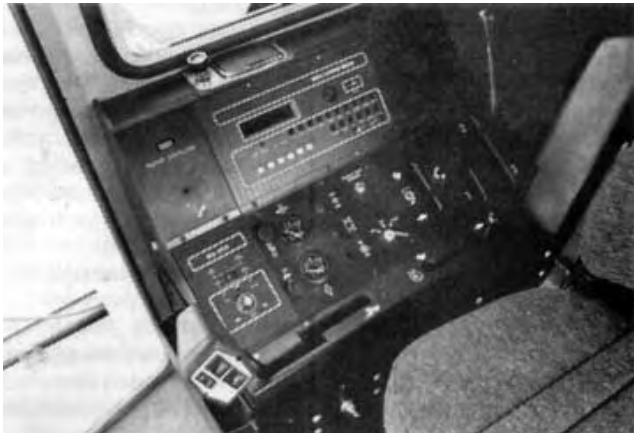
The instruments were located on a console to the right of the operator (FIGURE 19). The console contained gauges, warning lights, and a digital display. The gauges indicated engine hours, oil pressure, and coolant temperature, while the warning lights and an audible alarm indicated low fuel level, reduced battery voltage, excessive coolant temperature, low engine oil pressure, low coolant level, air filter restriction, parking brake engagement, full grain tank, and speed reduction of major drives. The digital display selectively indicated engine, ground, rotor, and cleaning fan speeds, remaining fuel and battery voltage. A separate warning light indicated overload of the hydrostatic rotor drive.

FIGURE 19. instrument Console.

Most of the controls were located to the right of the operator (FIGURE 19). The unloading auger engagement lever was on the left, and the lights and cab climate controls were situated overhead (FIGURE 20). Most of the controls were conveniently placed and easy to use.

The "rotor overload" light was effective at night as the light was easy to see and caught the operator's attention. However, during the day the light was often too dim to effectively alert the operator, and no audible alarm was provided. It is recommended that the manufacturer consider modifications to the rotor overload indicator to make it more noticeable during daylight operation.

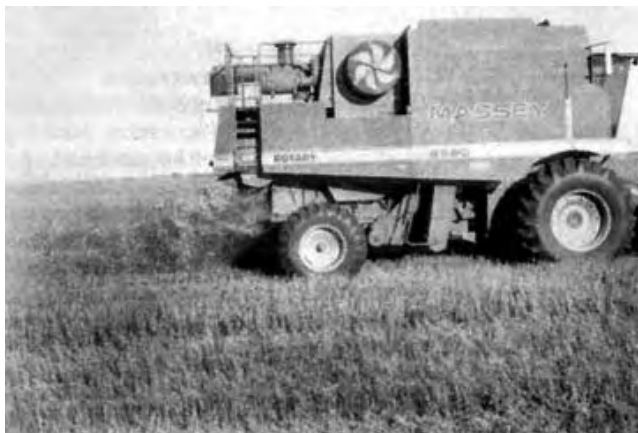
FIGURE 21. Shoe Discharge.

The discharge area of the shoe was relatively unobstructed and was convenient for catching a sample. The grain tank was difficult

to access from the operator's station to get a clean grain sample. It is recommended that the manufacturer consider modifications to improve grain tank access from the operator's station. No provision was made for sampling the return tailings. It is recommended that the manufacturer consider modifications to permit safe, convenient sampling of the rerun tailings while harvesting.
