Evaluation Report

629

Case IH 1680 Self-Propelled Combine

CASE IH 1680 SELF-PROPELLED COMBINE

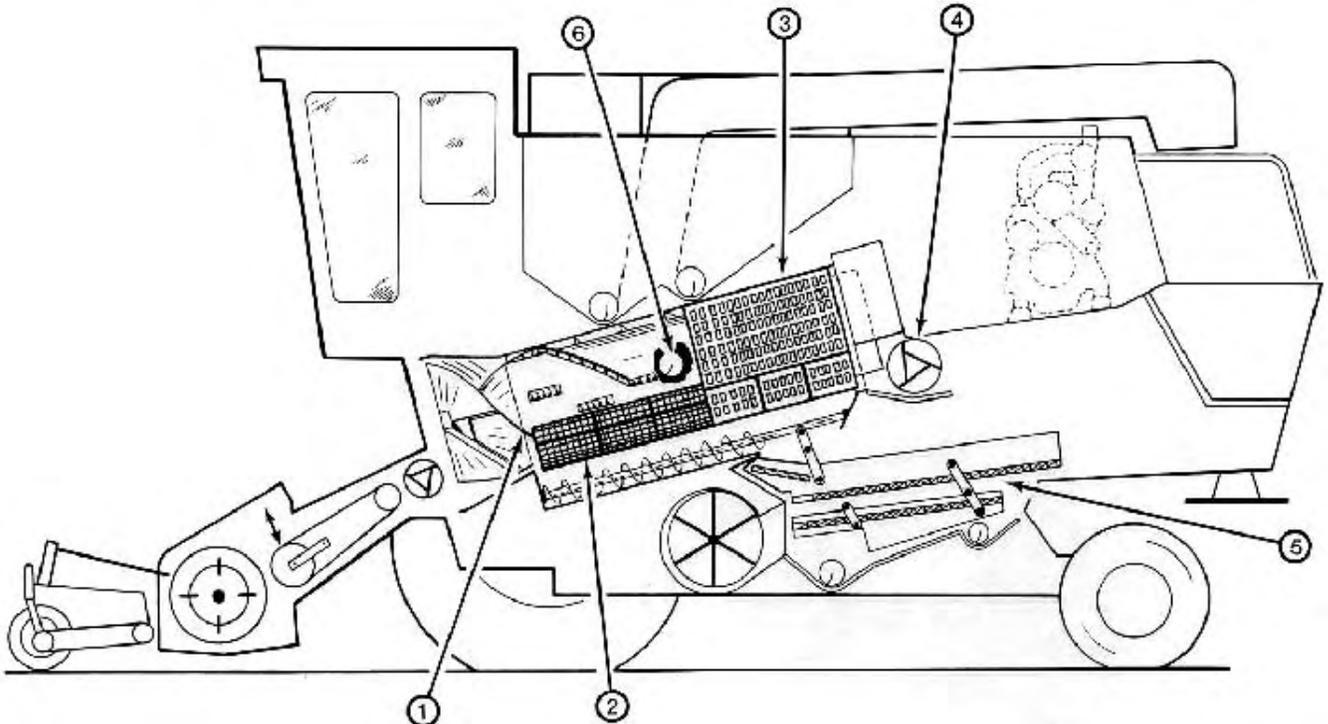
FIGURE 1. Case IH 1680: (1) Rotor, (2) Threshing Concaves, (3) Separating Concaves, (4) Discharge Beater, (5) Cleaning Shoe, (6) Tailings Return.

The Case IH 1680 is a self-propelled combine. It has a single longitudinally mounted rotor, threshing and separating concaves, discharge beater, and a cleaning shoe. The closed tube rotor has four impeller blades, a combination of longitudinal and helical rasp bars, and four longitudinal separating bars (FIGURE 2). The threshing concaves are of typical bar and wire construction, and the separating grates are slotted, pressed steel (FIGURE 3). The discharge beater is a three blade wing type beater. The cleaning fan is a single, six blade paddle fan, and the adjustable lip chaffer sieve and cleaning sieve move in opposed motion.

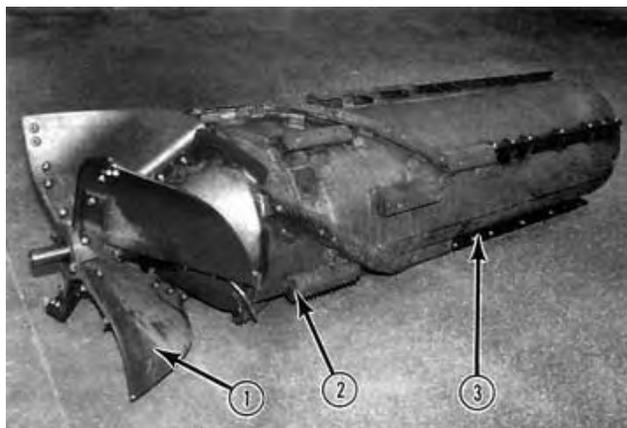
FIGURE 2. Rotor: (1) Impeller Blades, (2) Rasp Bars, (3) Separating Bars.

Crop is fed to the rotor impeller blades, which spiral the material into the rotor. Threshing begins upon first contact with the rotor and

continues throughout the length of the threshing concaves. The angled rasp bar ribs and adjustable transport vanes in the top of the rotor cage move the crop rearward. Grain separation occurs throughout the full length of the threshing and separating concaves. The discharge beater strips the processed crop away from the rotor and propels it out the back of the combine. Grain and chaff passing through the concaves fall into conveying augers, which deliver the material to the front of the cleaning shoe. The grain is cleaned by a combination of pneumatic and sieving action, and tailings are returned to the rotor above the third threshing concave (FIGURE 3)

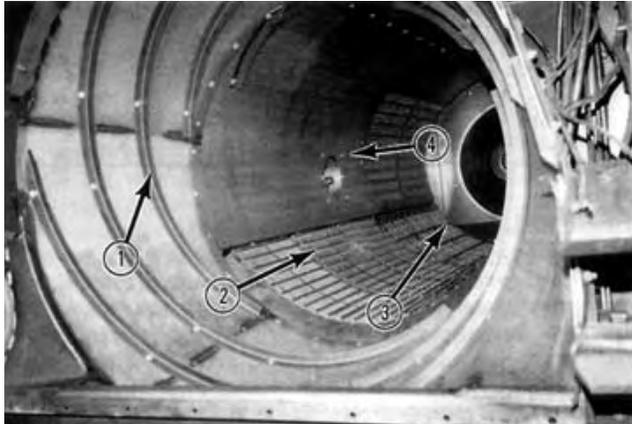
FIGURE 3. Rotor Cage: (1) Transition Cone, (2) Threshing Concaves, (3) Separating Grates, (4) Tailings Return.

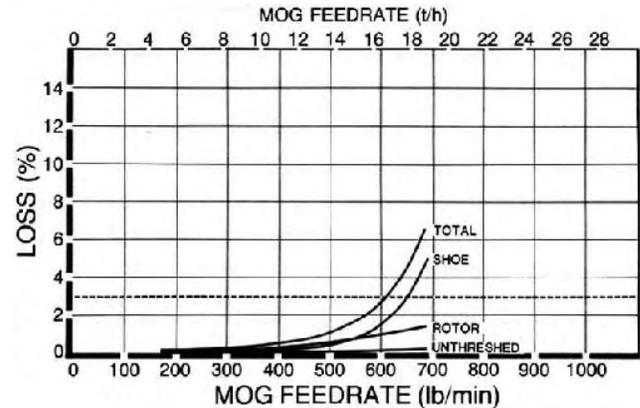
In this barley crop, two capacity tests were performed; the first using all small wire or narrow spaced threshing concaves and the

second using two large wire or wide spaced threshing concaves behind the first narrow spaced concave. In these conditions, the narrow spaced concaves provided slightly greater capacity at losses above 1.5 to 2%. Also, more stable shoe performance occurred with the narrow spaced concaves. Capacity at 3% total loss was 620 lb/min (16.9 t/h) MOG when using all narrow spaced concaves. Rotor loss was the greatest component of total loss, and unthreshed and shoe loss remained very low. After installing two wide space concaves, rotor loss was greatly reduced. Unthreshed loss was low; however, the change in shoe load and chaff composition caused shoe loss to become the greatest component of total loss.

FIGURE 4. Grain Loss in Harrington Barley (Wide-Space Concaves).

The performance curves for the capacity tests are presented in FIGURES 4 to 8. The curves in each figure indicate the effect of increased feed rate on rotor loss, shoe loss, unthreshed loss and total loss. From the graphs, combine capacity can be determined for loss levels other than 3%. The rate at which loss changes with respect to feed rate shows where the combine can be operated effectively. Portions of loss curves, which are "flat" or slope gradually indicate stable performance. Where the curves hook upward sharply, small increases in feed rate cause loss to increase greatly. It would be difficult to operate in this range of feedrates without having widely varying loss.

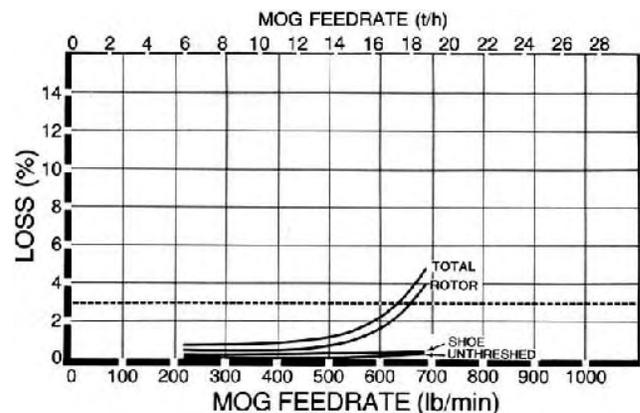
FIGURE 5. Grain Loss in Harrington Barley (Narrow-Space Concaves).

With the narrow space concaves, combine losses were stable at feedrates up to about 600 lb/min (16.4 t/h) but increased rapidly at higher feedrates. With the wide spaced concaves loss increased rapidly after about 500 lb/min (13.6 t/h).

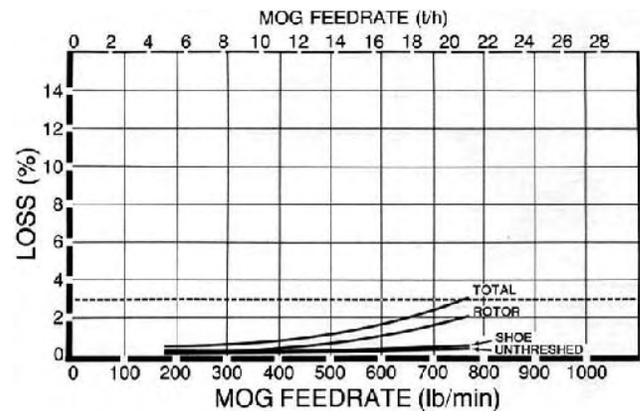
FIGURE 6. Grain Loss in Katepwa Wheat "A".

The Katepwa "A" wheat crop came from a stand that was uniform but somewhat lodged. This resulted in variations in windrow formation, although windrow uniformity was not greatly affected. The windrow was wider than the combine feeder, and the heads were generally well distributed across the windrow. Both the straw and grain moisture were tough, and straw break-up was about average. The grain yield was above average, but so was the straw yield. This provided a MOG/G ratio that was above average, which meant that the grain feedrate was slightly lower than typical. The grain was hard-to-thresh, and was easily damaged due to weather conditions during the harvest season.

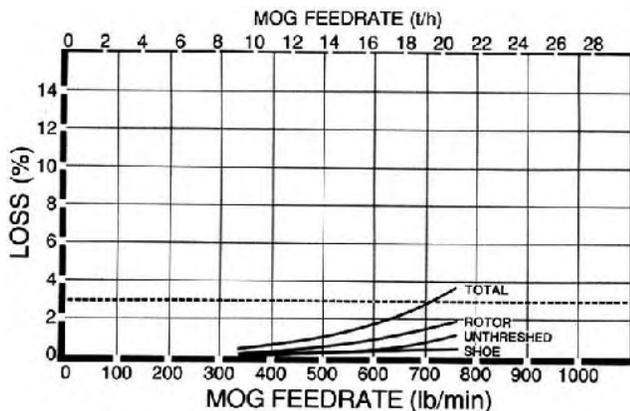
FIGURE 7. Grain Loss in Katepwa Wheat "C".

The Katepwa "C" wheat crop came from a stand that was uniform and very heavy. The crop was very mature and was windrowed just prior to testing. This resulted in a large, bushy, windrow. The windrow was much wider than the feeder and the heads were uniformly distributed across the full width of the windrow. Both the straw and grain moisture were in the tough range, which made threshing difficult and kept straw break-up relatively low. The above average straw and grain yield produced an above average MOG/G ratio, which in turn resulted in lower grain feedrates than might normally occur.

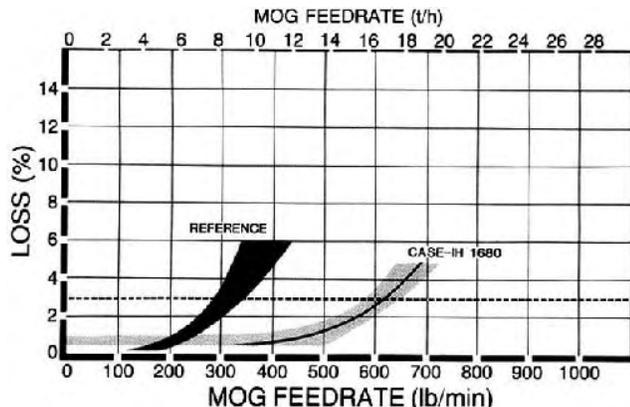
FIGURE 8. Total Grain Loss in Harrington Barley.

FIGURES 8 to 10 compare the total loss of both combines over their practical operating range of feed rates. The graphs show that at total losses greater than 1% the Case IH 1680 usually had significantly greater capacity than the Reference II combine. This difference in capacity would usually be easily noticed when operating. At lower total losses (less than 1%), the confidence belts in the graphs often overlap, indicating that the difference in capacity may not be statistically significant. Differences when operating at these very low loss levels would generally be much harder to distinguish in the field.

Capacity Compared to Reference Combine: The capacity of the Case IH 1680 was greater than that of the PAMI Reference II combine in both wheat and barley. At 3% total loss, the Case IH 1680 had about 1.9 times the Reference II's capacity in Harrington barley, and 1.6 and 1.5 times its capacity in the Katepwa "A" and Katepwa "C" wheat crops, respectively.

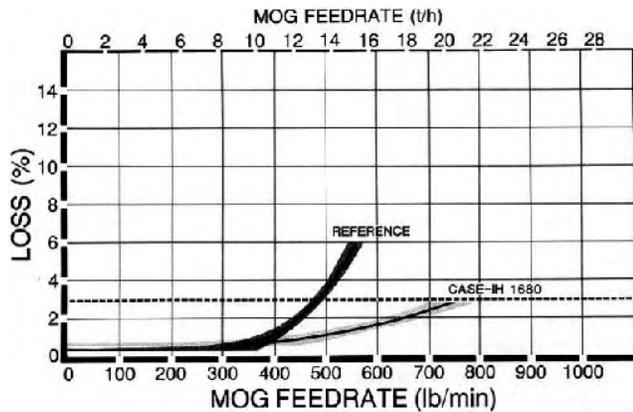
FIGURE 9. Total Grain Loss in Katepwa Wheat "A".

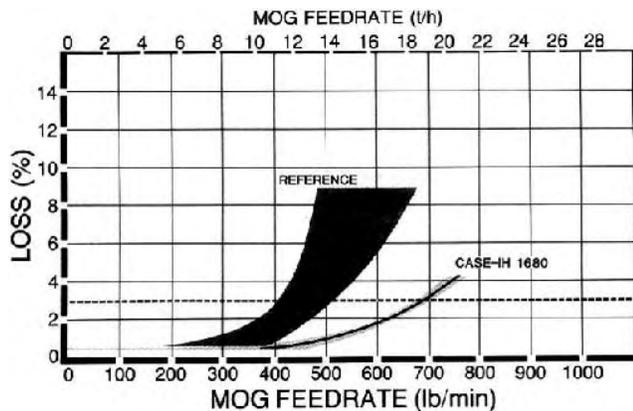
FIGURE 10. Total Grain Loss in Katepwa Wheat "C".

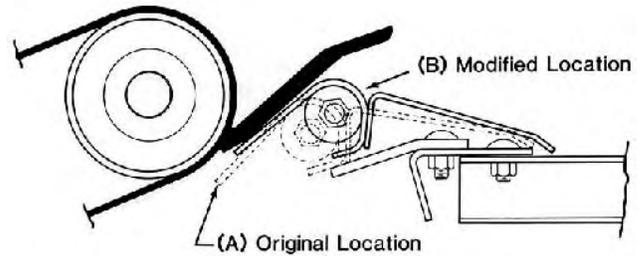
When the pickup stripper was located in the "grain" position (FIGURE 11), the pickup teeth caused rapid wear on the stripper bar.

short, plugging frequently occurred between the drapers and the pickup stripper. The severity of this plugging was not affected by the position of the pickup stripper. It is recommended that the manufacturer consider modifications to reduce pickup stripper plugging.

FIGURE 11. Pickup Stripper Position: (a) Manufacturer's Recommended for Small Grain, (b) Modified Position.

1. Modifications to reduce pickup stripper wear.
2. Modifications to reduce pickup stripper plugging.
3. Providing full bin sensors as standard equipment.

1. Design changes have been implemented which will reduce stripper wear.
2. Design changes have been implemented to reduce stripper plugging.
3. A full bin sensor is optional equipment.
4. Straw spreading improvements are being evaluated.
5. Automatic height control for pickup heads will be evaluated.
6. Rotor and fan speed adjustment response has not proven to be a point of customer comment. Future model evaluation will be done.
7. Tailings sampling will be evaluated for future models.
8. The recommendation is under consideration for future action.
9. A horn is available as a factory option.
10. The new manual will give necessary indication with next revision.
11. An optional reduced wear cone provides excellent wear resistance for areas that require this feature.

PAMI found that relocating the stripper to a slightly less aggressive position as recommended by the local Case IH Dealer greatly reduced the stripper wear, without reducing stripper performance. This alternate stripper position was not provided for by the manufacturer. It is recommended that the manufacturer consider modifications to reduce pickup stripper wear.

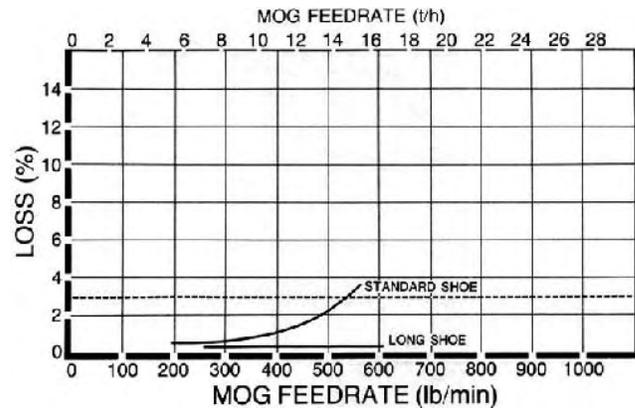
FIGURE 12. Shoe Loss Comparison Using Wide Space Concaves in Barley.

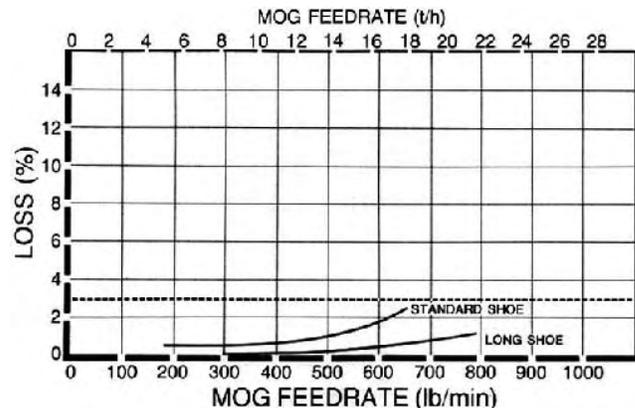
FIGURE 13. Shoe Loss Comparison Using Narrow Space Concaves in Barley.

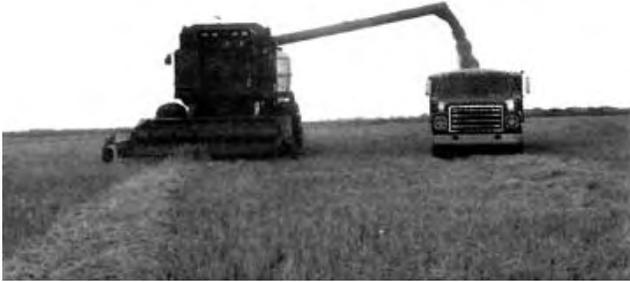
FIGURE 14. Unloading.

The unloading auger had ample reach and clearance for all trucks encountered (FIGURE 14). The unloading auger was hydraulically positioned for unloading to the left and would unload in any position. The auger discharged the grain in a compact stream, unloading a full tank of dry wheat in about 125 seconds. The hydraulic swing, along with the optional long unloading auger, made topping loads or unloading on the go more convenient. The high discharge height with the optional long unloading auger fully extended, resulted in some grain scattering and loss in moderate

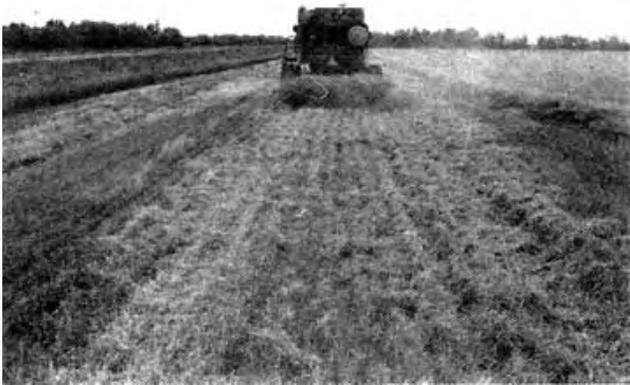
In most conditions, most of the straw from the rotor was delivered to the right spreader. This resulted in a heavier discharge of straw to the right (FIGURE 15).

FIGURE 15. Typical Straw Spread Pattern.

The bat type spreaders typically spread the straw about 15 to 20 ft (4.6 to 6.1 m). This spread was narrow compared to the width of cut, which was suitable for this combine. It is recommended that the manufacturer consider modifications to improve straw spreading.

4. Modifications to improve straw spreading.
5. Providing automatic header height control to be used with pickup headers.
6. Modifications to improve response of the rotor speed and fan speed adjustments.
7. Modifications to permit safe, convenient sampling of the return tailings while harvesting.
8. Modifications to improve the ease of cleaning the unloading auger sump.
9. Supplying the combine with a horn as standard equipment.
10. Revising the operator's manual to strongly emphasize the importance of not exceeding chaffer settings of 0.6 in (16 mm).
11. Modifications to reduce wear in the rotor intake cone.

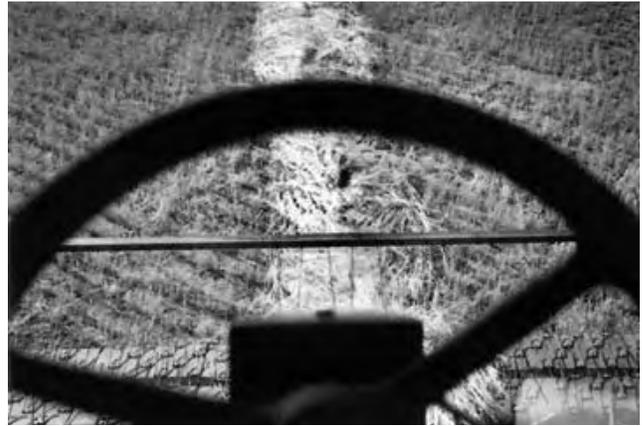
The operator had a clear view forward and to the sides. The large convex rear view mirrors provided adequate rear visibility. View of the incoming swath was slightly obstructed by the steering wheel (FIGURE 16). Visibility of the grain coming into the tank was restricted by the grain tank screen and completely blocked as the tank became nearly full. The unloading auger was visible when swung fully forward, but the operator had to lean forward to see the auger if it was swung back to less than 90 degrees from the combine body.

FIGURE 16. View of Incoming Windrow.

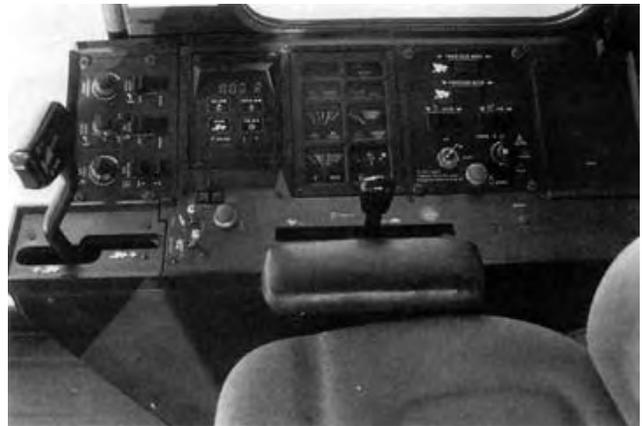
Most of the controls were located to the right of the operator (FIGURE 17), a few to the left, and the rest on the steering column. Most of the controls were conveniently placed and easy to use. Although clearly marked they were hard to identify at a glance. A neutral start system prevented the engine from cranking unless the separator switch was shut off and the "foot-n-inch" pedal was depressed. Fuel shut off was integrated into the throttle control lever. The gear shift was located to the left of the operator. Shifting at times was difficult; however, it was made easier if the hydrostatic lever was not in neutral and the "foot-n-inch" pedal was used like a clutch.

FIGURE 17. Right Side Instrument and Control Console.

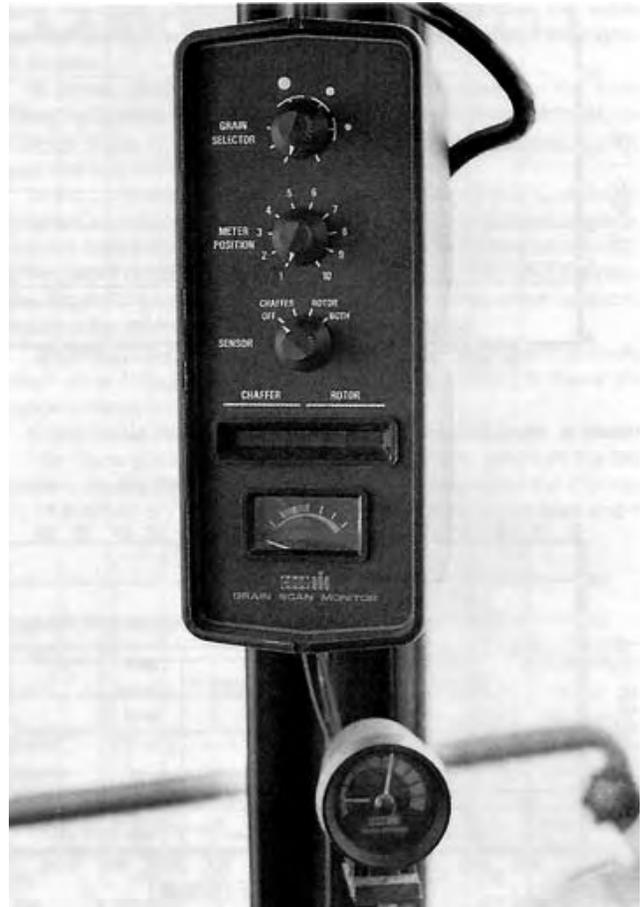
Two grain loss sensor pads were located at the rear of the rotor and two at the rear of the chaffer sieve. The monitor console was mounted separately from the control console for convenient viewing (FIGURE 18). A meter display on the monitor console indicated loss from the cleaning shoe, the rotor, or both, relative to acceptable loss observed behind the combine. The monitor console also contained four indicator lights that respectively signalled which sensor pads were being activated. These lights did not indicate the amount of loss.

The monitor was area based using a ground speed signal to regulated loss reading according to the distance traveled in a given time. This should have enabled operating to a fairly consistent loss behind the combine. However, PAMI found that this didn't always happen. Occasionally, an increase in ground speed resulted in a lower meter reading even though loss observed behind the combine had increased. Other times, changes in loss were observed yet the meter had not changed. The reason for the unpredictable response was not apparent, but may have been due to a change in shoe performance or a shift of the loss in relation to the sensors. This was confusing and reinforces PAMI's usual note of caution that meter readings have to be regularly compared to actual losses observed behind the combine.

FIGURE 18. Loss Monitor Console.

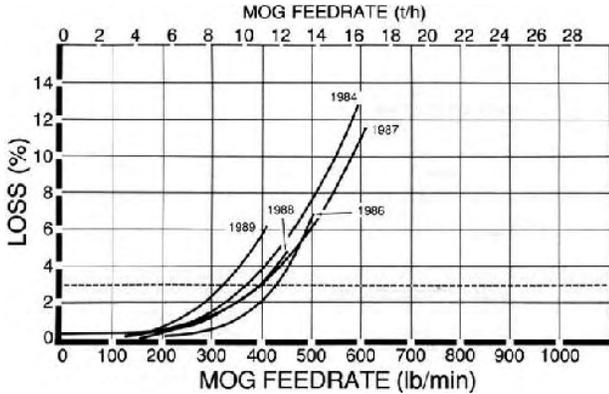
FIGURE 19. Total Grain Loss for the PAMI Reference II Combine in Barley.

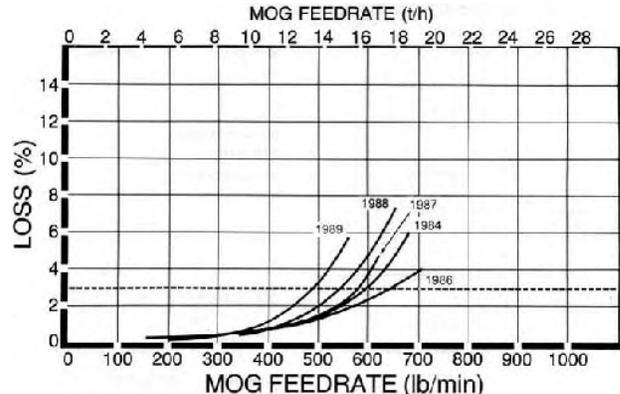
FIGURE 20. Total Grain Loss for the PAMI Reference II Combine in Wheat.
