Evaluation Report

Ford New Holland TR96

NEW HOLLAND TR96 SELF-PROPELLED COMBINE

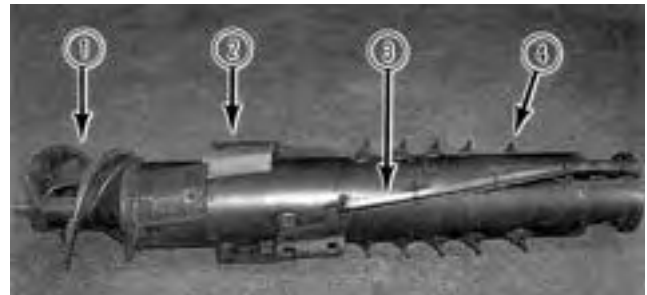
FIGURE 2. "S" Cubed Rotor: (1) Intake Flighting and Wear Plate, (2) Rasp Bars, (3) Separating Blades, (4) Agitating Pins.

The spiralled auger flighting on the front of the rotors divide the crop and pull it into the threshing section of the rotors (FIGURE 2).

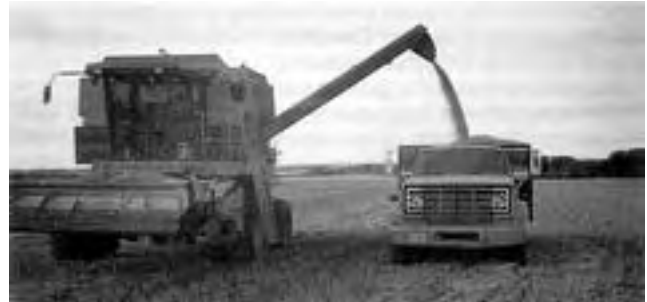
FIGURE 13. Unloading.

Fully extended, the unloading auger had ample reach for unloading into most farm trucks. Clearance was high (FIGURE 13). To prevent loss when unloading in windy conditions, using the original unloading auger spout required swinging the auger rearward to reduce clearance. This also reduced the reach and made it difficult for the operator to view the auger. A 4 ft (1.2 m) flexible spout, (not the New Holland Option), was installed by PAMI (FIGURE 14), which allowed the grain tank to be unloaded with the auger in the forward position with minimal loss due to wind.

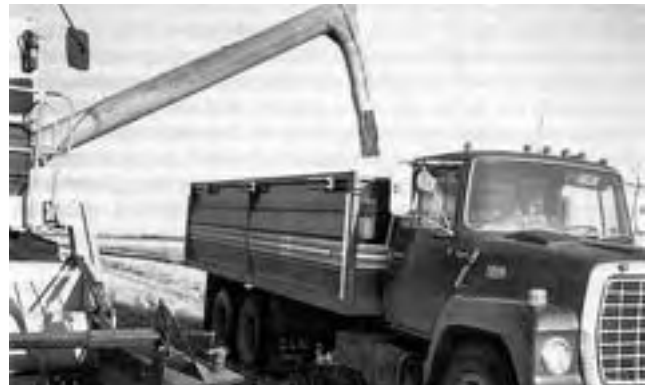
FIGURE 14. PAMI Installed Loading Spout.

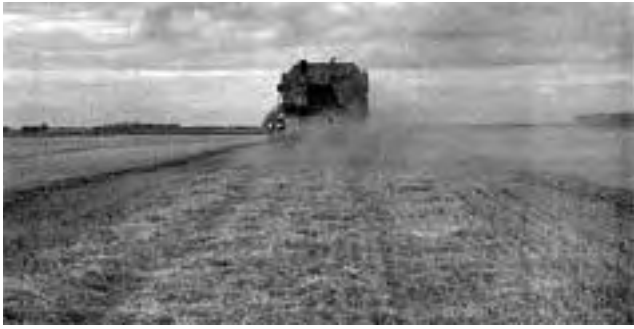
FIGURE 15. Typical Straw Spread Pattern.

Straw was spread from the New Holland TR96 by two angled rotating discs with 3 rubber bats on each disc. The straw from the rotors was usually well broken and further chopping was not necessary. However, when using less aggressive threshing settings or if the straw was green or damp, the discharged straw was nearly full length. Some light airborne chaff was spread with the straw. Typically the straw was spread in a range from 15 to 22 ft (4.6 to 6.7 m) (FIGURE 15).

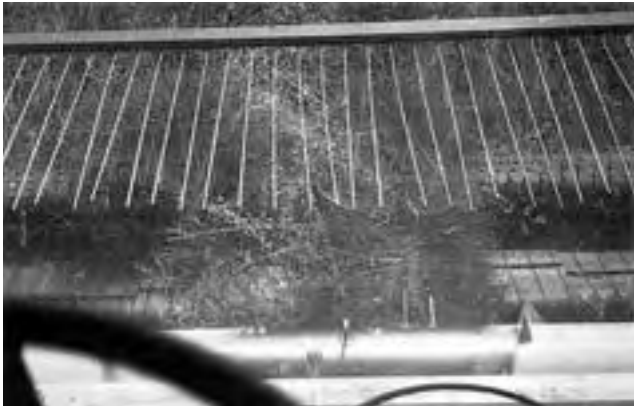
FIGURE 16. View of Incoming Windrow.

Most operators had a clear view of the incoming windrow with only a small section of the table auger being obstructed by the steering wheel (FIGURE 16). Leaning slightly left or right improved visibility of the auger but became uncomfortable after several hours of operating. Grain entering the tank was easily viewed through windows between the cab and grain tank.

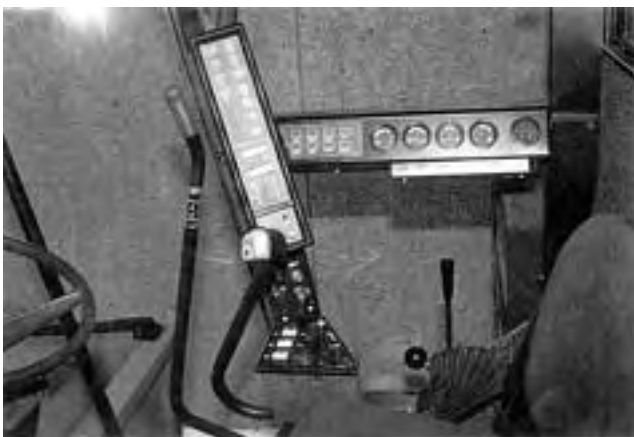
FIGURE 17. Instrument and Control Console.

Instruments: Instrumentation was very good. The instruments were located to the right of the operator in a vertical and a horizontal console (FIGURE 17).

The vertical console contained indicator lights for normal operation, full grain bin, straw spreaders, unloading auger, stone trap door, discharge beater, clean grain elevator, straw chopper, rotors, and cleaning fan, slow down of major harvest components as well as two displays, one for engine speed and the other which selectively displayed ground speed, fan speed or rotor speed. The horizontal console contained warning lights for low engine oil pressure, high coolant temperature, low coolant level, parking brake engagement, high hydrostatic/hydraulic temperature, engine air filter restriction, low battery, and drives engaged. It also had an engine hour meter, and gauges for electrical system voltage and fuel level. A separator hour gauge was located in a compartment in front of the throttle.

Some of the machine function controls were located to the right of the operator (FIGURE 17), some to the left beside the seat (FIGURE 18) and some on the cab floor. Accessory controls were located in the overhead panel and steering column. The controls were conveniently placed and easy to identify and use.
