Evaluation Report

655

Urvold Straw/Chaff Spreader

URVOLD STRAW/CHAFF SPREADER

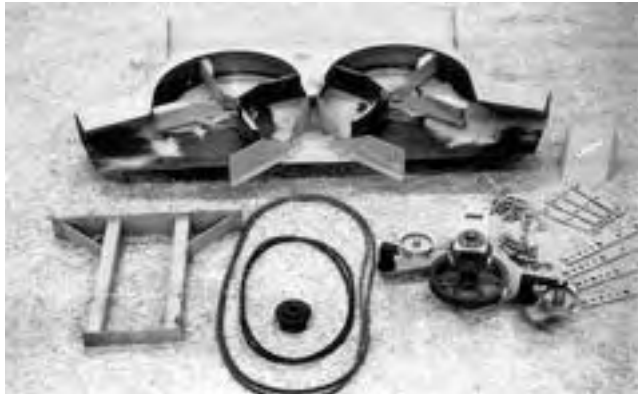
FIGURE 1. Urvold Straw and Chaff Spreader.

Straw and chaff fall on two counter rotating impellers. The impellers throw the material to the sides and rear (FIGURE 1).

The machine evaluated by PAMI was configured as described in the General Description, FIGURE 1 and Specifications section of this report. The manufacturer may have produced different versions of this machine either before or after the PAMI tests. Therefore, when using this report, check to ensure the machine being considered is the same as the one evaluated in this report. If differences are found, PAMI or the manufacturer may be contacted to determine the effect of the changes on performance.

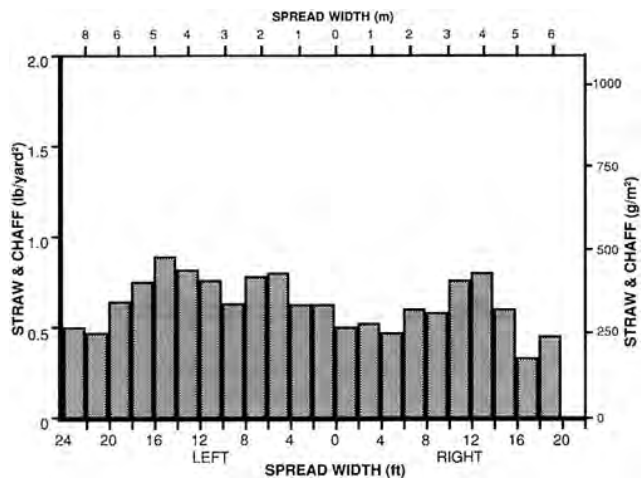
FIGURE 2. Typical Spread Pattern Uniformity for Straw and Chaff Combined.

FIGURE 2 shows the combined straw and chaff spread pattern. It also shows the material concentration across the spread that would be typical for a 50 bu/ac (3.4 t/ha) wheat crop (MOG/G = 1)*, when the spread and cut widths are closely matched. APPENDIX II provides a guideline for crop residue ratings.

The Urvold spread in FIGURE 2 shows that straw and chaff could be spread up to 44 ft (13.4 m). Total material concentrations were in the desirable range when width of cut was similar to spread width. Higher yields or wider widths of cut would increase the concentration while lower yields would reduce the concentrations.

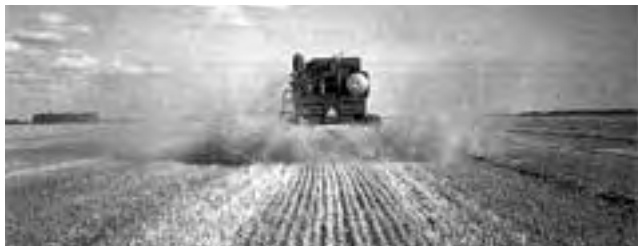
FIGURE 3. Typical Spread Pattern.

In the field, typical spread widths were up to 30 ft (9.1 m) (FIGURE 3). Most of the material was spread to the sides and no dense rows or heavy concentrations were apparent. Finely chopped straw reduced the spread. The relatively high discharge height also made the spread susceptible to the effects of wind.
