Evaluation Report

676

New Holland TX36

NEW HOLLAND TX36 SELF-PROPELLED COMBINE

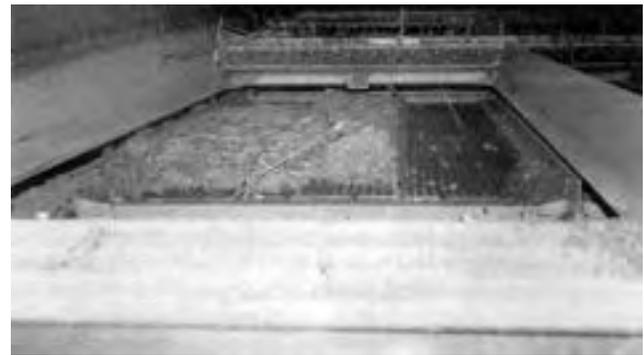
The right side of the shoe had a slightly stronger air blast, resulting in higher grain loss on the right side. Conversely the left side of the cleaning sieved occasionally plugged with barley awns, rye awns and wheat white caps (FIGURE 10). Opening the cleaning sieve more than 0.13 in (3.2 mm) and increasing fan speed slightly prevented this plugging.

FIGURE 10. Plugging of the Left Cleaning Sieve.

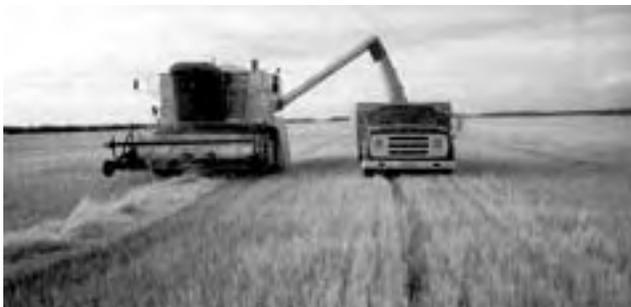
Fully extended, the unloading auger had ample reach for unloading into most farm trucks. However, clearance was too high for convenient unloading into most trucks and was susceptible to loss in windy conditions (FIGURE 12). To prevent loss when unloading in windy conditions, the auger had to be swung rearward to reduce clearance. This also reduced the reach and made it difficult for the operator to view the auger. A 4 ft (1.2 m) flexible spout, (not the New Holland Option), was installed by PAMI. This allowed unloading with the auger in the forward position with minimal loss due to wind.

FIGURE 12. Unloading.

No shear bolt or safety device was used on the unloading drive so extreme care was required to prevent plugging this auger spout. It is recommended that the manufacturer consider supplying a safety mechanism in the unloading system to prevent unloader system damage should a restriction occur. The unloading auger was hydraulically positioned for unloading to the left and would unload in any position. The grain stream was compact and uniform, and a full tank unloaded in about 115 seconds.

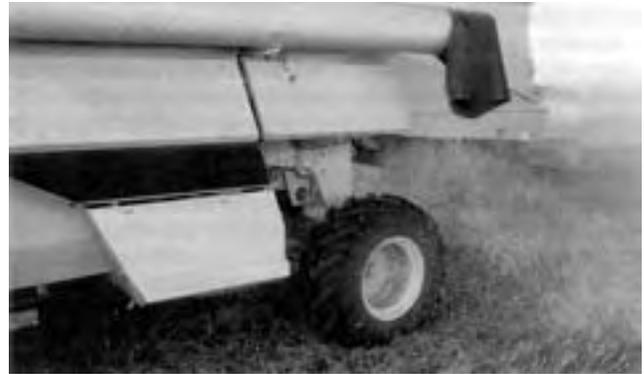
The chaff spreaders maximum spread width was 20 ft (6.1 m) (FIGURE 13). The chaff spread pattern was greatly affected by wind.

FIGURE 13. Chaff Spreading.

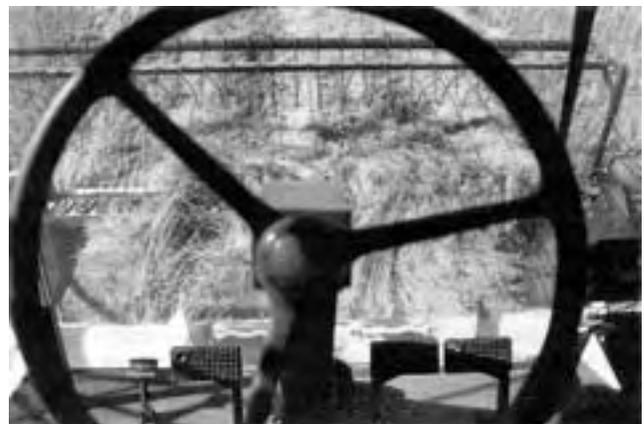
Most operators had a clear view of the windrow coming into the pickup. However, when the header was close to the ground the operator had to lean forward to see the table auger. In a normal seated position, view of the table auger was obstructed by the steering wheel (FIGURE 14). Grain entering the tank was easily viewed through windows between the cab and grain tank.

FIGURE 14. View of Incoming Windrow.

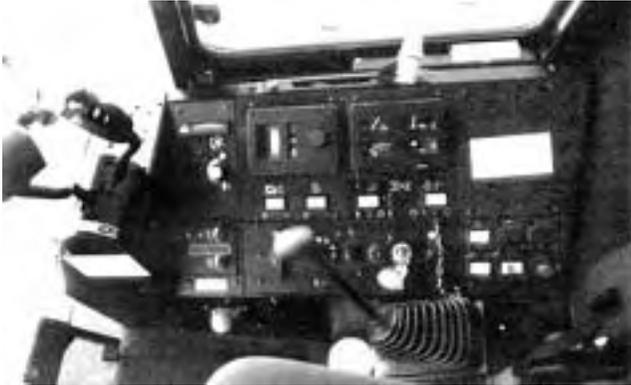
Instruments were grouped in three modules on the horizontal console. One module contained lights, the other a speed display and the other gauges. The light module was located in the forward right corner. The speed display module and gauges module were located in the centre of the horizontal console and were sloped towards the operator (FIGURE 15). The lights module contained lights to indicate high beam, combine and trailer turn signal, cleaning shoe levelling and limit, obstructed air cleaner and unloading auger out.

The light module also contained warning lights for low engine oil, low hydrostatic charge pressure, high hydrostatic oil temperature and engaged park brake. An audible alarm sounded when a warning light was activated. The speed display module selectively showed shoe fan rpm, cylinder rpm and ground speed. The gauge module contained gauges for voltage, fuel level, engine hours and engine coolant temperature. An audible alarm also helps signal excessive coolant temperatures. Slow down of the return auger, cleaning shoe, clean grain cross auger and elevator, straw walkers, rotary separator, straw chopper and beater were monitored by the module in the overhead console. The activation point for each component could be individually set. The manufacturer suggested setting the alarm for 80% of full speed. When activated a warning light triggered and an audible alarm sounded.

FIGURE 15. Instrument and Controls Console.

Some of the machine function controls were located right of the operator (FIGURE 15), some to the left beside the seat (FIGURE 16) and some on the cab floor. Accessory controls were located in the overhead panel and horizontal console. The controls were conveniently placed and easy to identify and use.

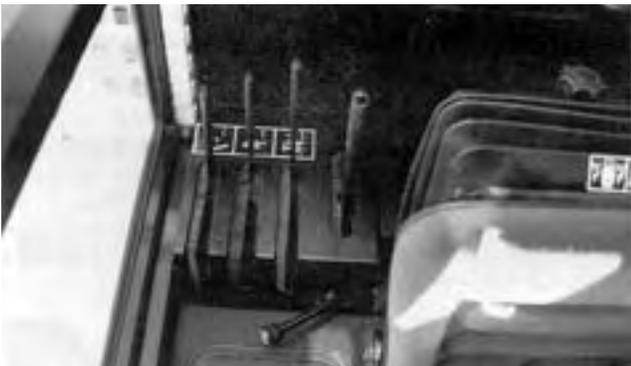
FIGURE 16. Lower Left Controls.
