# Evaluation Report

# 691

## AGCO R72 Gleaner Combine

## AGCO R72 GLEANER COMBINE

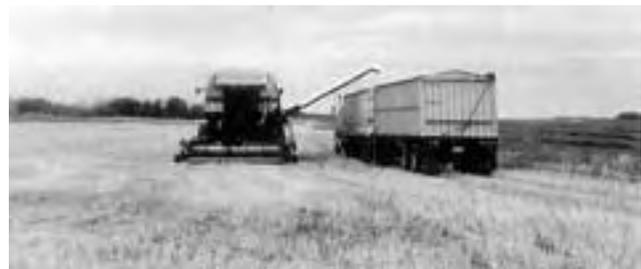
unloading into most farm trucks (FIGURE 13). However, clearance was 12.0 ft (3.7 m) high making unloading into most trucks inconvenient and resulted in loss in windy conditions. A 4.0 ft (1.2 m) flexible spout, was installed by PAMI to minimize loss due to wind. This spout was too long for loading into semi trailers. A safety switch ensured that the unloader would operate only when the auger was fully extended.

**FIGURE 13.** Unloading Auger Clearance.

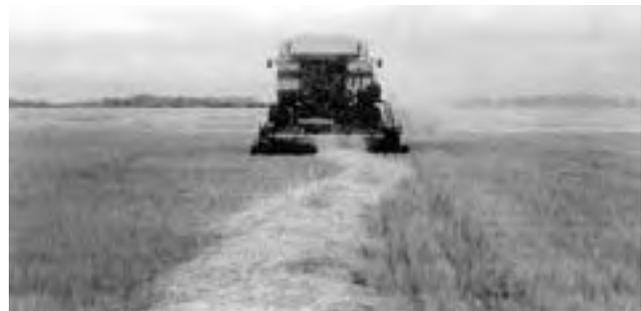
**FIGURE 14.** Offset Straw Spread.

**Straw and Chaff Spreading:** Straw and chaff spreading was good. The test machine was equipped with the optional rear beater in place of the straw chopper. The bat-type straw spreader spread straw up to 22.0 ft (6.7 m) under ideal conditions. This occurred when two bats had a forward angle and two bats had a reverse angle. Since the straw discharge was on the left (FIGURE 14) the total spread width was slightly offset to the left. When travelling back and forth in narrow cut windrows, the pickup picked some of the straw spread from the previous pass when the offset was towards the windrow being picked.

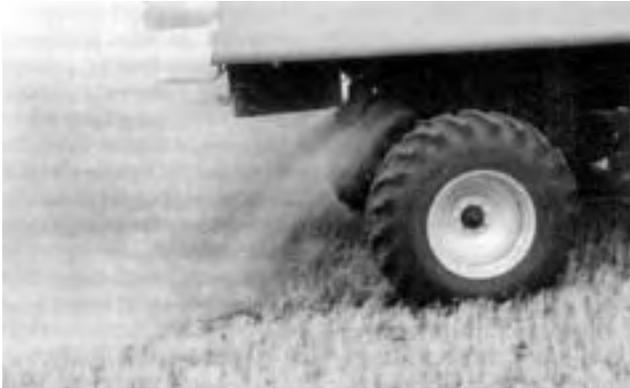
The high volumes of air from the shoe along with an adjustable tail plate with guide vanes were used to spread chaff (FIGURE 15). In dry wheat, the R72 was capable of putting 50% of the total MOG over the shoe, which made chaff spreading very important. Maximum spread width was 16.0 ft (4.5 m). The chaff spread pattern was greatly affected by wind.

FIGURE 15. Chaff Spreading.

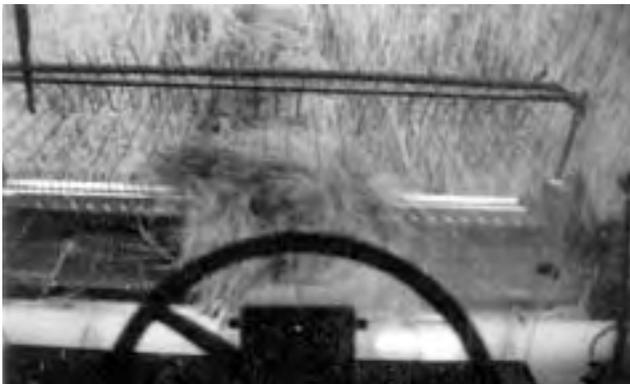
Most operators had a clear view of the windrow coming into the pickup. However, when the header was close to the ground the operator had to lean forward to see the table auger. In a normal seated position, view of the table auger was obstructed by the steering wheel (FIGURE 16). Windows between the cab and grain tank allowed the operator to watch the grain entering the tank until it was about 40% full. After this, the operator could not view grain tank level from the operator's seat until grain covered the screened windows on either side of the cab. This occurred when the tank was about 80% full.

FIGURE 16. View of Incoming Windrow.

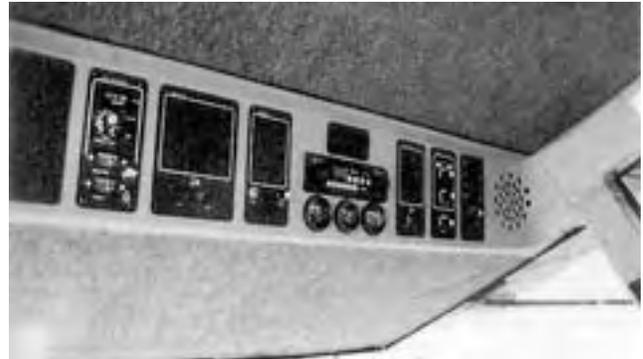
The instruments located in the overhead panel were grouped in three modules (Acre Estimator, Shaft Monitor and Warning System) along with three gauges. The Acre Estimator contained three mechanical counters for recording acres, engine and separator hours. The Shaft Monitor contained six red lights and an audible alarm that warned of a slow down of the rear feeder conveyor, tailings elevator, clean grain elevator, distribution augers, impeller chopper (discharge beater) and straw chopper. The Warning System contained eight lights indicating an open thresher door, park brake on, low engine oil pressure, high engine oil temperature, low engine

blower speed, high hydraulic oil temperature, restricted engine air filter, high engine head temperature, full bin and unloading auger out and low battery voltage. One of the eight lights was used to show low engine oil pressure, high engine oil temperature or low engine blower speed. Amber lights were used on the thresher door, engine air filter and bin and unloader systems while red lights were used on the remainder. A warning was signalled by the corresponding light and an audio alarm. The warning system also had a test button and a dial to control volume of the audible alarm. The three gauges used a combination of color code and numbers that indicated battery voltage, oil pressure and engine oil temperature.

FIGURE 17. Overhead Console.

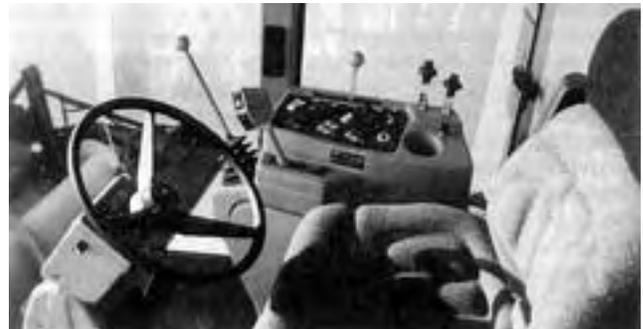
Most of the machine function controls were located to the right of the operator (FIGURE 18). The remainder were in the overhead console, with the exception of the air conditioner temperature control, brakes and signal light lever. Accessory controls were also located to the right of the operator. The controls were conveniently placed and easy to identify and use.

FIGURE 18. Control Console.

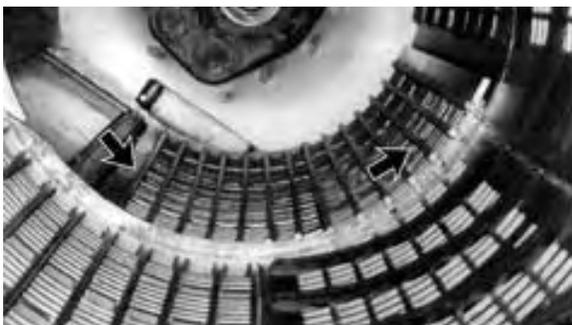
The exact cause of the failure was unknown. At sometime after failure, the front left concave bar contacted the cylinder damaging the hardened surface of the front concave bar (FIGURE 19). Damage to the cylinder was insignificant. The eye bolt was replaced. On replacing the eye bolts, fractures and a missing bolt were noticed on the filler strip at the front of the concave. Two pieces were removed and repaired at the end of the season.

FIGURE 19. Damaged Hardened Surface and Bent Concave Bars.

**Bent Concave Bars:** When operating in flax, several concave bars bent (FIGURE 19). The exact cause of the bending was undetermined, however, a number of green and very tough piles had been taken in.

**Left Concave Eye Bolt Failed:** Failure of the eye bolt used to adjust the front clearance of the concave was noticed during daily inspection.
