Evaluation Report

710

Case IH 1666 Combine

CASE IH 1666 COMBINE

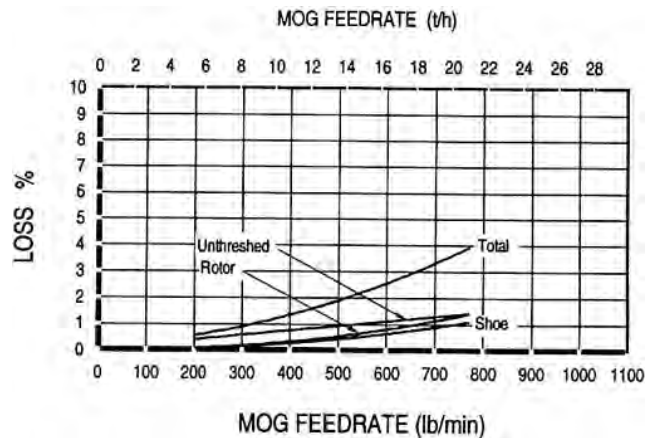
FIGURE 8. Grain Loss in Biggar Wheat.

The Biggar wheat was from an average stand. The crop received frost damage that noticeably affected the sample. The crop was cut the same day as the test. Grain yield was slightly below average for Biggar wheat, but the MOG/G ratio was typical. Straw and grain moisture were dry. The windrow was uniform and fluffy with the heads distributed across the windrow. The windrow was 1.5 times the width of the feeder. Threshing was difficult and straw break up was typical. Narrow wire concaves and square bar grates were installed for this test.

The performance curves for the capacity tests are presented in FIGURES 5 to 10. The performance curves are plots of rotor, shoe, unthreshed and total grain loss for a range of MOG feedrates. From the graphs, combine capacity can be determined at various loss levels. The rate at which loss changes with respect to feedrate shows where the combine can be operated effectively. Portions of the curves, which are "flat" or slope gradually indicate stable performance. Where the curves hook up sharply, small increases in feedrate cause loss to increase greatly. It would be difficult to operate in this range of feedrates without having widely varying loss.

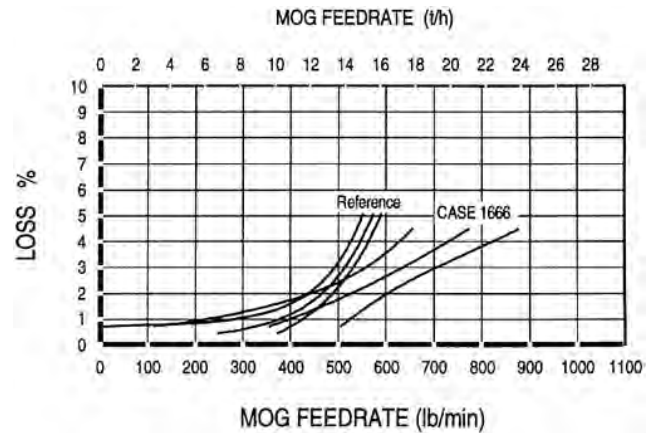
FIGURE 14. Total Grain Loss in Biggar Wheat.

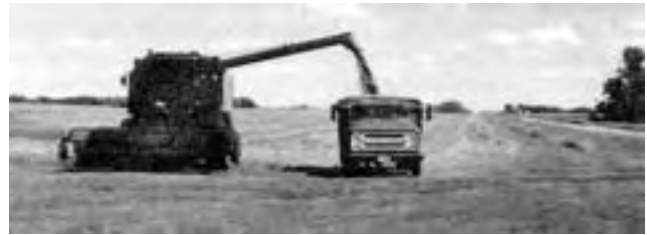
The unloading auger had ample reach and clearance for all trucks encountered (FIGURE 17). The unloading auger was hydraulically positioned for unloading to the left and would unload in any position through its full swing range. The auger discharged grain in a compact stream, unloading a full tank of wheat in about 85 seconds. The hydraulic swing, along with the optional long unloading auger, made topping loads or unloading on the go convenient. The high discharge height with the optional long unloading auger fully extended resulted in some grain scattering and loss in moderate winds. The scattering loss could be reduced by unloading with the auger swung partially back to reduce the discharge height.

FIGURE 17. Unloading.

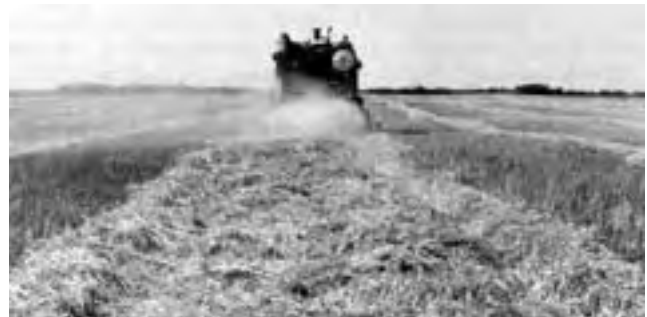
The bat type spreaders typically spread the straw uniformly from 14 to 16 ft (4.3 to 4.9 m) (FIGURE 18). The spread was narrow compared to the width of cut, which was suitable for this combine. The spread width was increased to about 20 ft (6.1 m) by using deeper bats. It is recommended that the manufacturer consider modifications to improve straw spreading.

FIGURE 18. Typical Straw Spread Pattern.

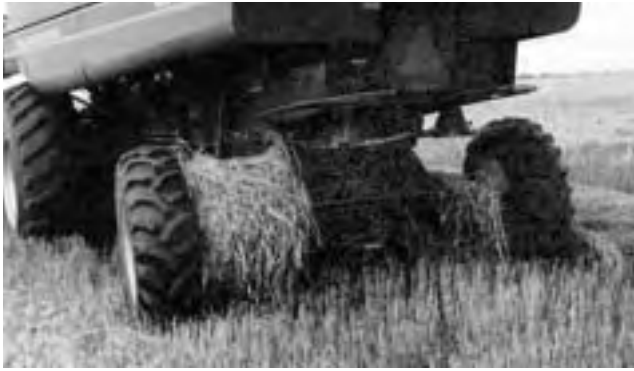
When operating in long straw and when travelling the same direction as the wind, straw built up on the axles (FIGURE 19). This build up of material was reduced when rubber deflectors were installed on the spreader guards.

FIGURE 19. Material Build Up on Axles.

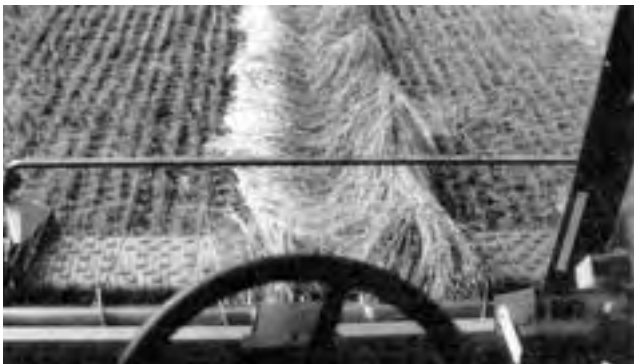
The operator had a clear view forward and to the sides. The large convex rear-view mirrors provided adequate rear visibility. View of the windrow was slightly obstructed by the steering wheel (FIGURE 20). Visibility of the grain entering the grain tank was restricted by the grain tank screen. The grain level in the grain tank could only be seen through the right cab window when the tank became about 90% full. The unloading auger was visible when swung fully forward, but the operator had to lean forward to see the auger if it was swung back to less than 90 degrees from the combine body.

FIGURE 20. Cab View of Windrow.

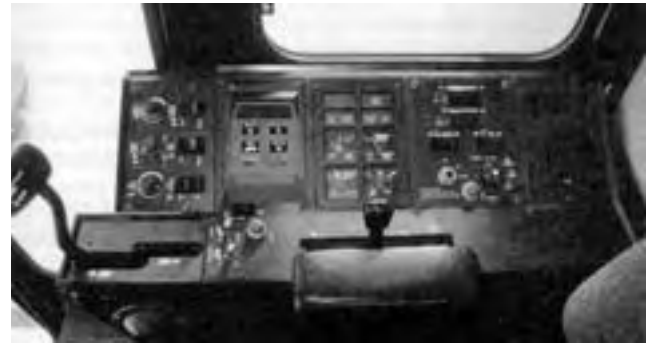
Most of the instruments were located to the right of the operator (FIGURE 21) and in the upper right corner of the cab. The instrument panel to the operator's right contained gauges for engine oil pressure, coolant temperature, battery voltage, fuel level

and engine hours. It also contained an alarm and warning lamps for low engine oil pressure, low coolant level, excessive coolant temperature, alternator malfunction, and parking brake engagement. A digital display selectively showed engine, fan, rotor and ground speed. A separate continuous readout for engine speed would have been useful.

FIGURE 21. Right Control Console.

Most of the controls were located to the right of the operator (FIGURE 21), a few to the left, and the rest on the steering column. Most of the controls were conveniently placed and easy to use. Although clearly marked, they were hard to identify at a glance. A neutral start system prevented the engine from cranking unless the separator switch was shut off and the "foot-n-inch" pedal was depressed. Fuel shut off was integrated into the throttle control lever. The gearshift was located to the left of the operator. Shifting at times was difficult; however, it was made easier if the hydrostatic lever was not in neutral and the "foot-n-inch" pedal was used like a clutch.

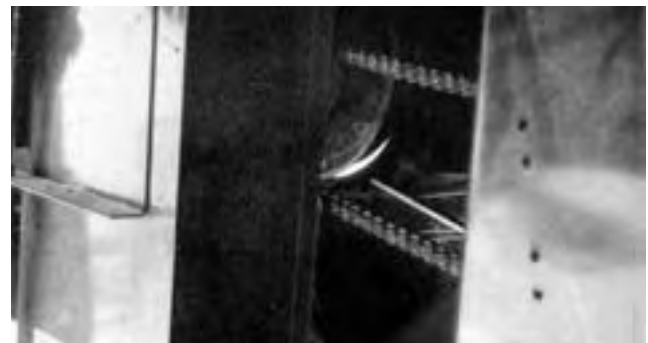
Clean Grain Elevator Sheet Metal: The tailing elevator drive chain caught the inside sheet metal on the clean grain elevator, slightly damaging it (FIGURE 22). This was caused by excessive slack in the tailing elevator drive chain. A spring loaded idler may have prevented this damage.

FIGURE 22. Damaged Sheet Metal on Grain Elevator.
