Evaluation Report

595

Hesston 8100 Self-Propelled Windrower

HESSTON 8100 SELF-PROPELLED WINDROWER

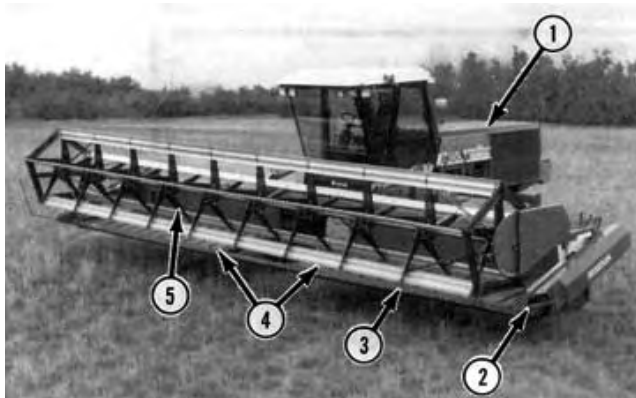
FIGURE 1. Hesston 8100: (1) Traction Unit, (2) Dividers, (3) Cutterbar, (4) Drapers, (5) Reel.

The Hesston 8100 (FIGURE 1) is a self-propelled windrower with a draper header capable of center, left or right end delivery

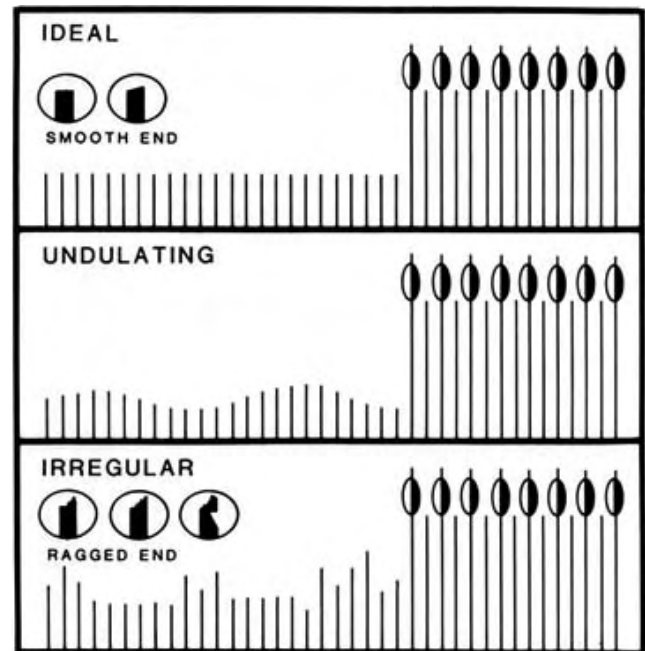
The knife had ample power and never stalled throughout the test. Stubble ranged from smooth to ragged ends depending on ground speed and condition of the knife system (FIGURE 2).

FIGURE 2. Types of Stubble.

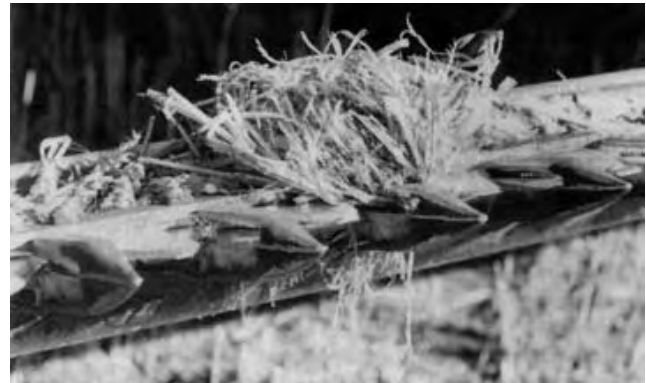
In green, tough or weedy crops, material collected around the guards at the knife overlap (FIGURE 3) resulting in irregular cut stubble. This area required frequent cleaning about every hour in these conditions. The knife should be maintained in good condition to provide clean cutting.

FIGURE 3. Knife Plugging.

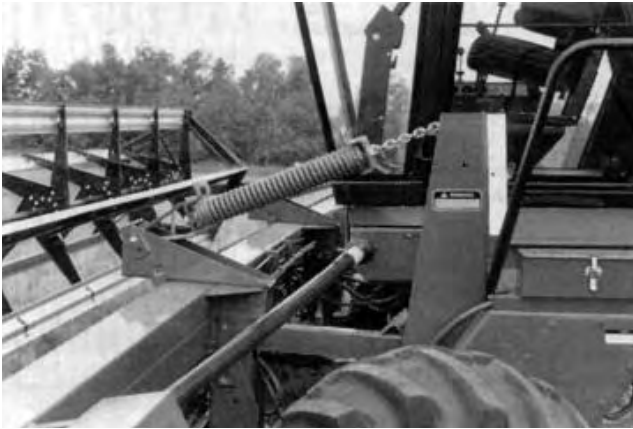
Flotation was provided by four tension springs (FIGURE 4). Header flotation minimized cutterbar damage in stony fields and enabled the header to follow most ground contours.

Undulating stubble occurred in rough fields as the header bounced.

FIGURE 4. Header Flotation System.

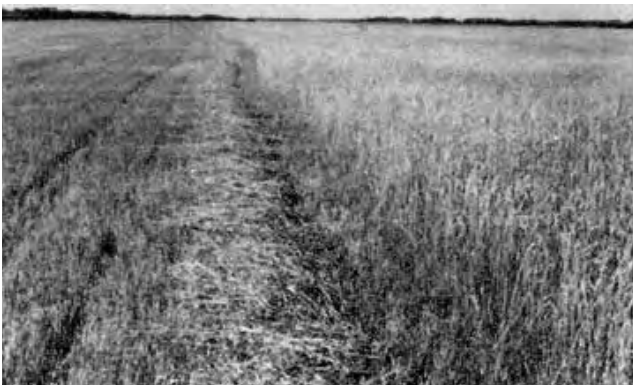
When double windrowing, the right divider draper laid the first windrow about 24 in (610 mm) from the standing crop edge (FIGURE 5). This kept the divider from snagging the windrow on the second pass.

FIGURE 5. First Pass While Double Windrowing.

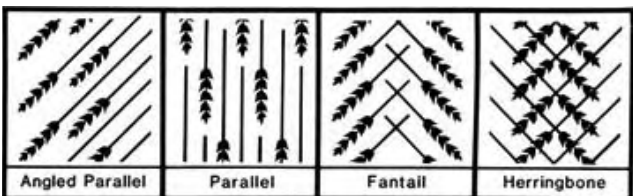
Windrows may be classified into four general patterns (FIGURE 6), although many combinations and variations exist. FIGURES 7 to 10 show typical windrows. Center and end delivery windrows were usually formed parallel. In short or leaning crops, single windrows were occasionally fantailed while double windrows were angle parallel.

FIGURE 6. Windrow Types.

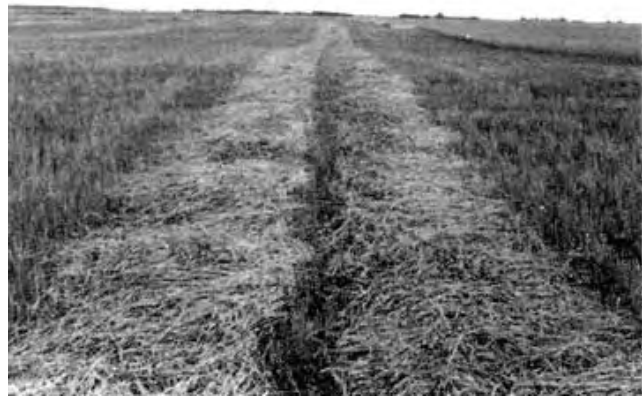
FIGURE 7. Wheat, Double Windrow: 35 bu/ac (2.3 t/ha).

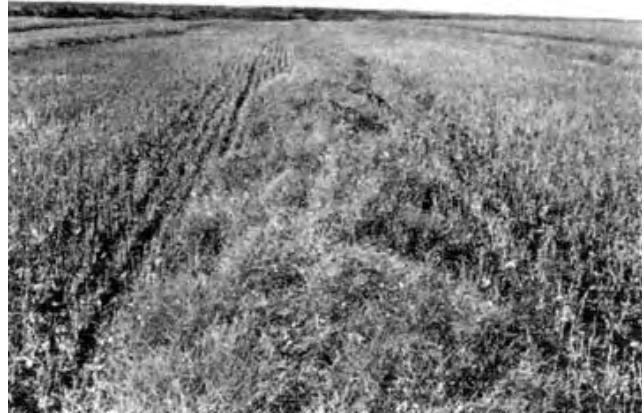
FIGURE 8. Canola, Single Windrow: 30 bu/ac (1.7 t/ha).

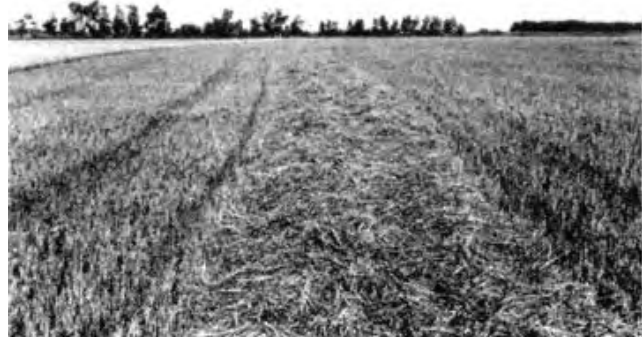
FIGURE 9. Barley, Double Windrow: 40 bu/ac (2.2 t/ha).

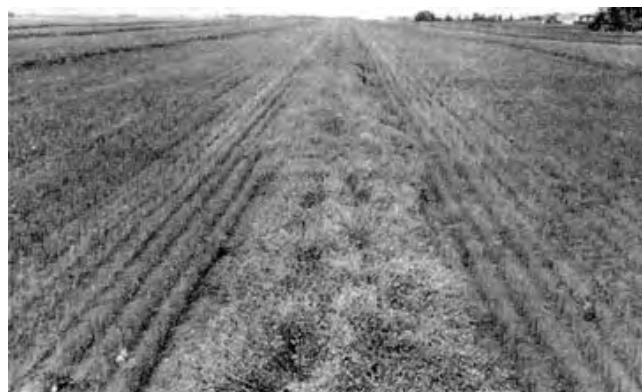
FIGURE 10. Flax, Single Windrow: 25 bu/ac (1.5 t/ha).

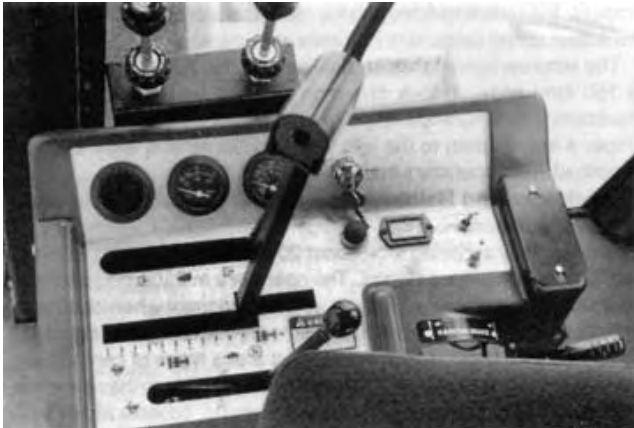
All controls were conveniently located (FIGURE 11). The travel speed control lever and header clutch lever were conveniently located and easy to engage.

FIGURE 11. Operator Station Instruments and Controls.

Reel and draper speed controls were not identified in the cab. It is recommended that the manufacturer consider labelling the draper and reel speed controls.

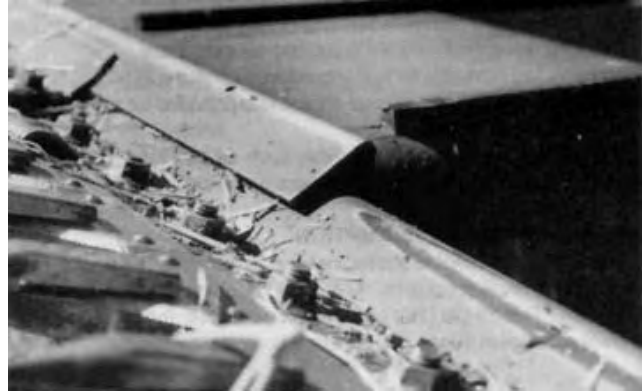
The sliding draper decks derailed on several occasions, while shifting for alternate end delivery. Dirt and crop material collected

under the warped draper slides (Figure 12) preventing smooth operations. Also, the draper stops were not effective in keeping the decks in position. It is recommended that the manufacturer consider modifications to improve the sliding draper decks.

FIGURE 12. Draper Deck Slide.

The sliding draper decks were warped up at their ends. The stops for the sliding draper decks were not effective in keeping the draper decks in position. This caused the right draper to derail after it overran the stop and collided with the divider draper. Also, dirt and crop material collected under the draper slides preventing smooth operation. Recommendations regarding the draper decks have been made.

2. A solution for this problem is currently being evaluated which will be incorporated on to the header after field evaluation. We expect it to be adaptable to older units.
