Evaluation Report No. E0679B  
Printed: June, 1980  
Tested at: Portage la Prairie  
ISSN 0383-3445

# Evaluation Report 164

## Lockwood Mark 15 Potato Harvester

# LOCKWOOD MARK 15 POTATO WINDROWER

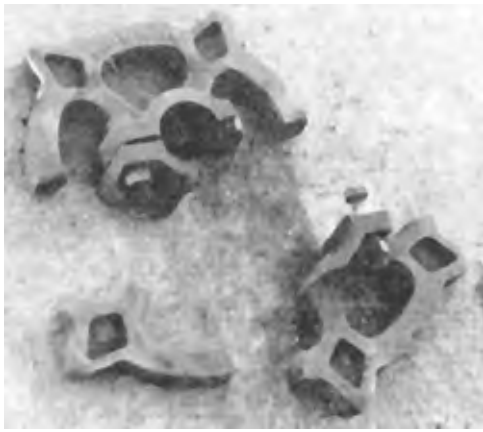
**Deviner:** The cast iron sprockets on the deviner drive (FIGURE 5) broke twice despite a properly adjusted slip clutch. One failure was caused by large vine clumps, carried between the stripper roller and deviner chain, forcing the deviner chain below the cone rollers at the sides.

The second failure was caused by a link being caught in a groove worn in the lower stripper bar. It is recommended that the manufacturer consider placing a separate slip clutch on the de-

**FIGURE 5.** Deviner Chain Cast Iron Drive Sprocket.

3. Eliminating the interference between the return side of the conveyor chain and frame cross members on the drive end of the digger chains.
4. Installing a separate slip clutch on the deviner drive shaft to reduce drive component failures.

viner drive shaft, since the existing one also protects the digger chain.

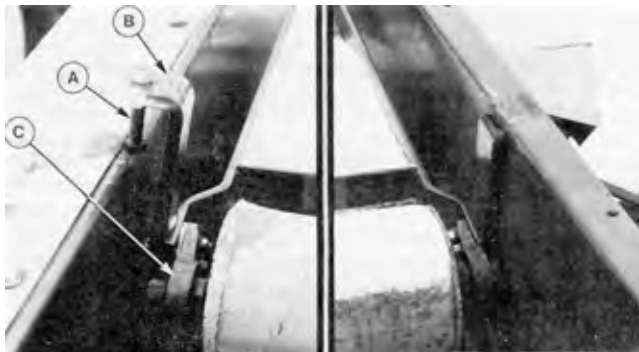
**Stripper Roller:** Although the stripper roller height was relatively easy to adjust, the stripper roller bearing supports and adjusting mechanism were not sufficiently rigid to permit full use of the adjusting range. If the stripper roller was set too high, the constant jarring caused by passing vine clumps, loosened and de-

formed the bearing mounts during operation. In addition, one support strap eventually broke. It is recommended that the manufacturer provide a better method of securing the hanger bearings to prevent them from loosening during operation, and modify the method of stripper roller adjustment to reduce durability problems.

**FIGURE 6.** Failure of Support Strap on Stripper Roller: (A) Adjustment Bolt, (B) Support Strap, (C) Hanger Bearing.

**Stripper Roller:** The carriage bolts securing the stripper roller hanger bearings would not remain tight. Continuous jarring of the roller due to vine clumps caused the bolts to loosen, and caused the right support strap to break (FIGURE 6).

1. Lengthening the deviner to improve separating performance.
2. Providing a better method of securing the stripper roller hanger bearings to prevent them from loosening, and modifying the method of stripper roller adjustment to reduce durability problems.

2. We will investigate the stripper roll hanger bearing mounting. Subsequent models have been improved.
3. In the adverse test conditions expressed above, an additional roller is often added to the idle end of the cross conveyor to prevent "vine rolling" and buildup. The stripper bar corner can be trimmed to reduce catching.
