Evaluation Report

56

McConnell Model 555 Potato Planter

McCONNELL MODEL 555 POTATO PLANTER

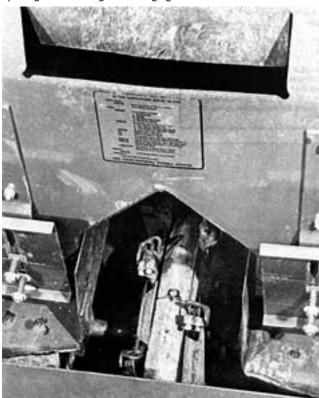
Planting: It was easy for the planter operator to monitor seed flow. With the fertilizer feed belt covers removed, the tractor operator could monitor fertilizer application. It was difficult for the planter operator to break seed bridging in the seed hoppers as no access holes were provided. Holes had to be cut into the hopper (FIGURE 4). It is recommended that the manufacturer provide appropriate openings for breaking seed bridging.

FIGURE 4. Access Holes Cut in the Seed Hopper.
