# Evaluation Report

# 642

## Tebben Automatic Reset Deep Till

# TEBBEN AUTOMATIC RESET DEEP TILL

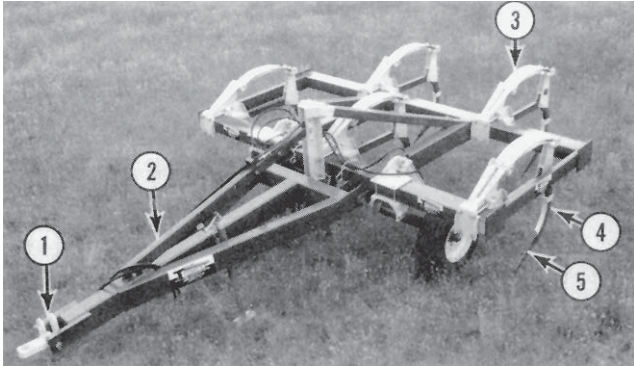
**FIGURE 1.** Tebben Automatic Reset Deep Til (1) Cat Hitch, (2) Pole Hitch, (3) Spring Assembly, (4) Parabolic Shank and (5) Reversible Point.

FIGURE 1 shows the location of major components while detailed specifications are given in APPENDIX I.

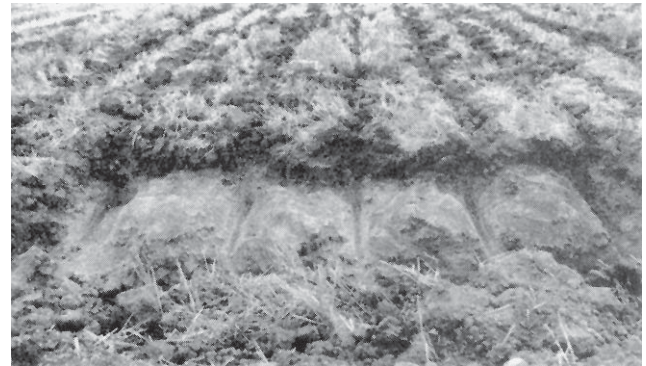
FIGURE 4 shows a soil fracture pattern in an untilled loam soil condition. The dry and hard soil provided ideal deep tillage conditions. Tillage depth measured 16 in (406 mm). Average soil fracture between the shanks was 10 in (254 mm), resulting in 6 in (152 mm) of undisturbed soil. FIGURE 5 shows the soil fracture pattern in the same field where the amount of soil fracture between

FIGURE 4. Soil Fracture of 10 in (254 mm) Between Shanks.

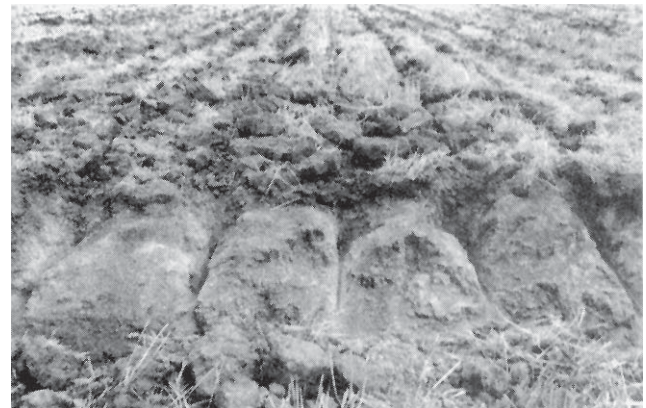
the shanks averaged 6 in (152 mm), leaving 10 in (254 mm) of undisturbed soil.

FIGURE 5. Soil Fracture of 6 in (152 mm) Between Shanks.

For proper soil fracturing between tillage passes, the spacing between passes should not exceed the 30 in (762 mm) lateral shank spacing.

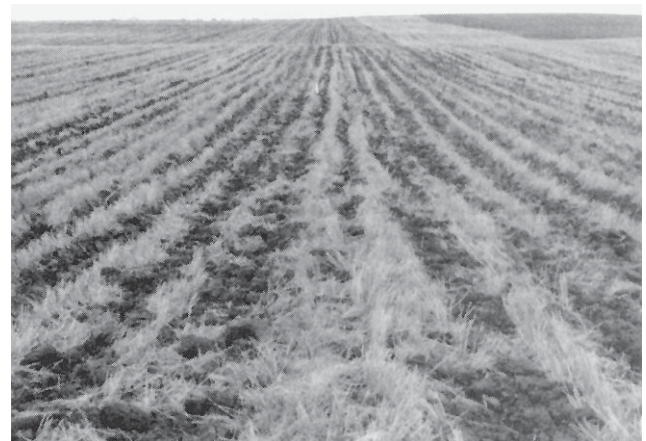
**Soil Surface:** FIGURE 6 shows the soil surface after deep tilling into an untilled loam soil condition. Significant soil disturbance occurred, leaving furrows with large lumps of soil on the surface. In some field conditions the shank tripping action would scatter soil. Straw was buried in the furrows in every field condition. The amount of straw buried depended on the tillage depth, furrow size, speed of tillage and soil conditions. In fields with light straw coverage the majority of the straw was buried.

FIGURE 6. Soil Surface Left by the Tebben Deep Til.

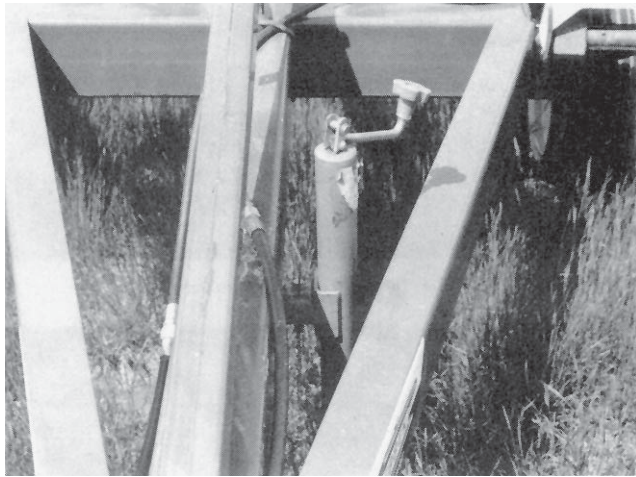
**Hitching:** Ease of hitching the Tebben was good. One person could hitch or unhitch the unit in five minutes. To move the hitch jack (FIGURE 7) to the vertical position required the operator to remove the jack from the jack stub. The jack was then turned and placed back on the stub. It is recommended that the manufacturer consider repositioning the jack stub to allow for easier movement of the hitch jack.

FIGURE 7. Hitch Jack Location.

1. Supplying a slow moving vehicle sign as standard equipment.
2. Providing a safety tow chain and the accommodations to secure the chain.
3. Repositioning the jack stub to allow for easier movement of the hitch jack.

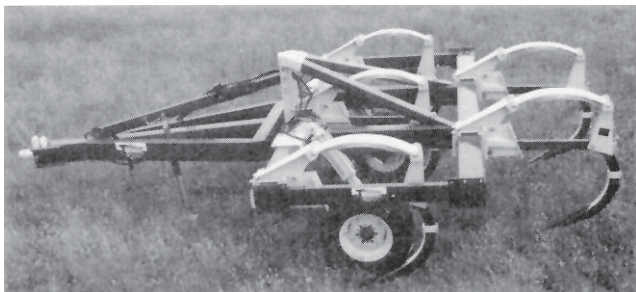
**Transporting:** Ease of transporting the Tebben was very good. To place the unit into transport position (FIGURE 8) required five minutes. The optional cat hitch allowed safe transporting of the unit by either a tractor or a vehicle.

FIGURE 8. Transport position.

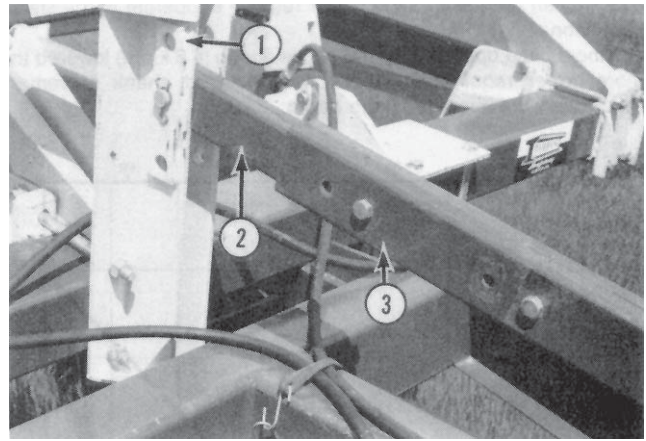
**Frame Leveling:** Ease of leveling the frame of the Tebben was very good provided the operator had assistance. Recharging the gauge wheel cylinders controlled lateral leveling. The sliding arms (FIGURE 9) on the pole hitch controlled fore-and-aft leveling. Holes spaced at 1.0 in (25.4 mm) on the interior arm and three vertical positions on the centre mast provided ample adjustment of the sliding arms.

FIGURE 9. Pole Hitch Sliding Arms: (1) Centre Mast, (2) Interior Arm and (3) Exterior Arm.

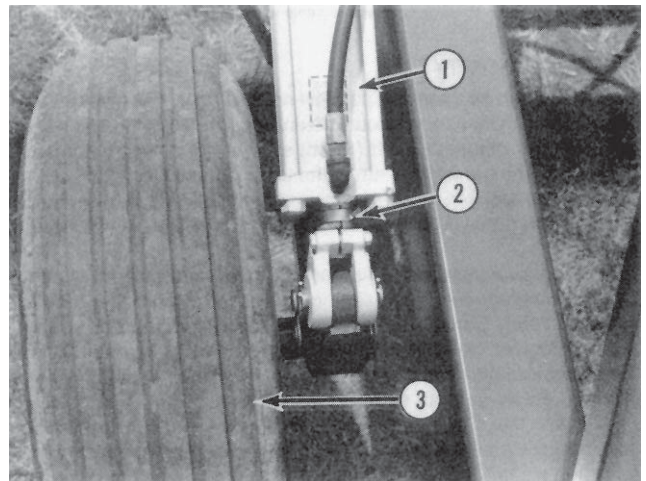
**Depth Adjustment:** Ease of setting the tillage depth was very good. Tillage depth was set by inserting depth stops on the master (left) cylinder (FIGURE 10). Four different sizes of depth stops were provided. No depth stops were used at the maximum tillage depth. The manufacturer suggested that the distance between the pivot pins (FIGURE 3) of the leaf springs, or the camber, be set to 27 in (666 mm). A hydraulic jack was required to set the spring camber. The adjusting bolt on the shank was loosened before setting the spring camber.

FIGURE 10. Depth Adjustment (1) Master Cylinder, (2) Depth Stop and (3) Gauge Wheel.

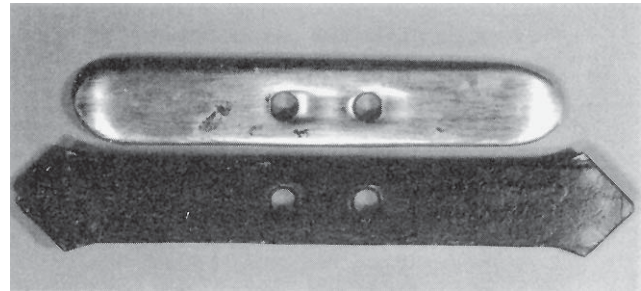
**Wear Parts:** FIGURE 12 shows a new point compared to a worn point. The worn points were turned after deep tilling 250 ac (101 ha) giving 50 ac (20 ha) per point. Total point wear could be doubled for wear on both points. The replacement cost of one point complete with nuts and bolts was \$46.75. The wear on the 0.5 in (13 mm) thick wear plates for the shanks showed rounding on the corners. The plates were considered to have considerable wear left.

FIGURE 12. Point Wear: Tip New Point, Bottom Worn Point.

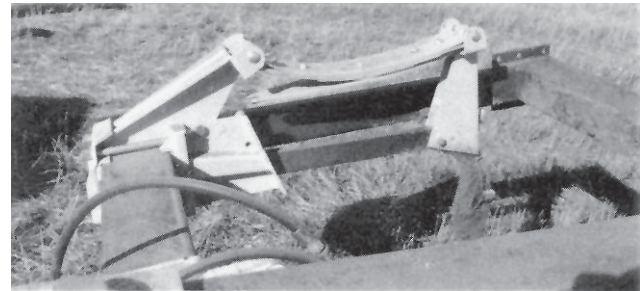
**Over-Centred Leaf Spring:** After encountering a rock, the resetting of the shank assembly was very quick. Return force and loose shank bolts caused one leaf spring assembly (FIGURE 13)

FIGURE 13. Over Centred Leaf Spring.

to go over centre. The leaf spring camber was re-set and the bolts retightened. No other problems occurred to the leaf spring assemblies.
