Evaluation Report

222

Degelman LC14 Rock Rake

DEGELMAN LC14 ROCK RAKE

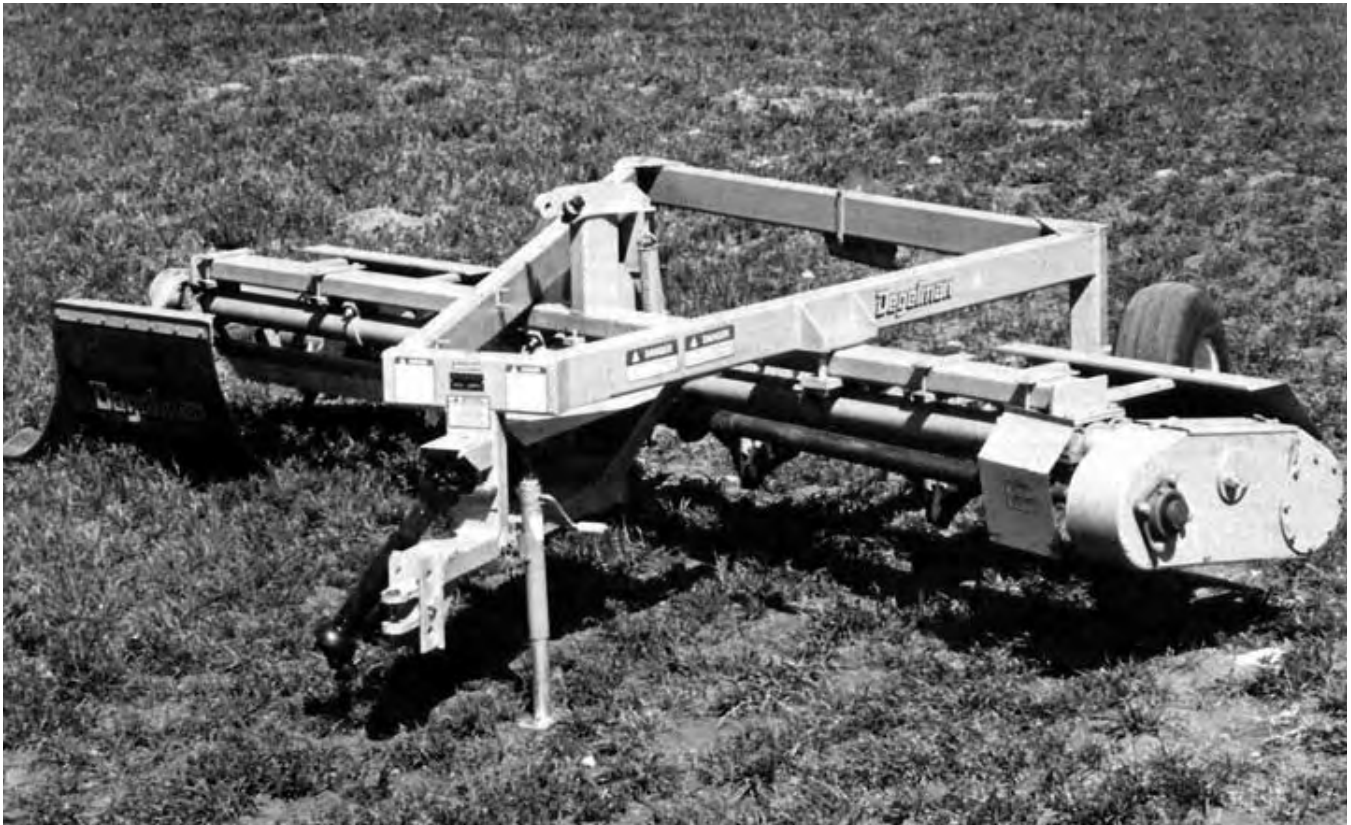
FIGURE 1. Degelman LC14: A) Depth Control, B) Rake Drum, C) Slip Clutch, D) Rock Shaft Assembly, E) Rock Deflectors, F) Optional Small Stone Deflector.

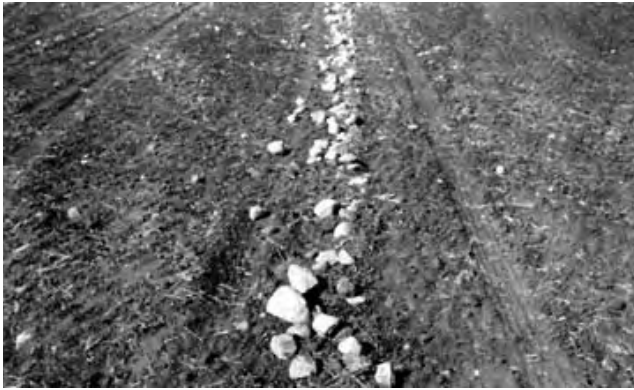
FIGURE 2. Typical Raking Performance in a Field Heavily Concentrated with Small Rocks. Optional Small Rock Deflector Attachment Used.

In fields with a heavy concentration of small rocks a number of rocks were missed by being thrown back over the drum. The

optional small rock deflector attachment effectively prevented carry over of small rocks in these conditions (FIGURE 2). The small rock deflector attachment should not be used in fields infested with rocks larger than 375 mm (15 in). If large rocks are caught and thrown over the drum, as occasionally happens, the small rock deflector can be damaged (FIGURE 3).

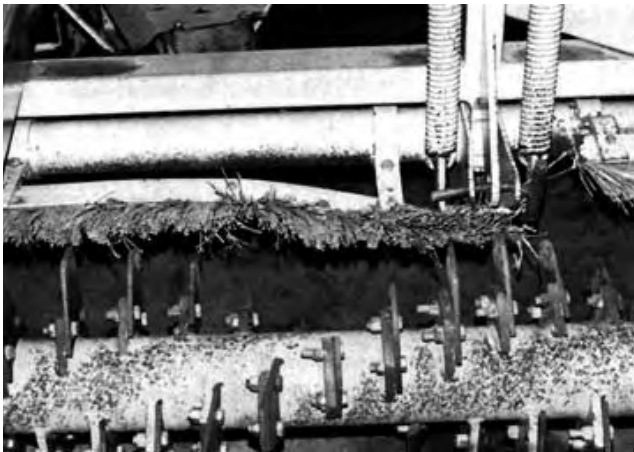
FIGURE 3. Small Rock Deflector Damaged by Large Rocks.

Small Rock Deflector: The best performance of the optional small rock deflector attachment was obtained by positioning the brushes to point directly at the centre of the rake drum. When operating in larger rocks, the deflector had to be removed to prevent

damage. The deflector could be removed in less than 15 minutes.

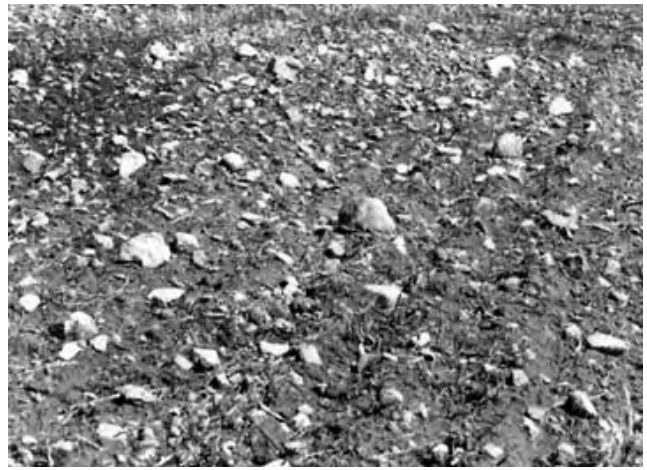
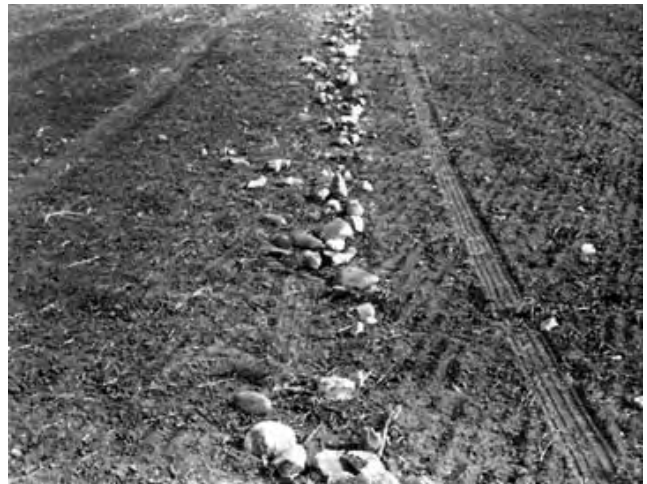
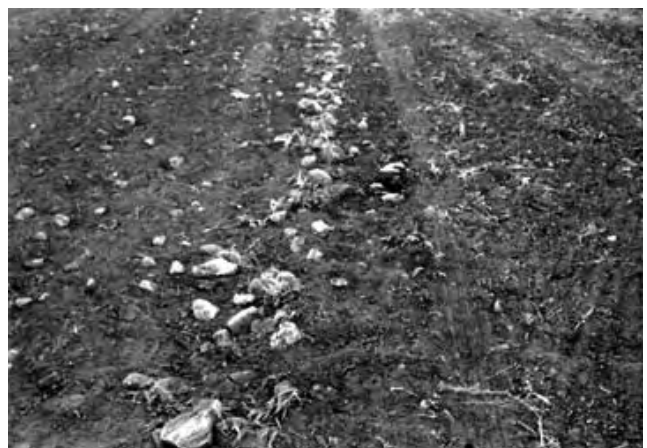
Windrow Formation: As is shown in FIGURE 4, windrow formation depended on ground speed. At speeds below 5 km/h (3 mph) dense, uniform windrows were formed in most conditions. High speeds resulted in scattered windrows.

FIGURE 4. Typical Performance in a Field with Medium Rock Concentration (A) Before Windrowing, (B) Windrowed at 5 km/h, (C) Windrowed at 7 km/h.

To effectively windrow surface rocks and to minimize soil retention in the windrow, forward speed had to be selected to suit field conditions. When set at an 18° rake angle best performance was achieved with a tooth index¹ of about 1.5 in fields with light rock concentrations, about 2 in fields with medium rock concentration and about 3 in fields with heavy rock concentrations. Since the rake drum speed was fixed at 143 rpm, corresponding ground speeds were about 8, 6 and 4 km/h (5, 3.7 and 2.5 mph) in light, medium and heavy concentration, respectively. FIGURE 4 shows the effect of ground speed on raking effectiveness in a field with medium rock concentration.

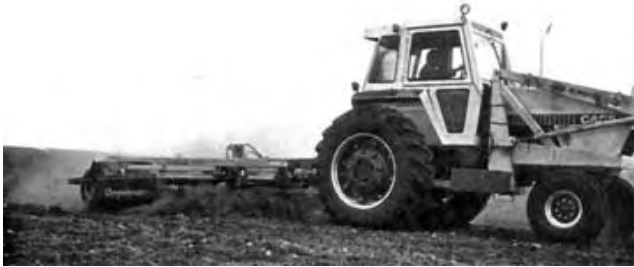
Soil Pulverization: The windrower caused considerable soil pulverization, especially at low ground speeds. Pulverization decreased with increased ground speeds. Raking levelled the field surface and broke most surface lumps, creating a condition susceptible to wind erosion. In dry fields, operation was very dusty (FIGURE 5), often causing the windrower to be completely obscured. At times the operator was unable to see where the rake had passed on the previous round. Because of the dust problem, a tractor equipped with a cab was desirable.

FIGURE 5. Typical Dust Conditions.

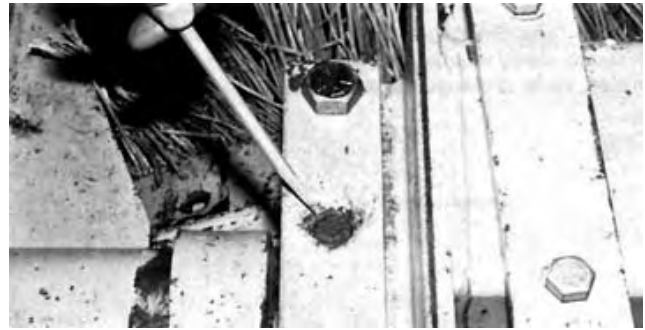
Ease of Servicing: The windrower was easy to service. All lubrication points, the drive chain and the slip clutch were accessible. As the grease fittings on the rock shaft assembly (FIGURE 6) were recessed into the support frame, the hole surrounding the fittings filled with soil and had to be cleaned before each lubrication. It is recommended that the rock shaft grease fittings be modified to eliminate this problem.

FIGURE 6. Soil Accumulation in Rock Shaft Grease Fittings.

3. The grease fittings are being changed to the bottom of the rockshaft bearing in the next production run. The grease fittings are recessed to protect them from rocks.
4. The rock deflectors will be changed to a better material with plies of reinforcing for more strength and tear resistance.

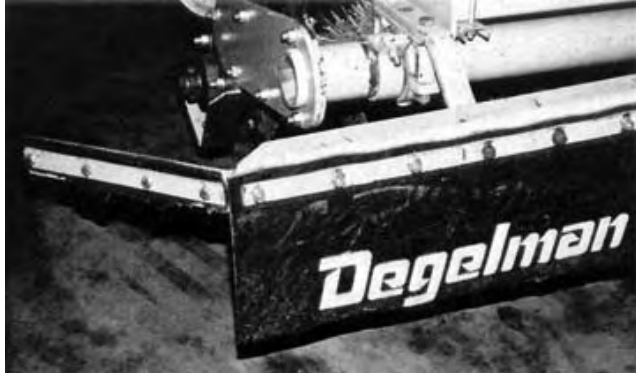
Rock Deflectors: The rock deflectors, which were constructed of a rubberized fabric, tore easily during normal operation (FIGURE 7). It is recommended that the manufacturer consider modifications to improve durability of the rock deflectors.

FIGURE 7. Tom Rock Deflector.
